M/V "SIMONE" (ex "YONG GI") IMO: 8035104

SHIP'S PARTICULARS

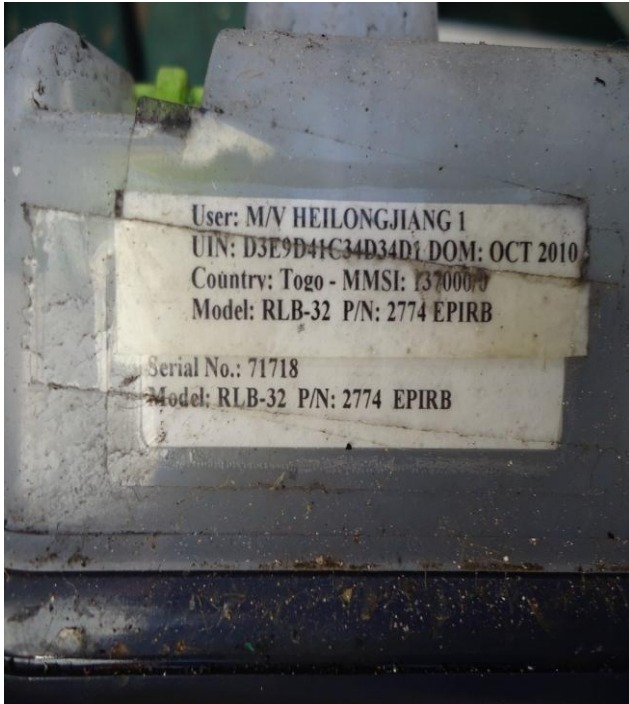
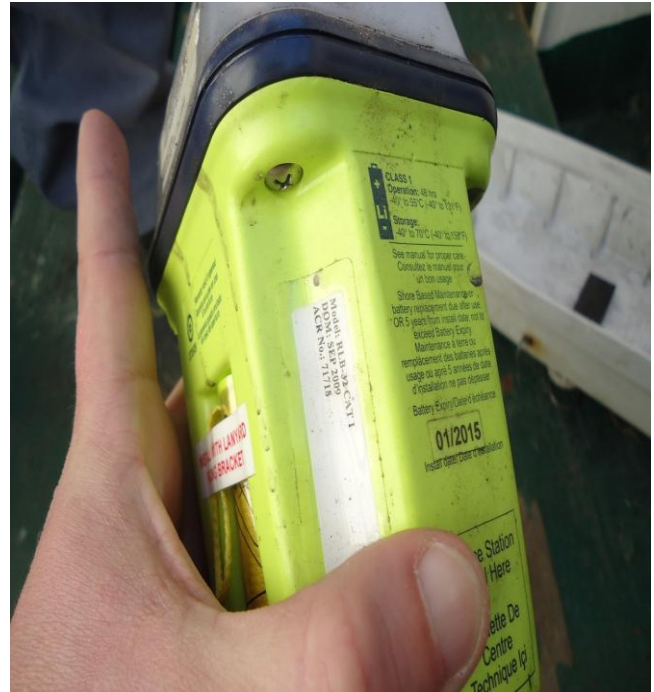
1. The EPIRB device was found on board but was programmed with a different MMSI number, flag State data and name of the ship. The Hydrostatic Release Unit of the aforementioned device was found expired. The deficiency was noted as ground for detention.

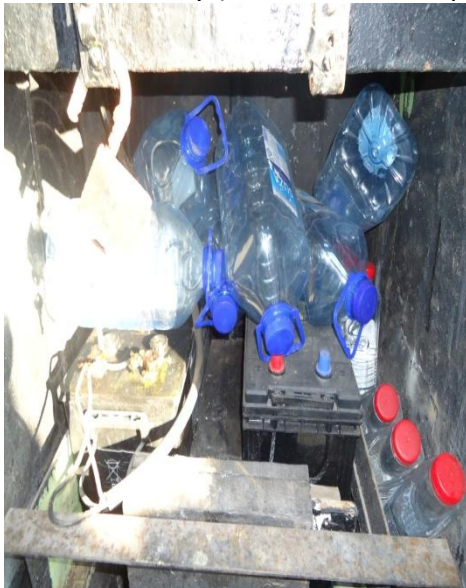
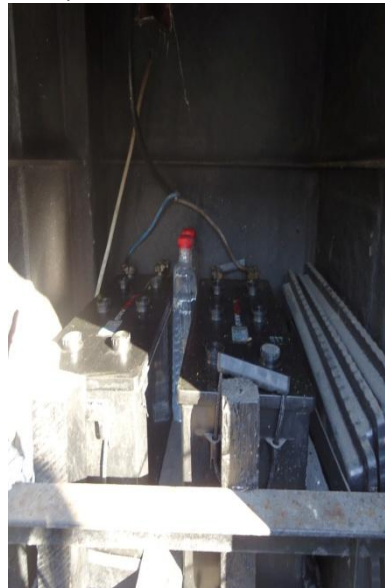
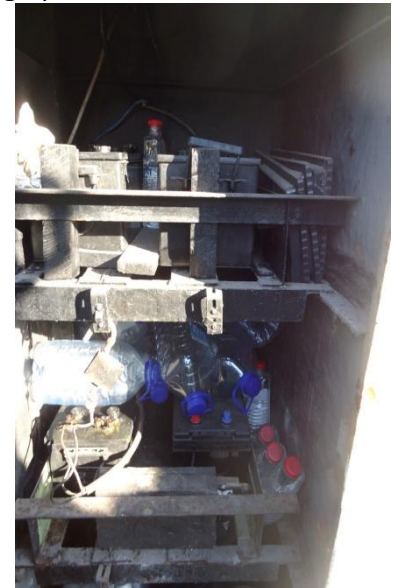
2. The battery (for the GMDSS equipment) room was used as a storage place.

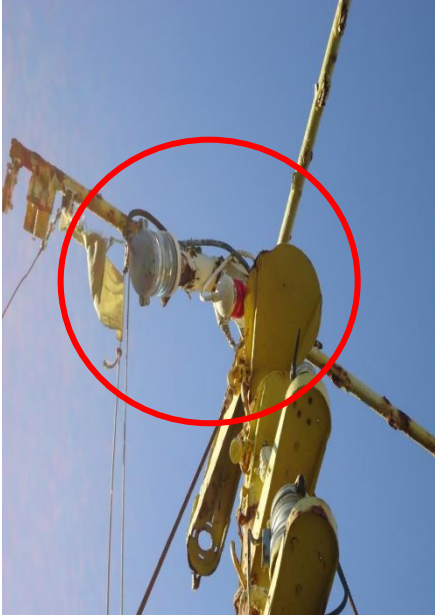
1. The upper part of the main mast above the bridge was found damaged/wasted. Also some of the navigation lights were fastened by ropes. The deficiency was noted as ground for detention.

Broken

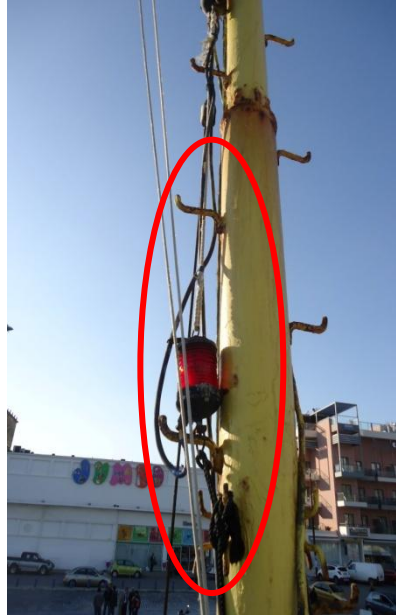
Fastened with rope

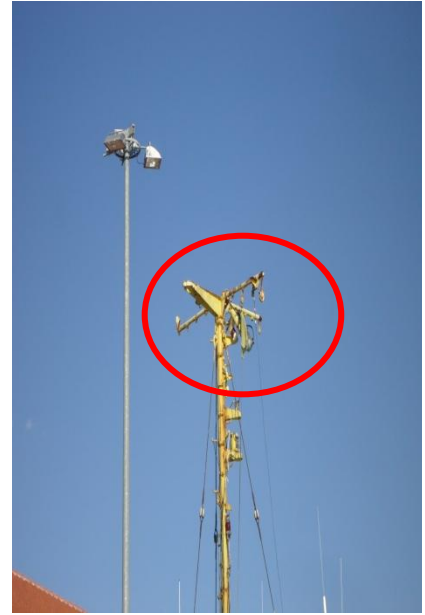
Broken

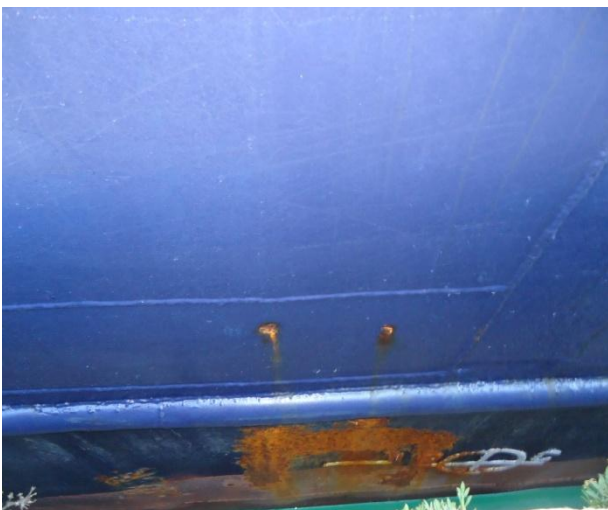
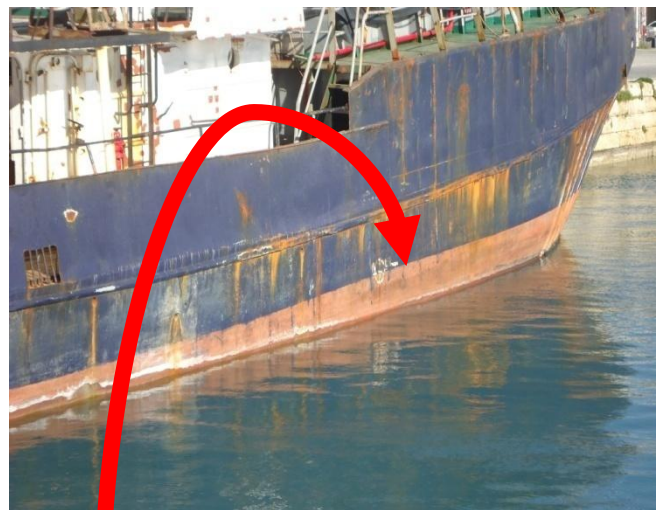
Plimsol mark

1. The deck lines on both sides of the vessel were missing. The deficiency was noted as ground for detention.

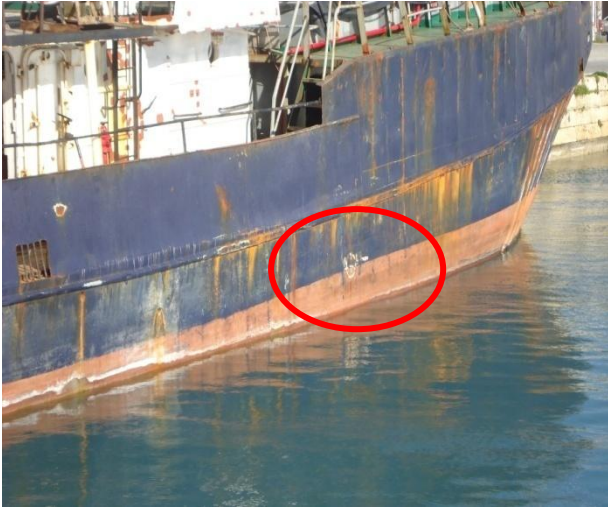
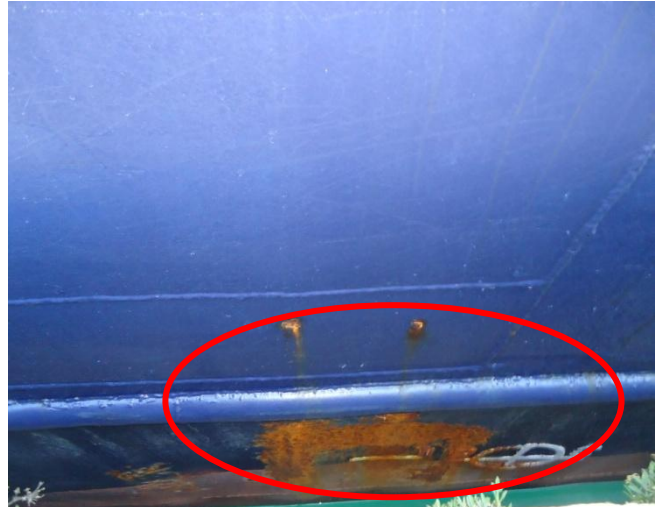
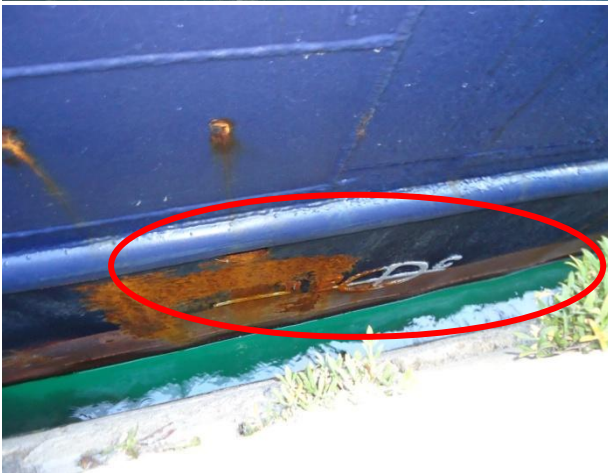
2. Load lines on both sides of the vessel were missing. The deficiency was noted as ground for detention.

Load lines missing

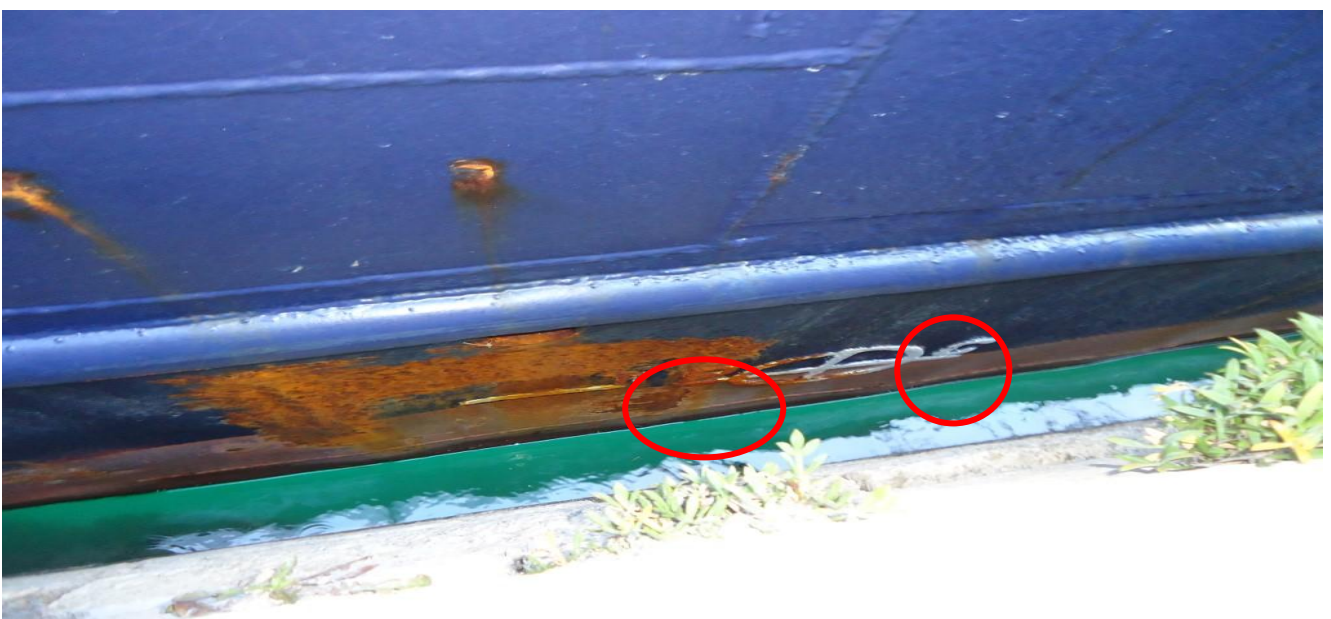
3. The assigning authority mark was not in accordance to the relevant ICLL certificate. The deficiency was noted as ground for detention.

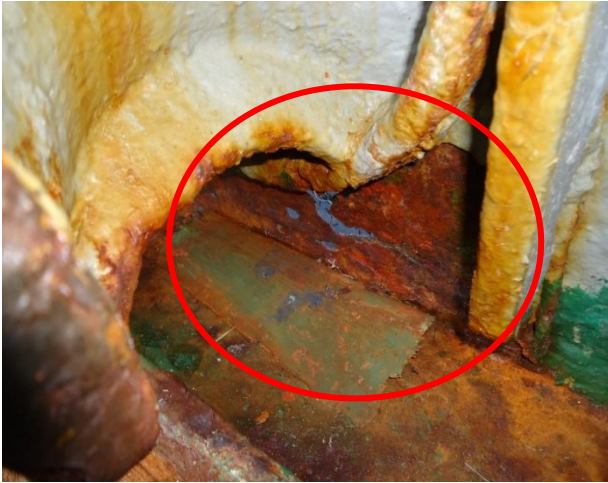
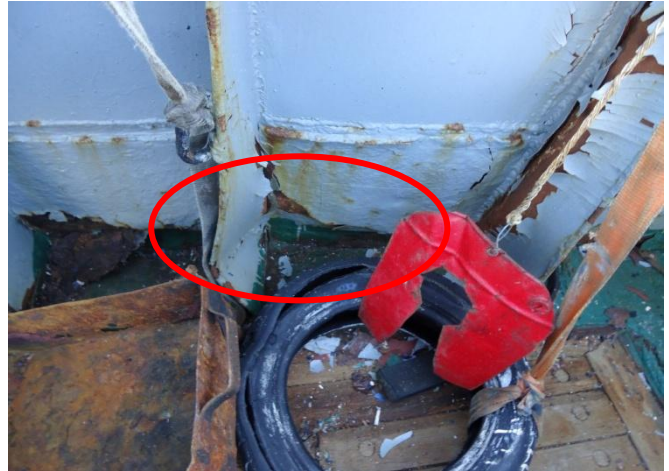
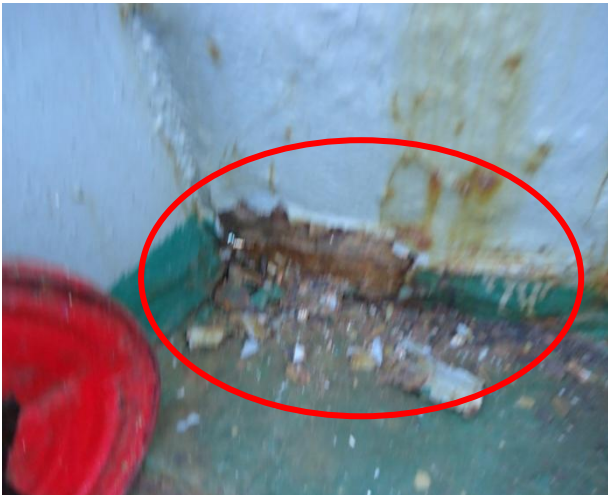
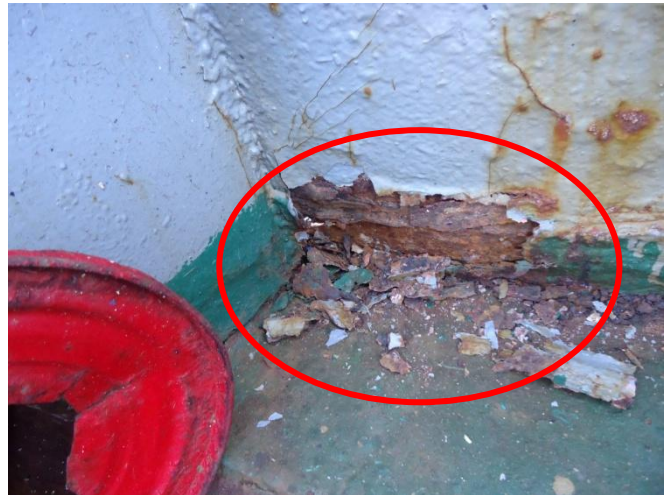
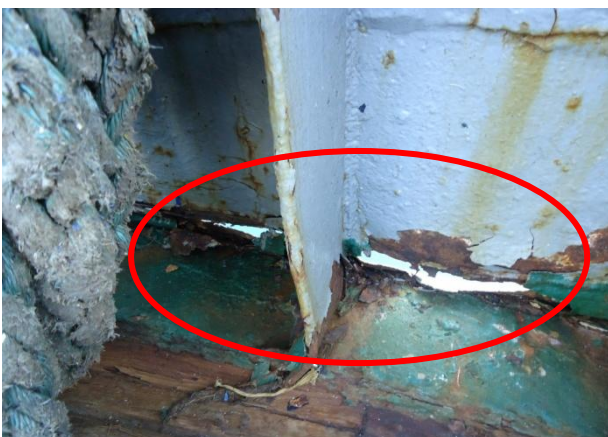
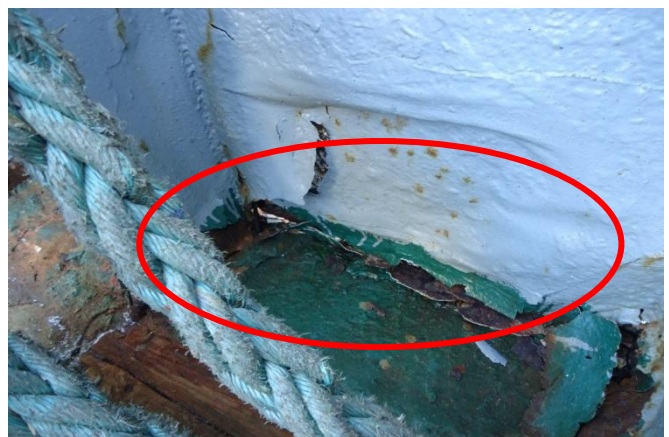
4. Many cracks were found at the connection of the bulwark on the main deck at port side and starboard side of the vessel. The deficiency was noted as ground for detention.

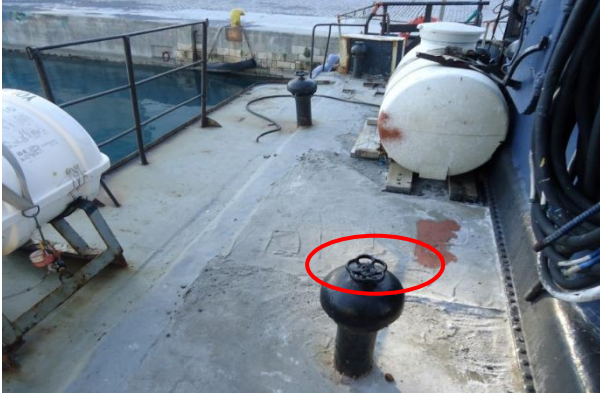
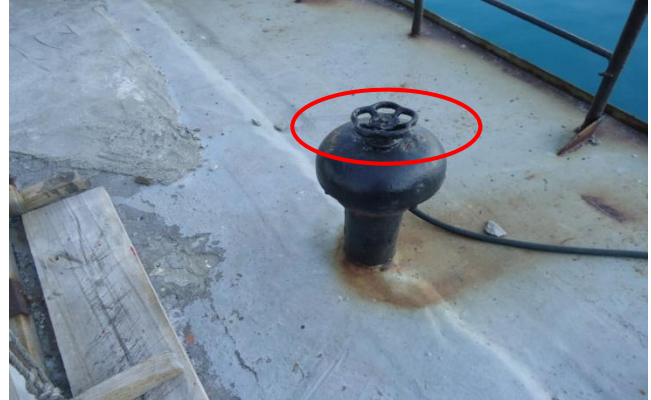
5. All the closing mechanisms of the natural ventilators located on the monkey deck and at the bridge deck were stuck. Also the hatch of the natural ventilator on the funnel (FWD) was missing and the butterfly nuts were stuck (due to rust and paint). The deficiency was noted as ground for detention.

Closing mechanisms completely stuck

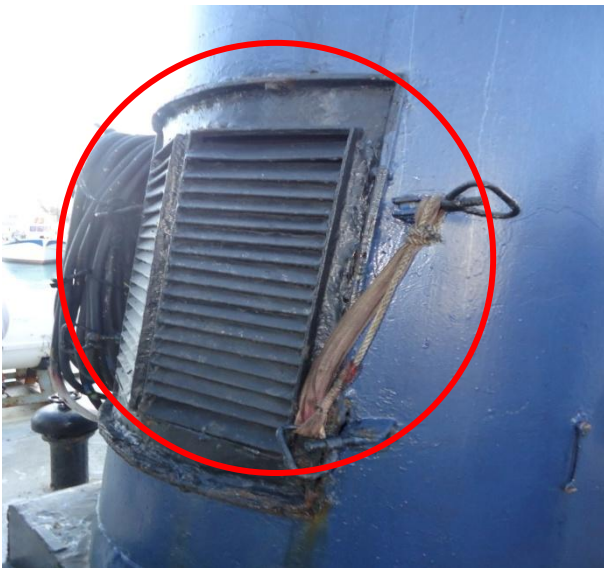
The hatch of the natural ventilator on the funnel (FWD) was missing

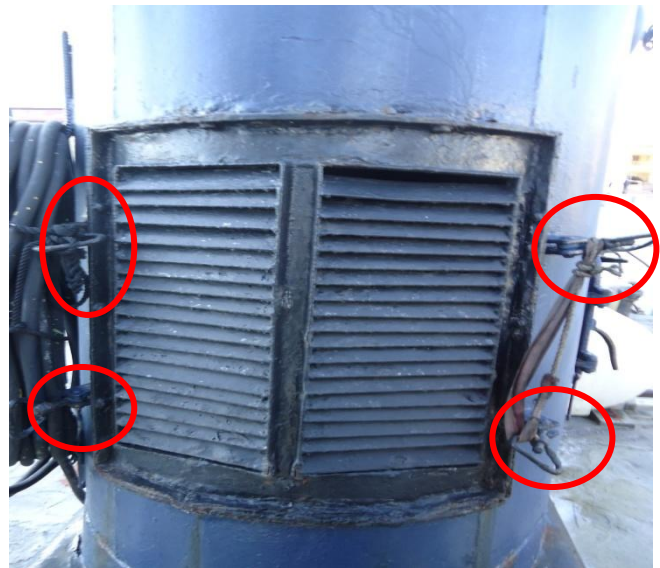
The butterfly nuts were stuck (due to rust and paint)

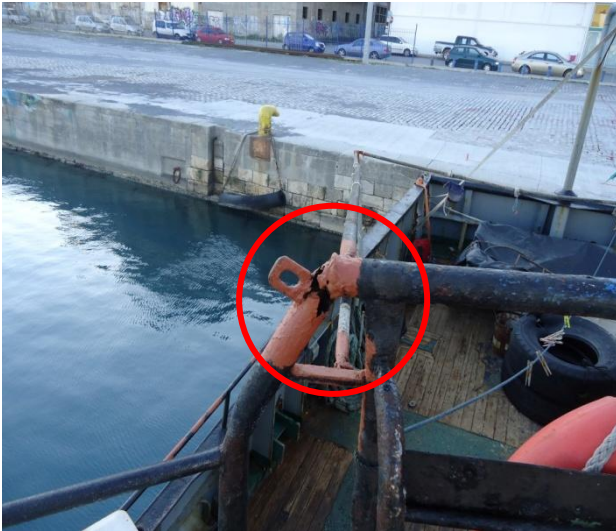
6. Protective rails at starboard side (FWD) were found damaged and almost destroyed (some were bended and some were missing). Other protective rails at starboard (AFT) side were missing: a clear danger for the working personnel at open decks. The deficiency was noted as ground for detention.

Broken

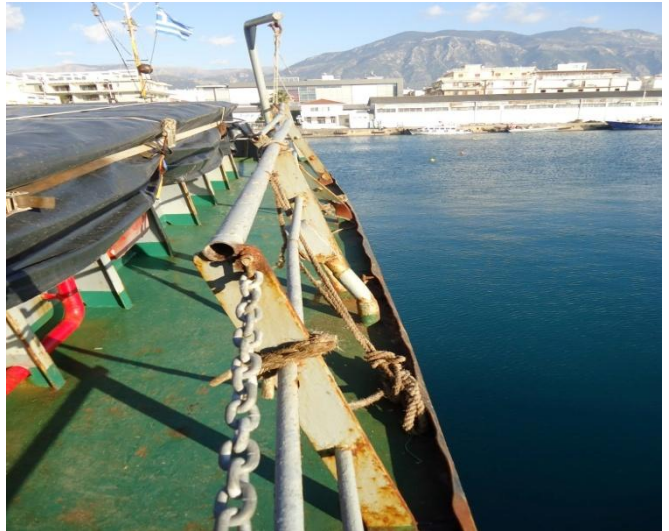
Broken and bended

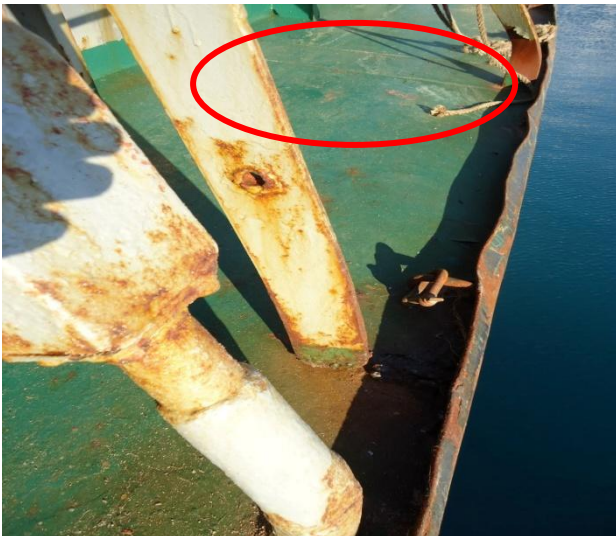
Missing

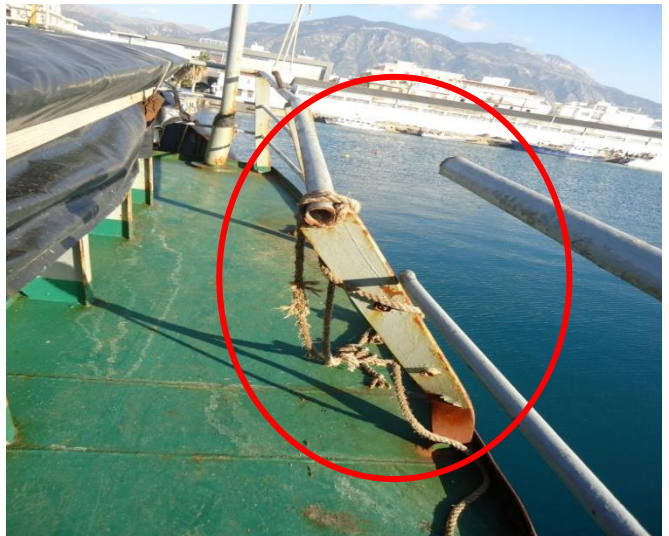
Damaged

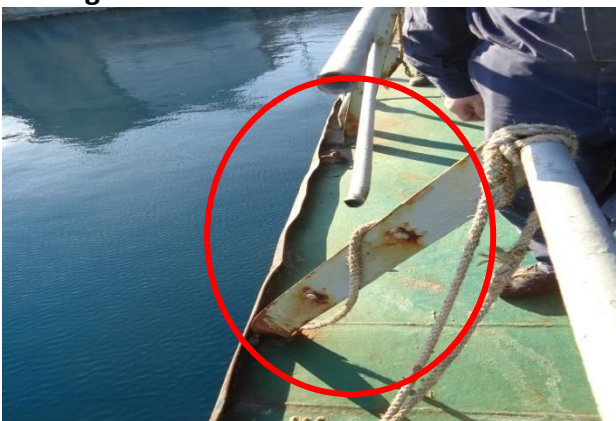
Damaged

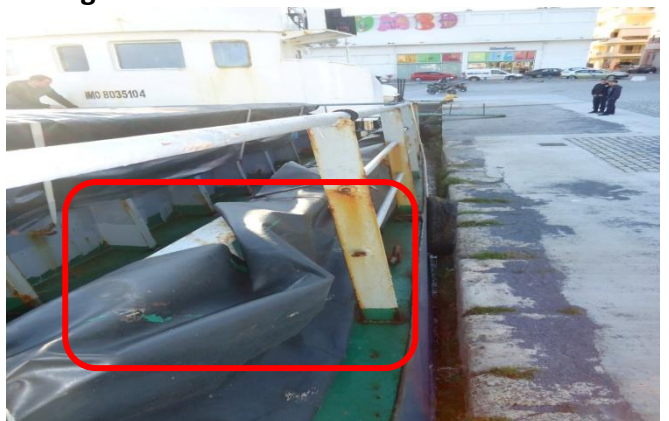
Missing

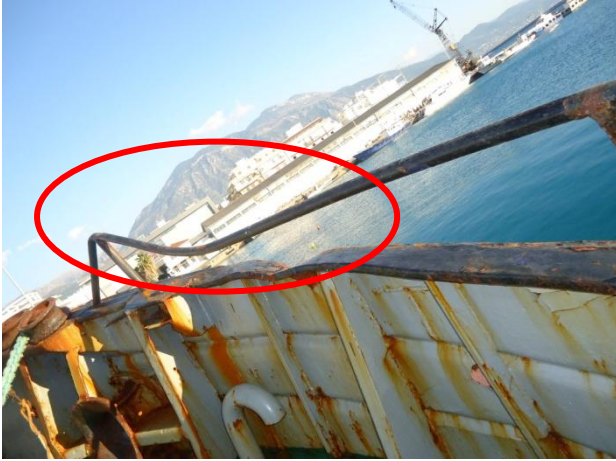
Bended

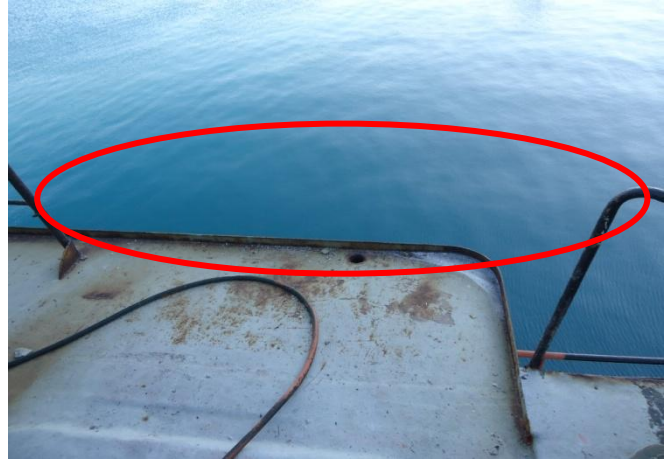
Missing

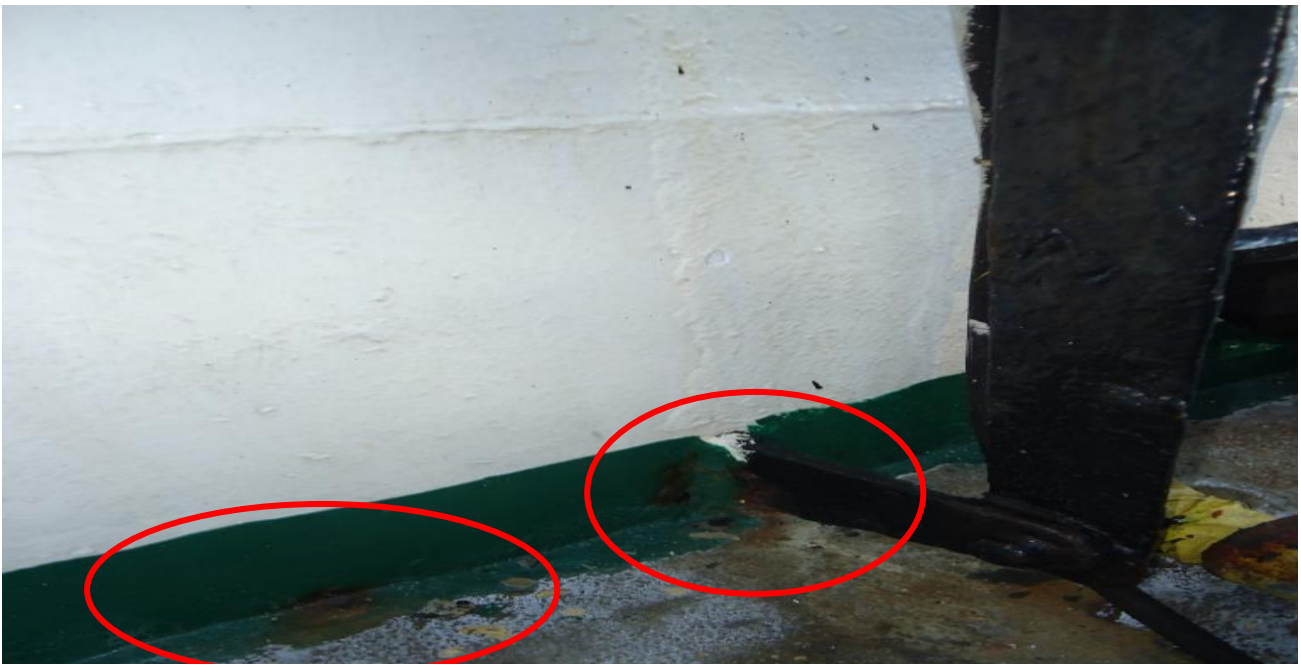
7. Cracks were found on the connection of the bulkhead of the bridge's superstructure with the open bridge deck (AFT). The deficiency was noted as ground for detention.

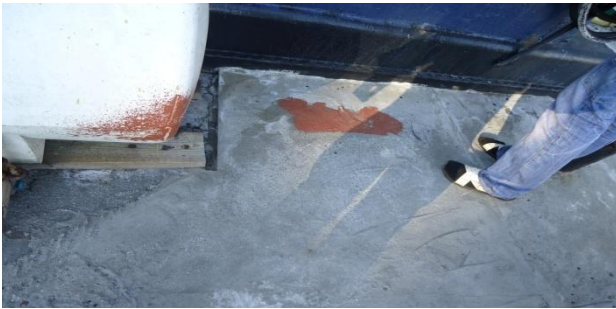
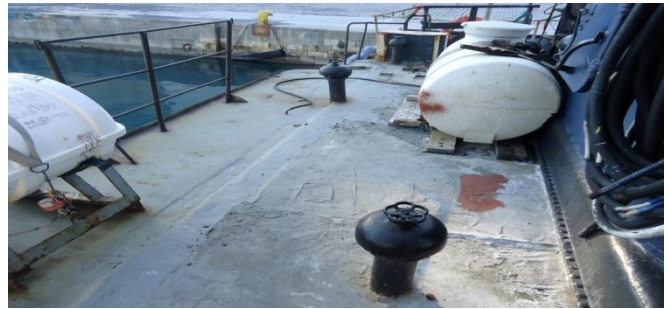
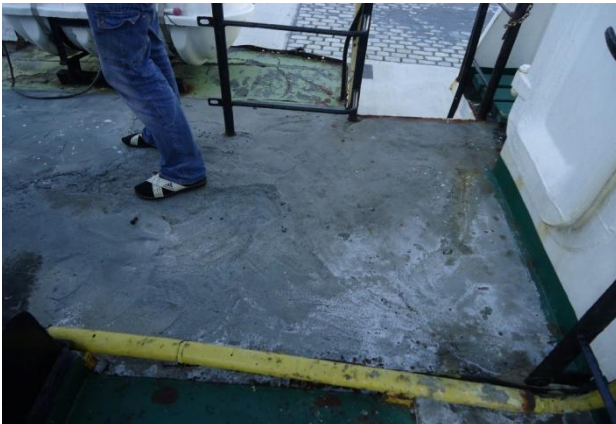
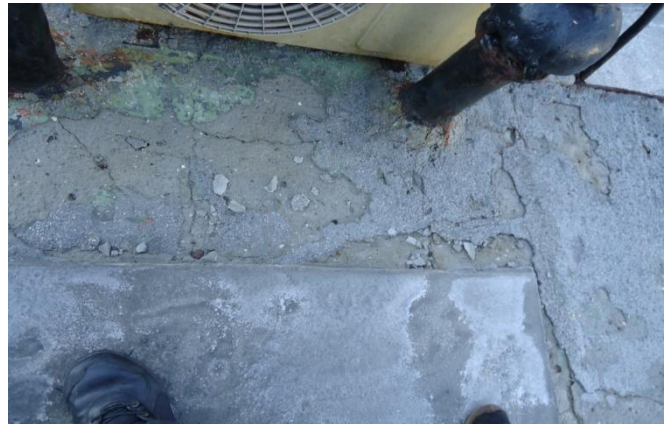
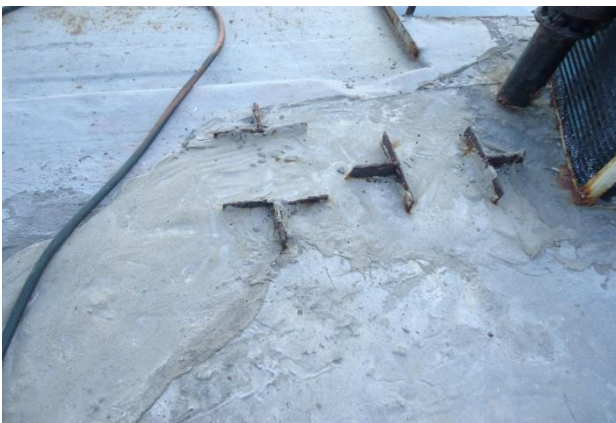
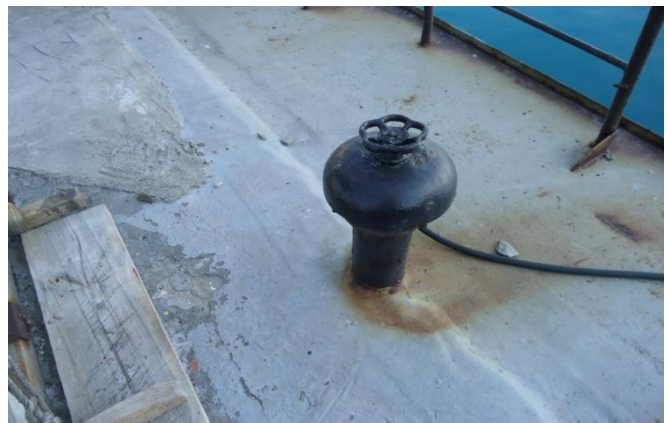
8. The whole surface of the deck plating of the bridge deck (around the funnel) was covered with cement. The PSCO demanded that the state of the metal plate was verified with the RO and that the cement had to be removed. The deficiency was noted as ground for detention.

Deck plating of the bridge deck (around the funnel) was covered by cement.

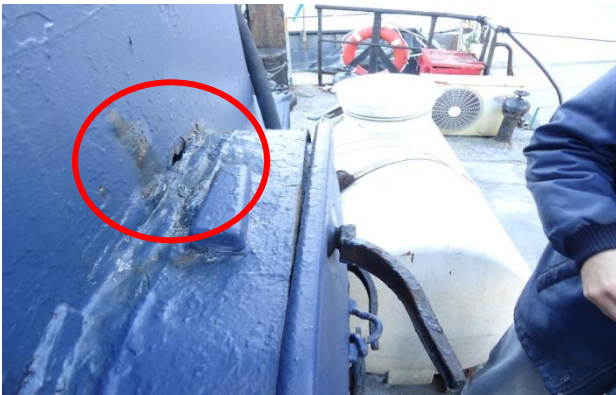
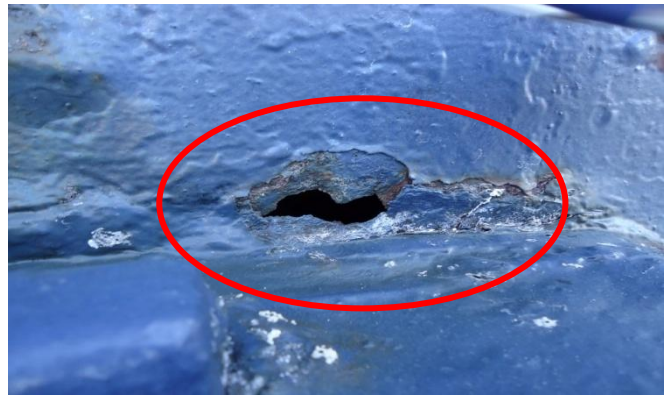
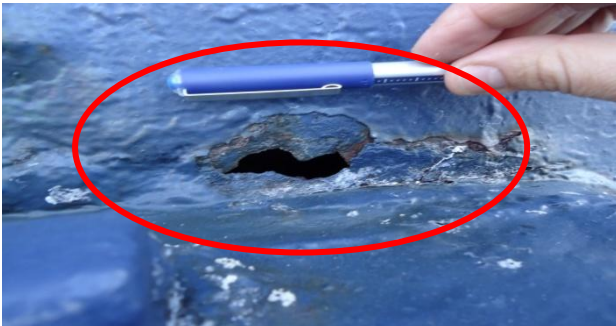
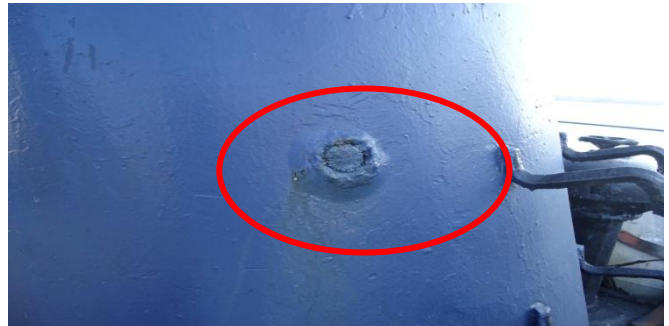
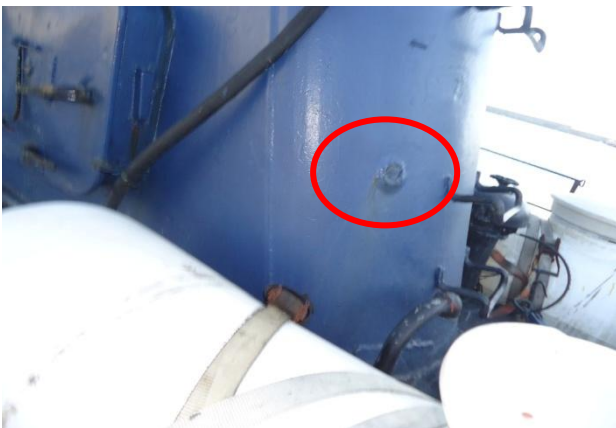
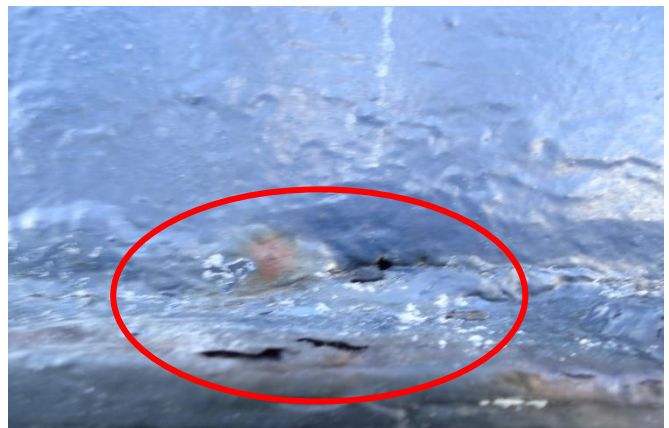
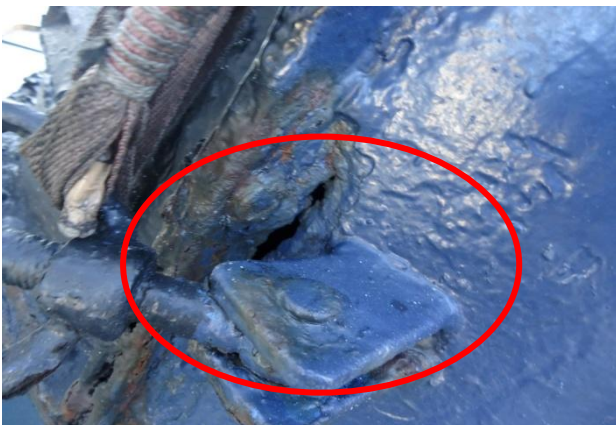
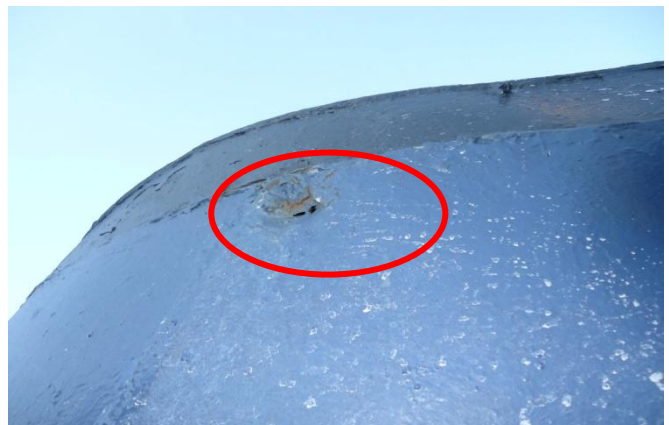
9. Many cracks were found around the main body of the funnel. Mainly around the port side natural ventilator opening. The deficiency was noted as ground for detention.

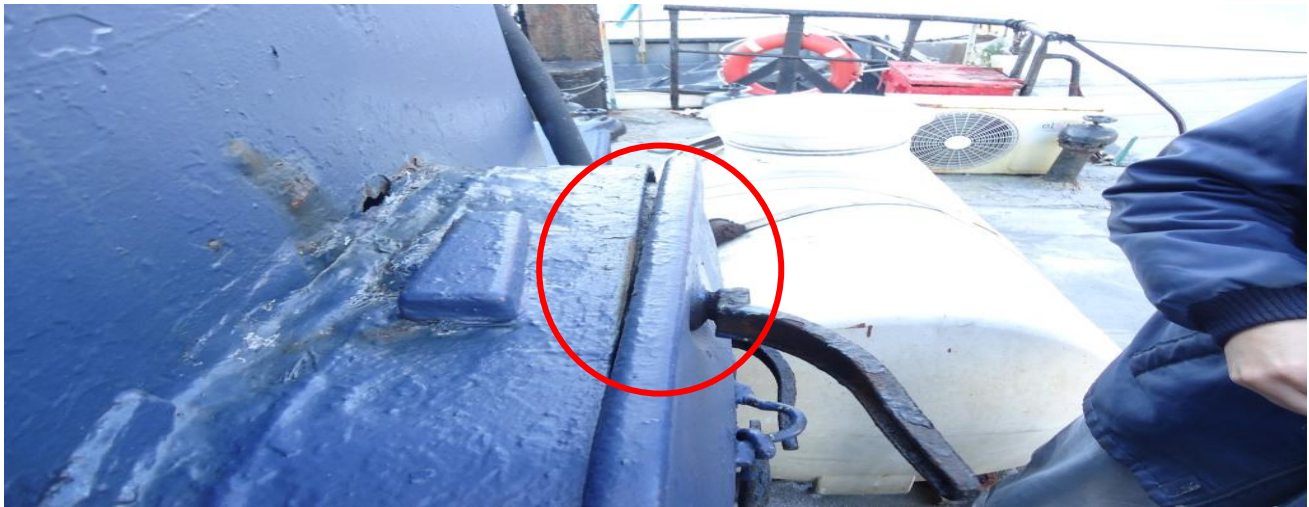
10. The hatch on the side of the natural ventilator on the port side of the funnel was not closing properly. The deficiency was noted as ground for detention.

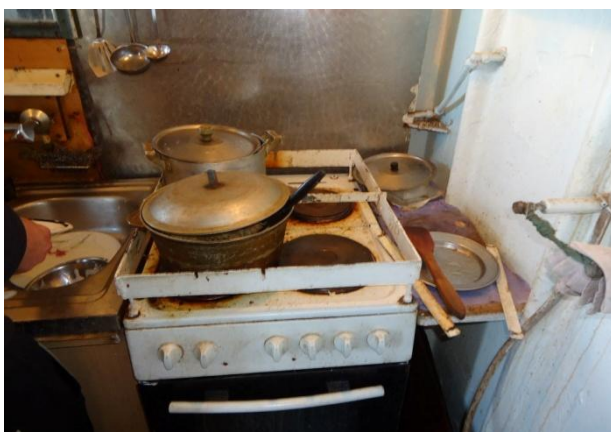
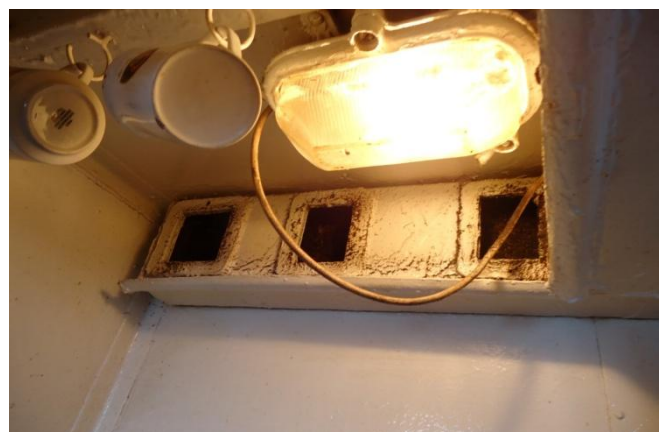
7. The overall tidiness condition of the accommodation areas must be improved. Especially in general areas like the mess room and in crew cabins.
8. The space of the galley must be cleaned and hygiene conditions have to be improved.

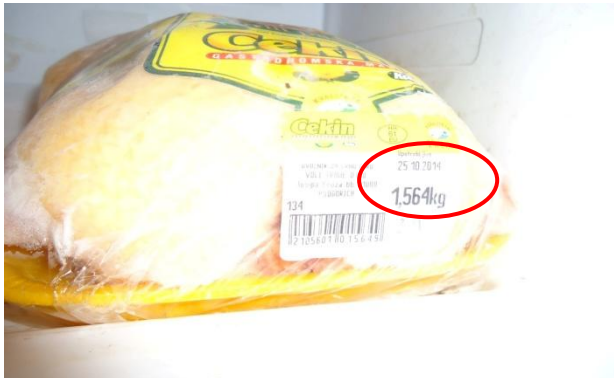
Expired

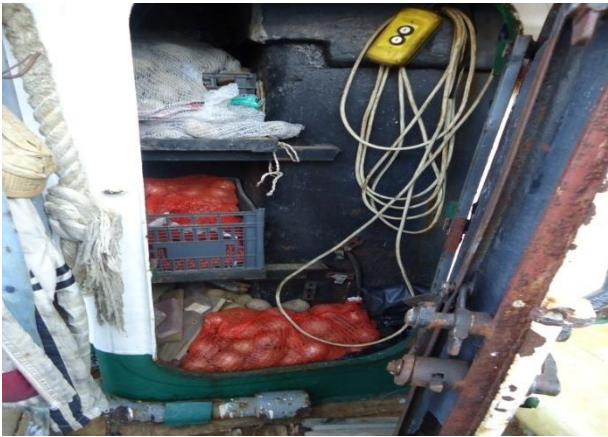
Various provisions (potatoes , onions) were placed in a storage with other materials

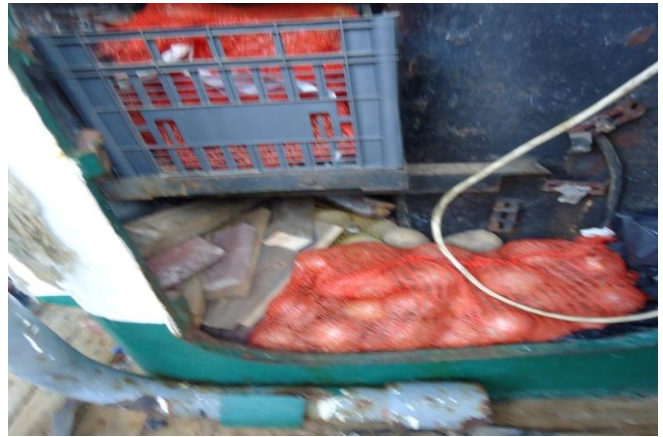
Insufficient quantity of fresh provisions (vegetables, fruits, etc.)
