SAFI

IMO no.: 7108899

Ship type: general cargo

Port of detention: Catania
(Italy)

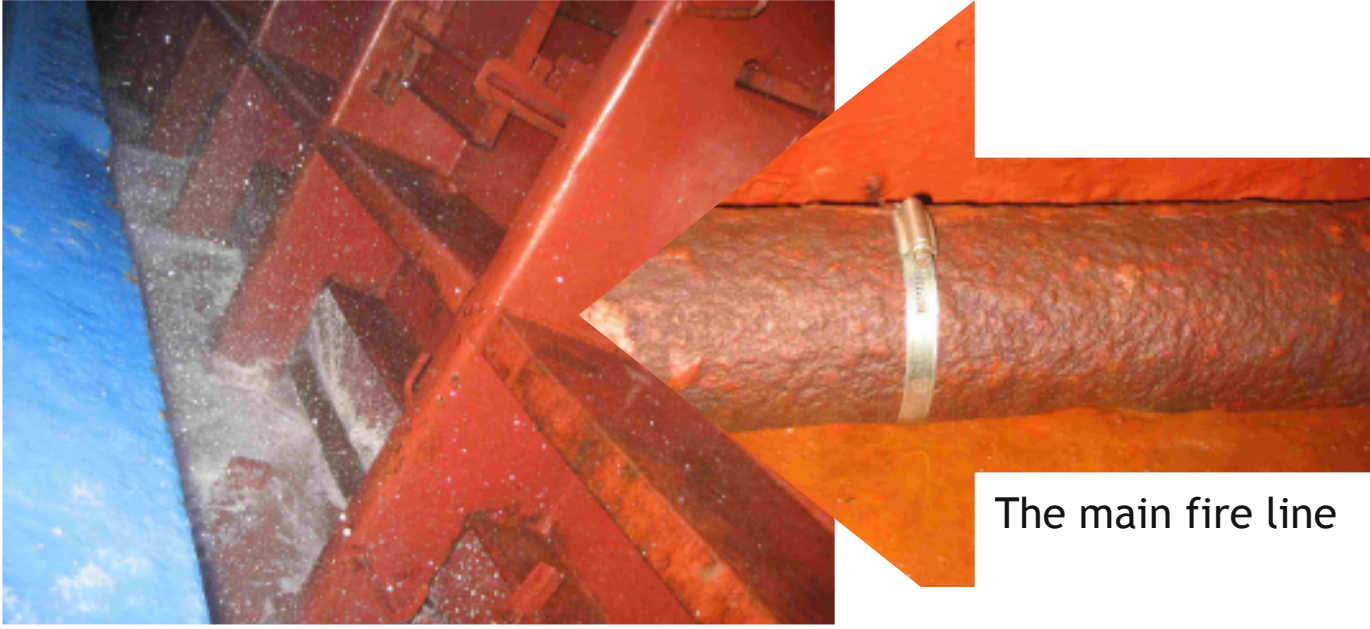
The main fire line

- main fire line is holed in main deck and heavy leaking (temporary repairs by clamps are noted);
- inflatable liferafts are fitted with expired hydrostatic release units (and weak links are not properly connected);
