HELLENIC REPUBLIC
MINISTRY OF MARITIME AFFAIRS AND INSULAR POLICY
HELLENIC COAST GUARD
CENTRAL PORT AUTHORITY OF KALAMATA
P.S.C. DISTRICT OFFICE OF KALAMATA

Detention of M/V "TOK TOK"

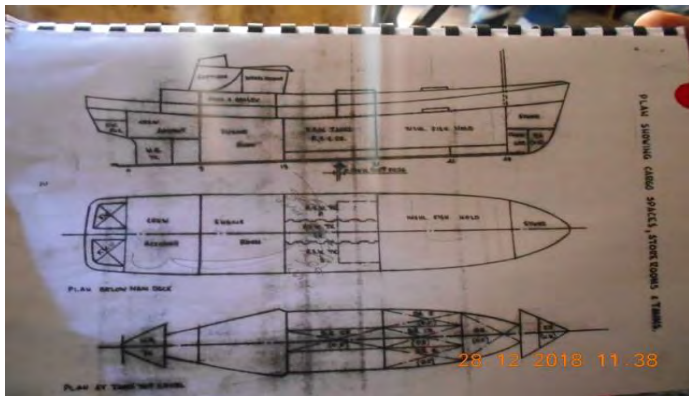
- .1 The presented Stability Booklet was approved by an Administration, other than the Flag Administration, describing the vessel as a fishing vessel.

Major modifications/alterations of the ship were found with regard of the ship's above mentioned Stability Booklet.

Specifically, new bulkheads, oil and ballast tanks, stringer plates, equipment (pumps, pipes, etc.) were found without the corresponding volumes and the center of gravity. Actual lightweight does not correspond to the above mentioned Stability Booklet.

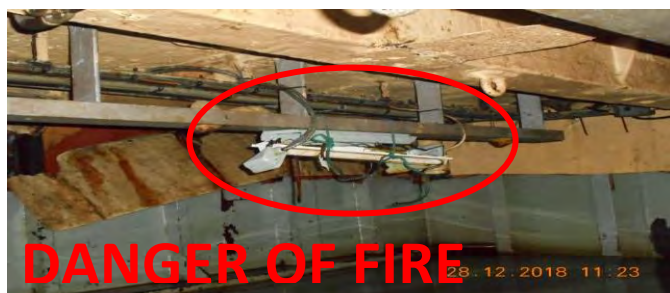
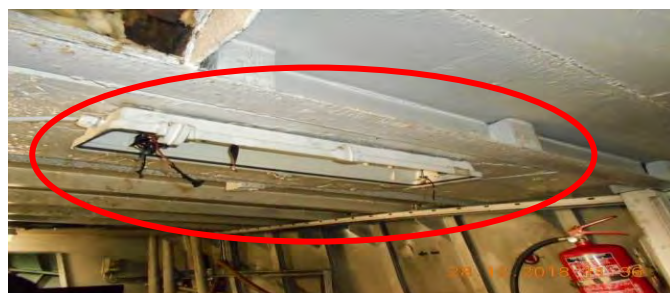
Broken light protective covers and other various cables. The bare electric cables on the above photo, are in the cargo hold, which was found with a significant amount of diesel oil.

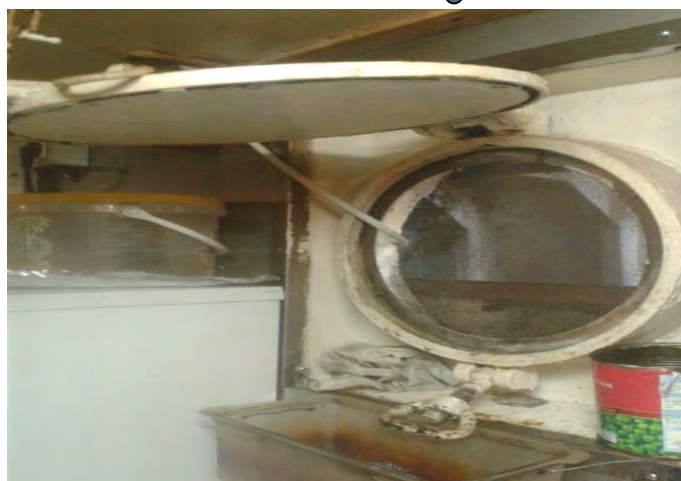
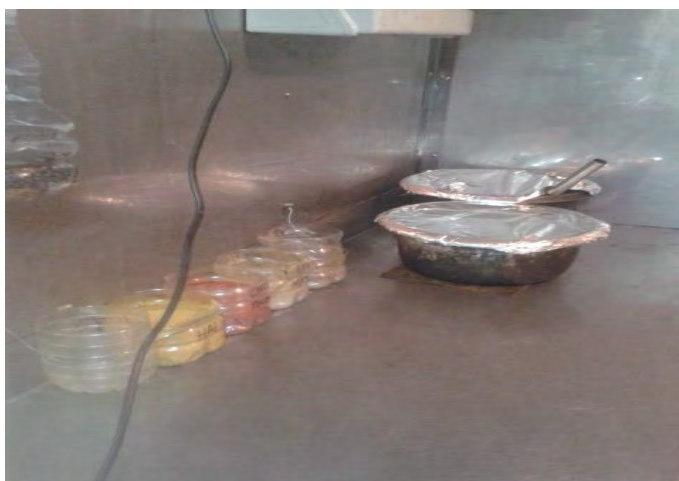
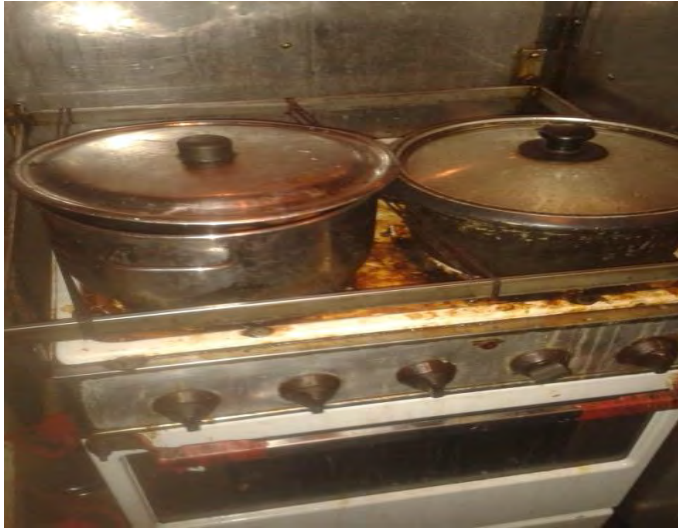
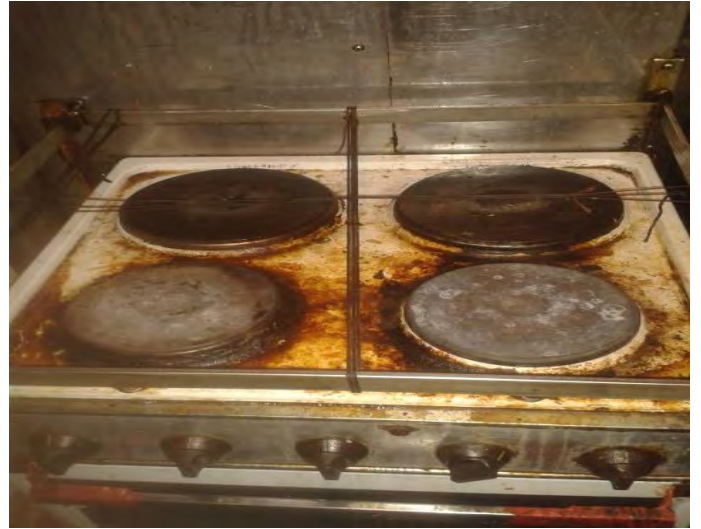
THE GALLEY

The condition of the electric kitchen is obviously indescribable

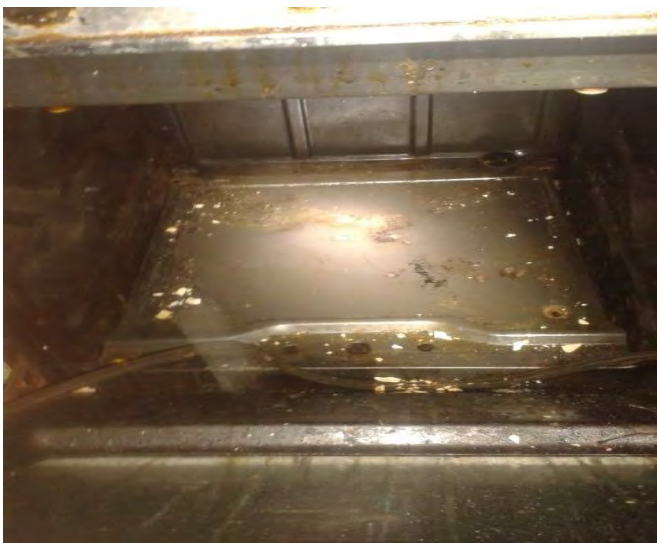
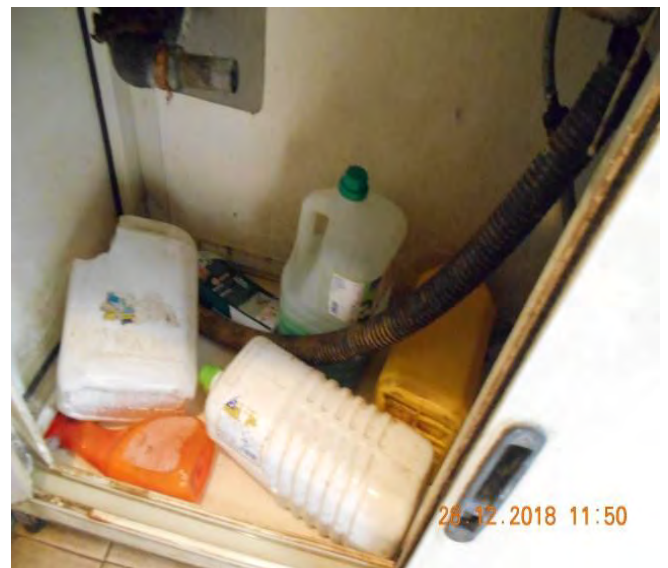
The condition of the oven

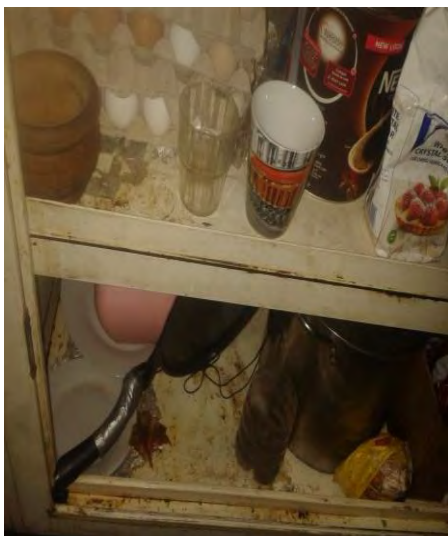
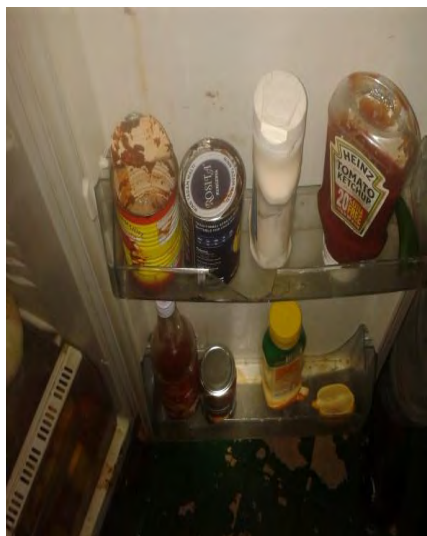
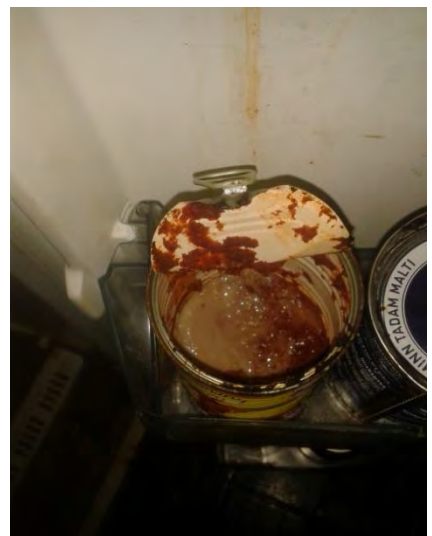
The condition of the refrigerator in the galley

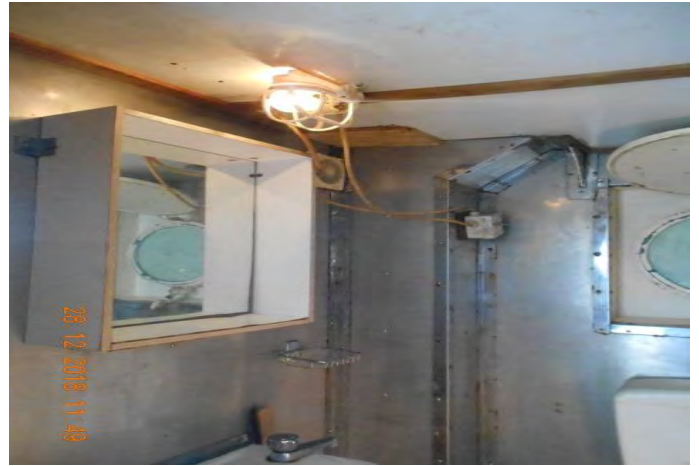
The common WC was found in poor condition

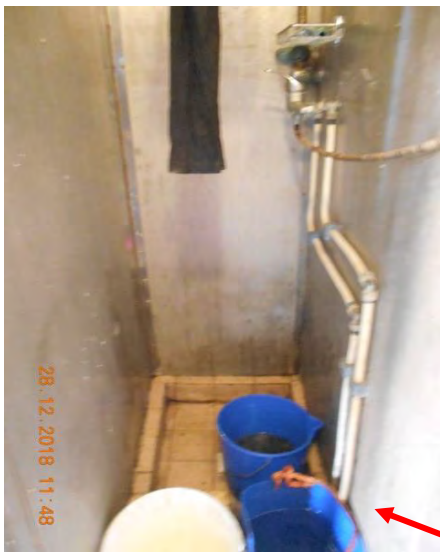
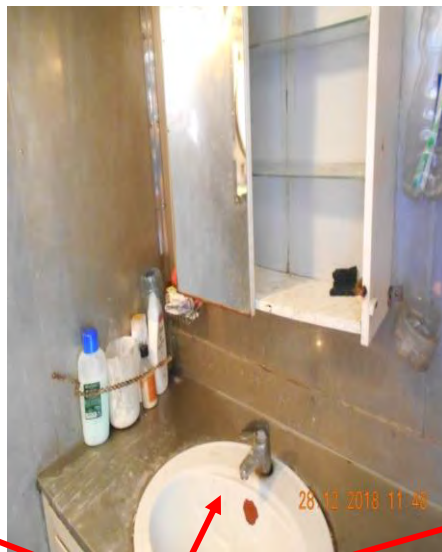
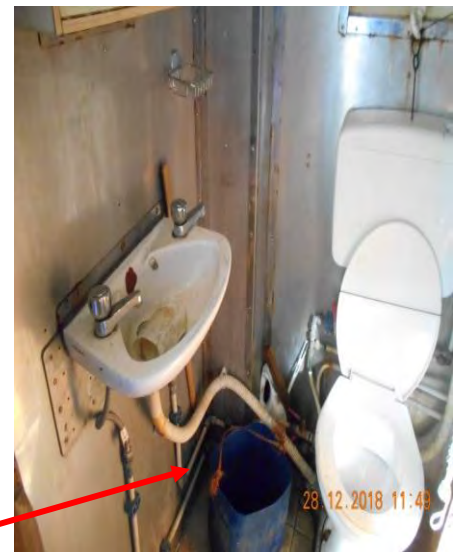
The condition of the common WC and shower

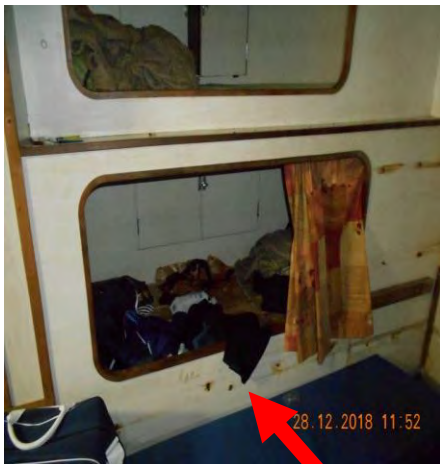
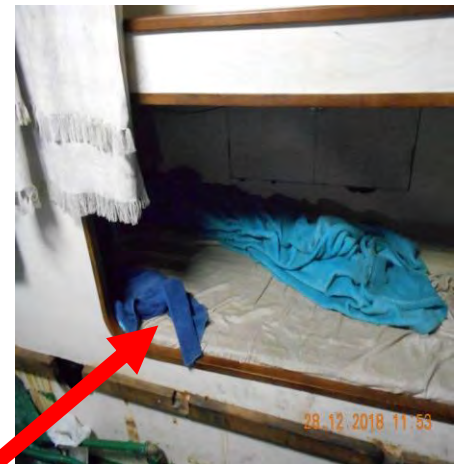
The beds of crew members

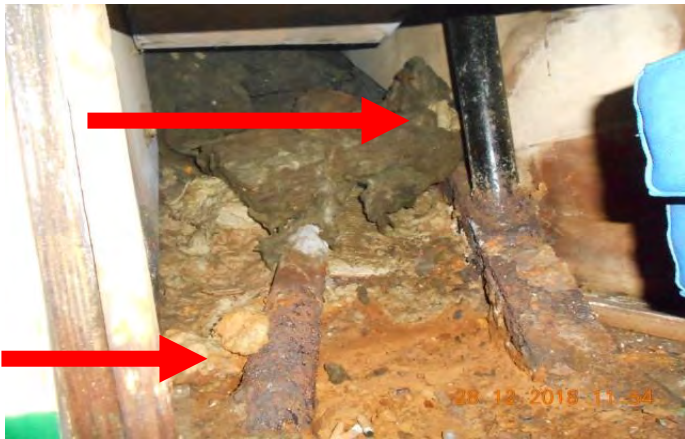
The condition of the structural supports under the beds

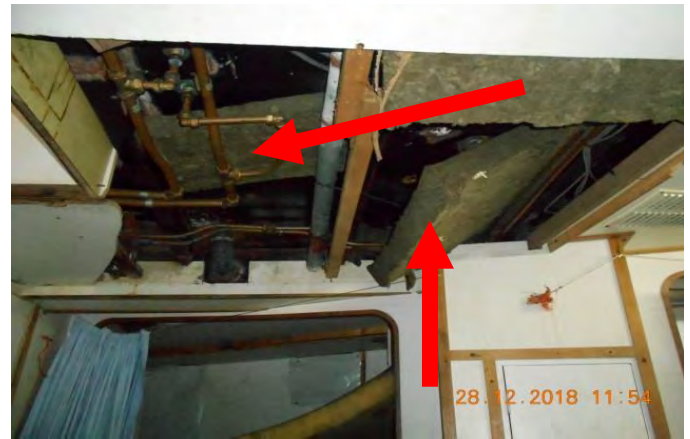
The condition of the roof of the crew cabin. The piping system above the roof insulation

The condition of the crew cabin was like nobody was using it

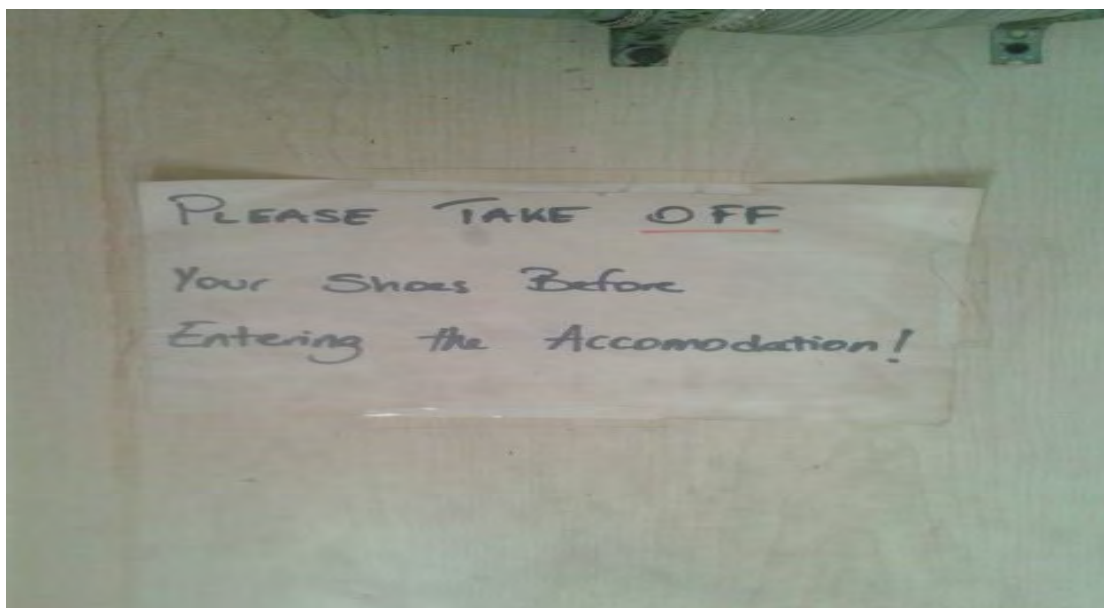
In general the condition of the accommodation was in an extremely substandard condition

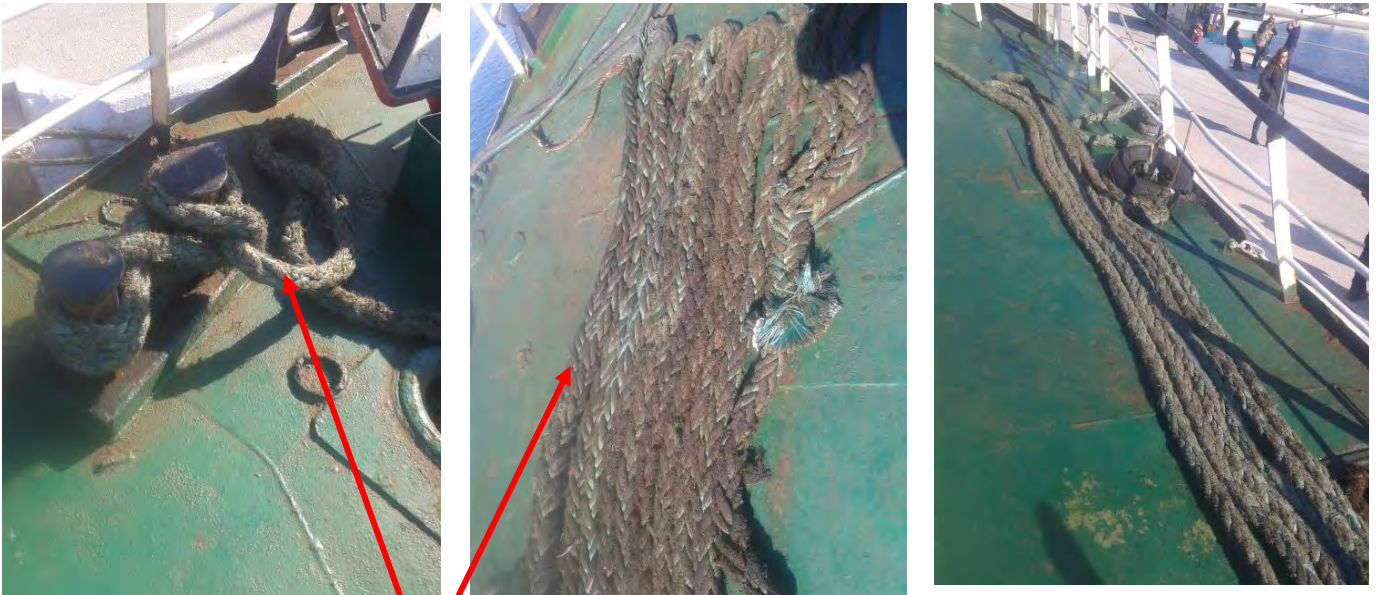
MOORING ROPES

The mooring ropes were totally wasted

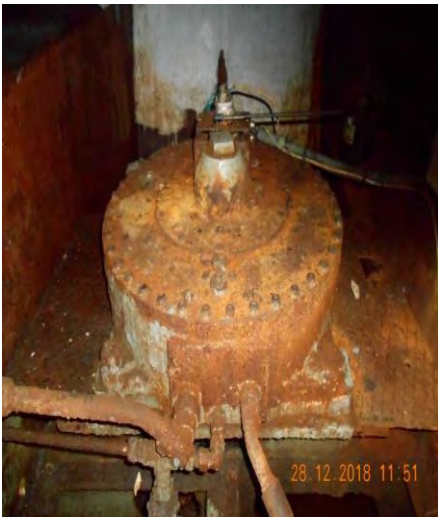
The Steering Gear motor

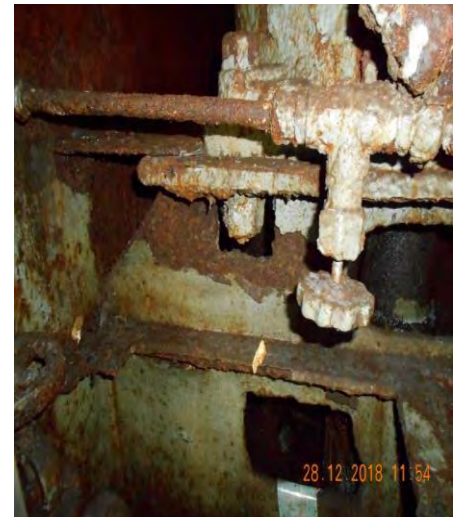
The Steering Gear hydraulic piping system

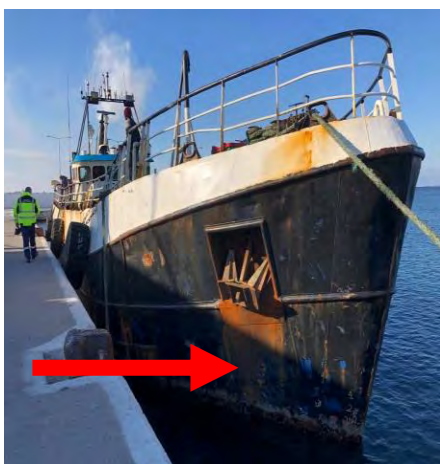
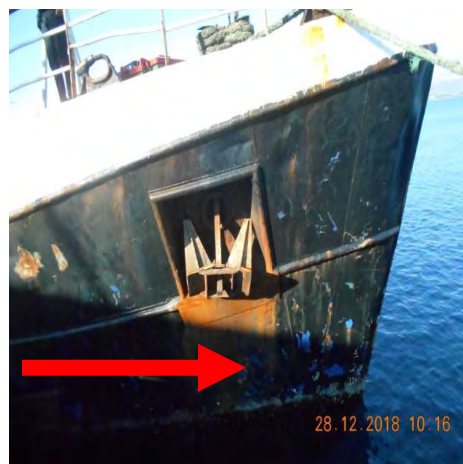
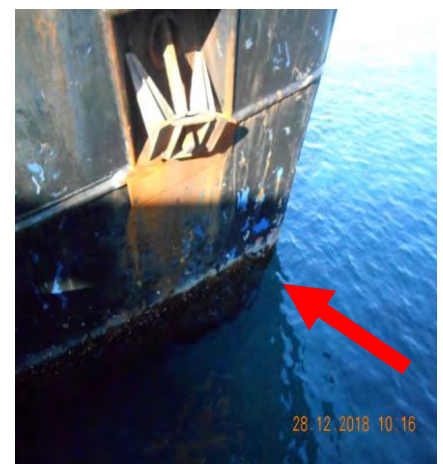
The draft marks FWD and AFT on both sides of the vessel were not readable and partly missing

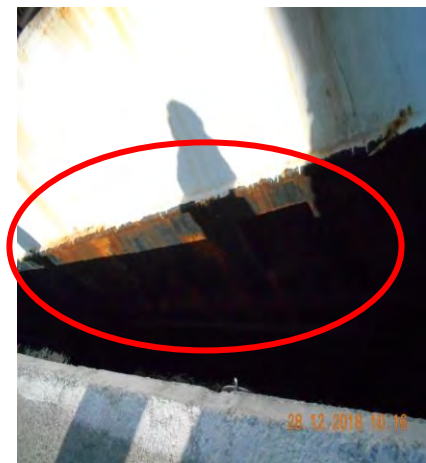
The Deck Lines, the Load Lines and the Mark of the Assigning Authority, on both sides of the vessel, were missing

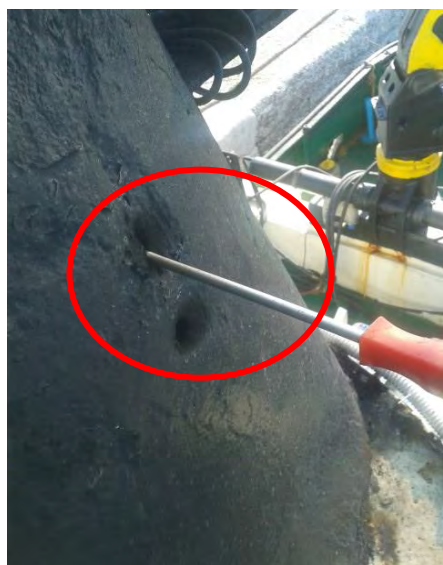
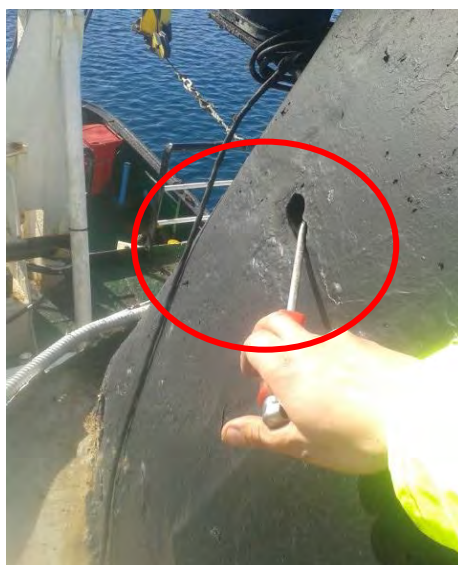
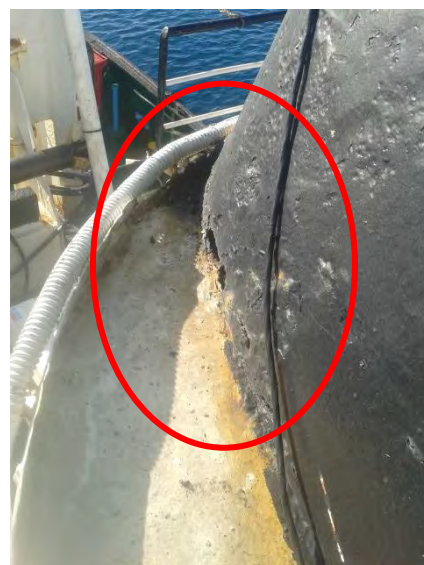
Cracks and holes all around the main body of the funnel

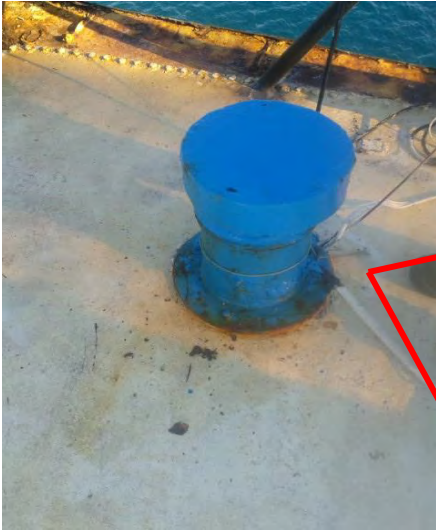
The ventilator on the monkey deck

The natural ventilators (mushroom type) located at the monkey deck and on the upper deck (aft of the wheel house) are corroded and the closing mechanism is inoperative

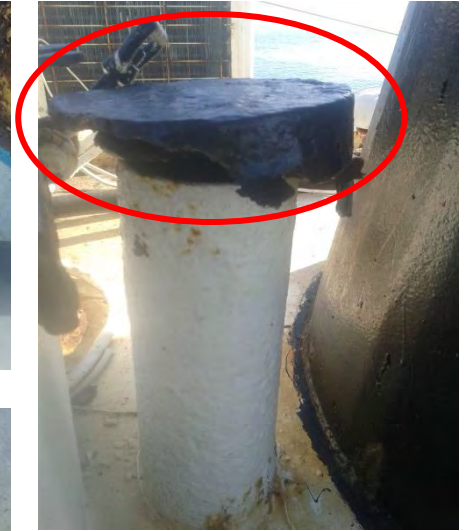
The ventilator of on the upper deck, aft of the wheel house

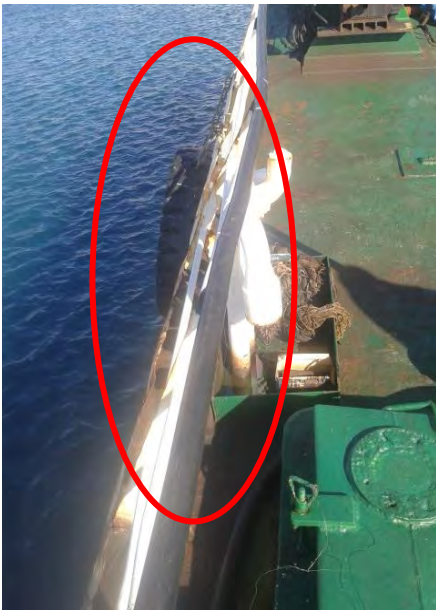
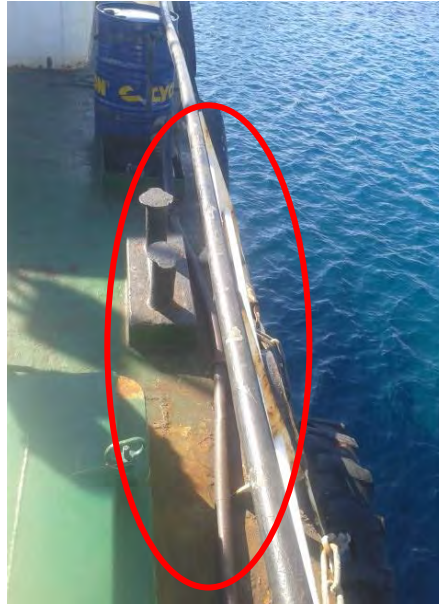
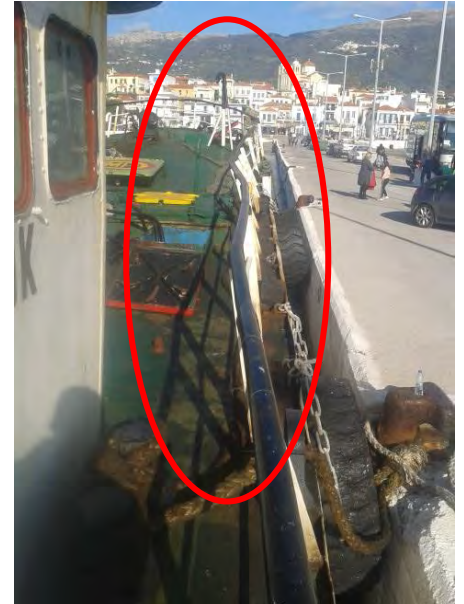
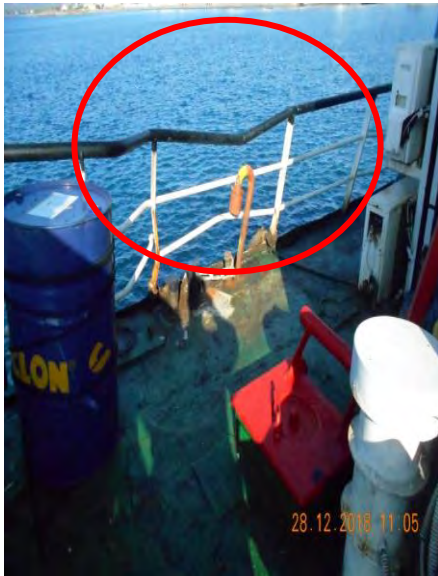
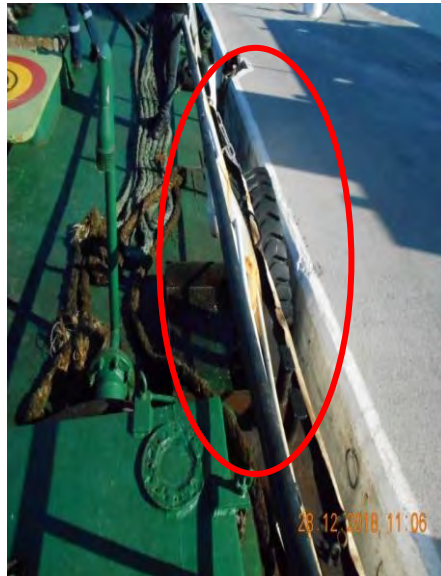
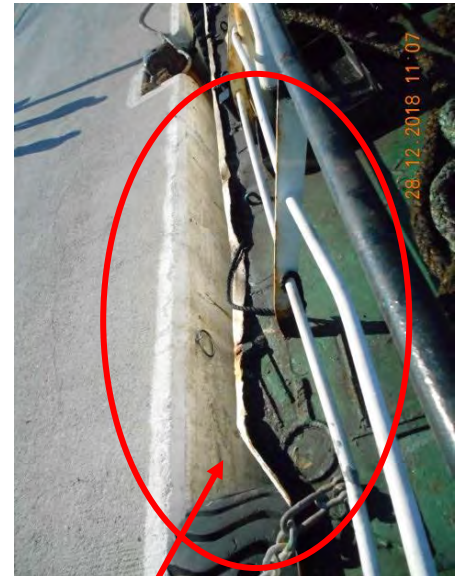
Many protective hand rails found damaged and bended. Also many cracks, bends and holes on the metal plate on both sides of the upper deck plate (between the bulwark slays of the rails) were found

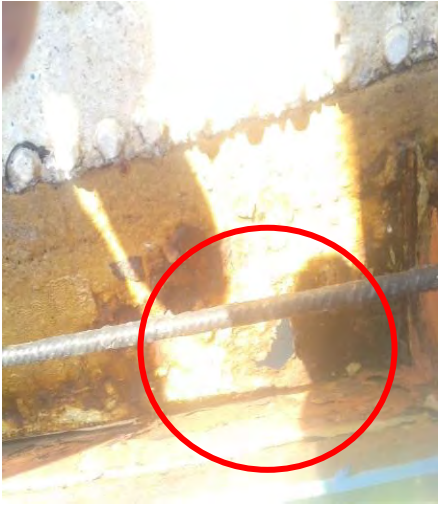
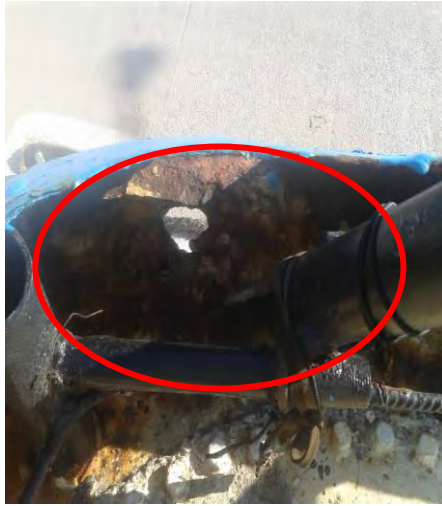
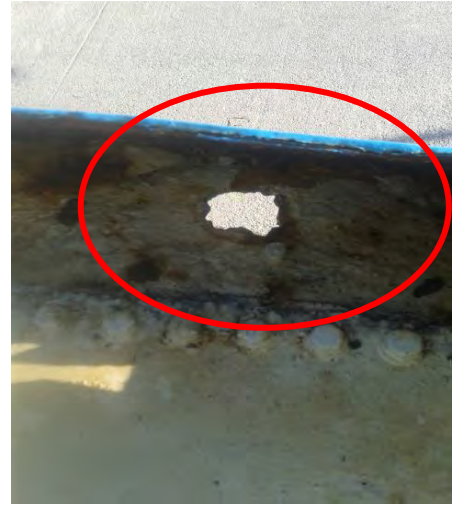
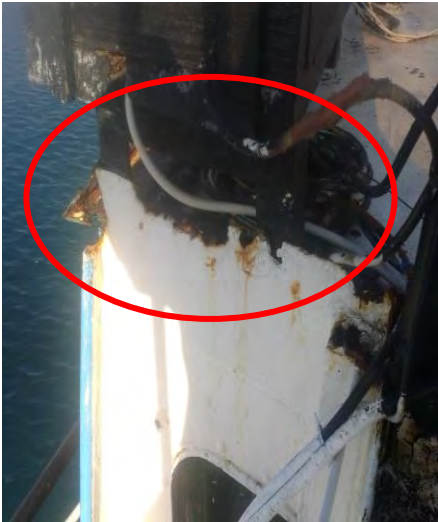
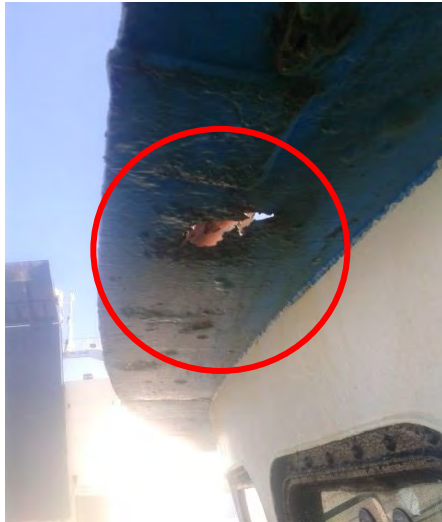
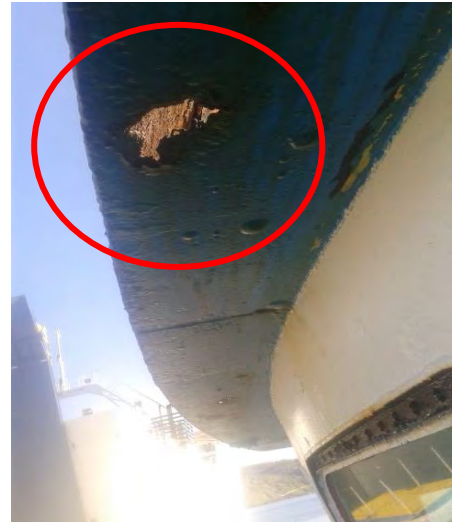
Various cracks / bends and holes, on the metal plate all around the monkey deck

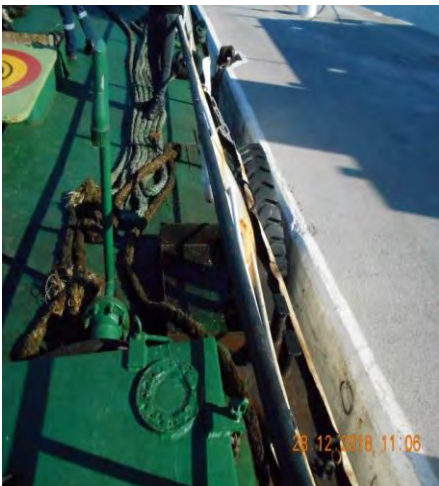
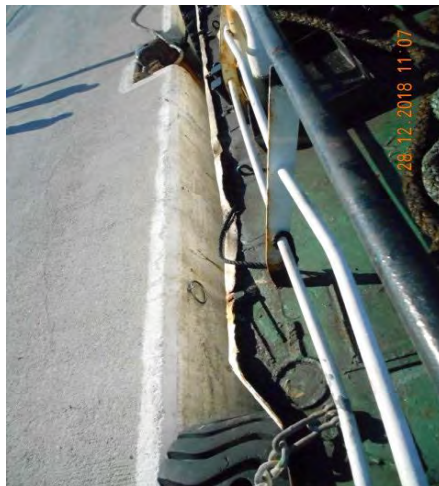
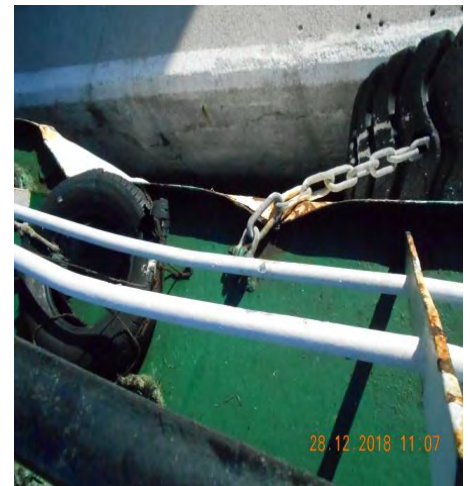
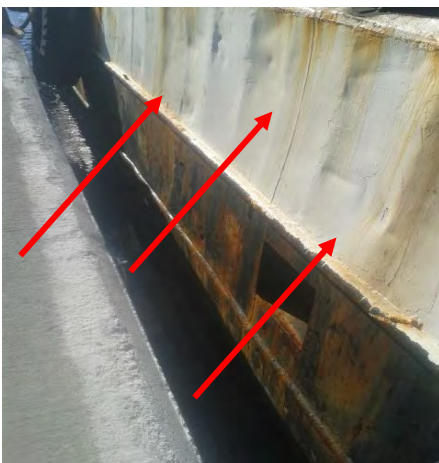
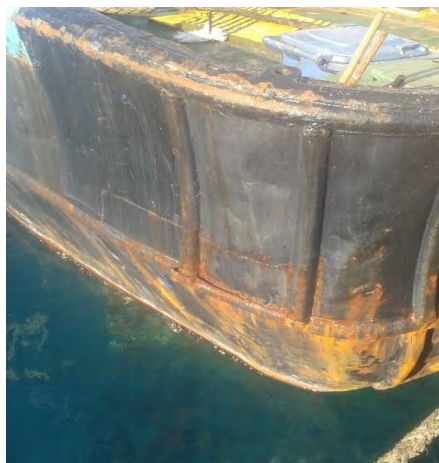
The side shell (STBD) and the internal longitudinal frames found bended above water line

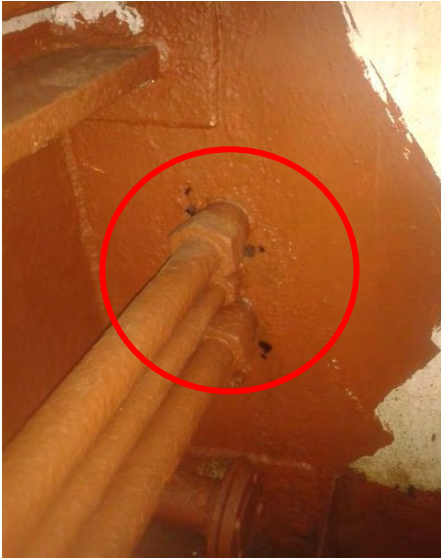
Vertical bulk head, with holes around piping penetrations

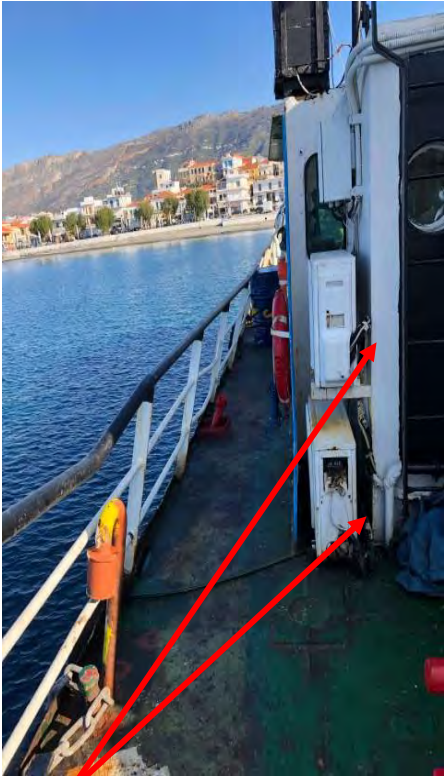
Penetrations of the superstructure by air condition piping system without any authorization

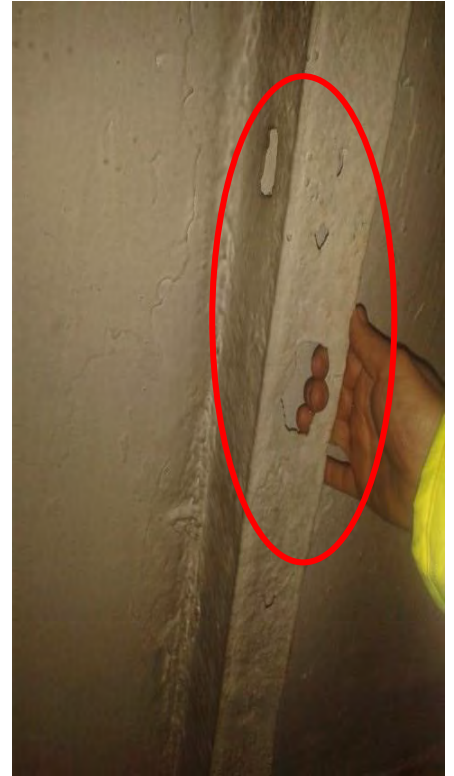
The condition of a vertical frame

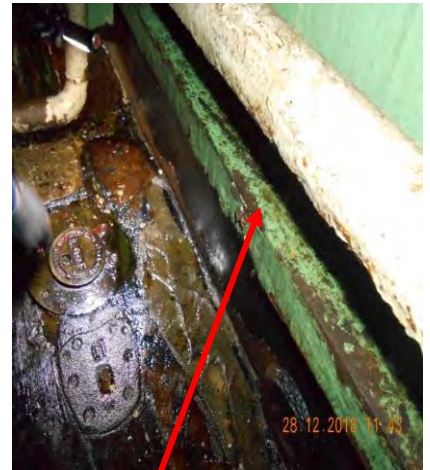
Corroded

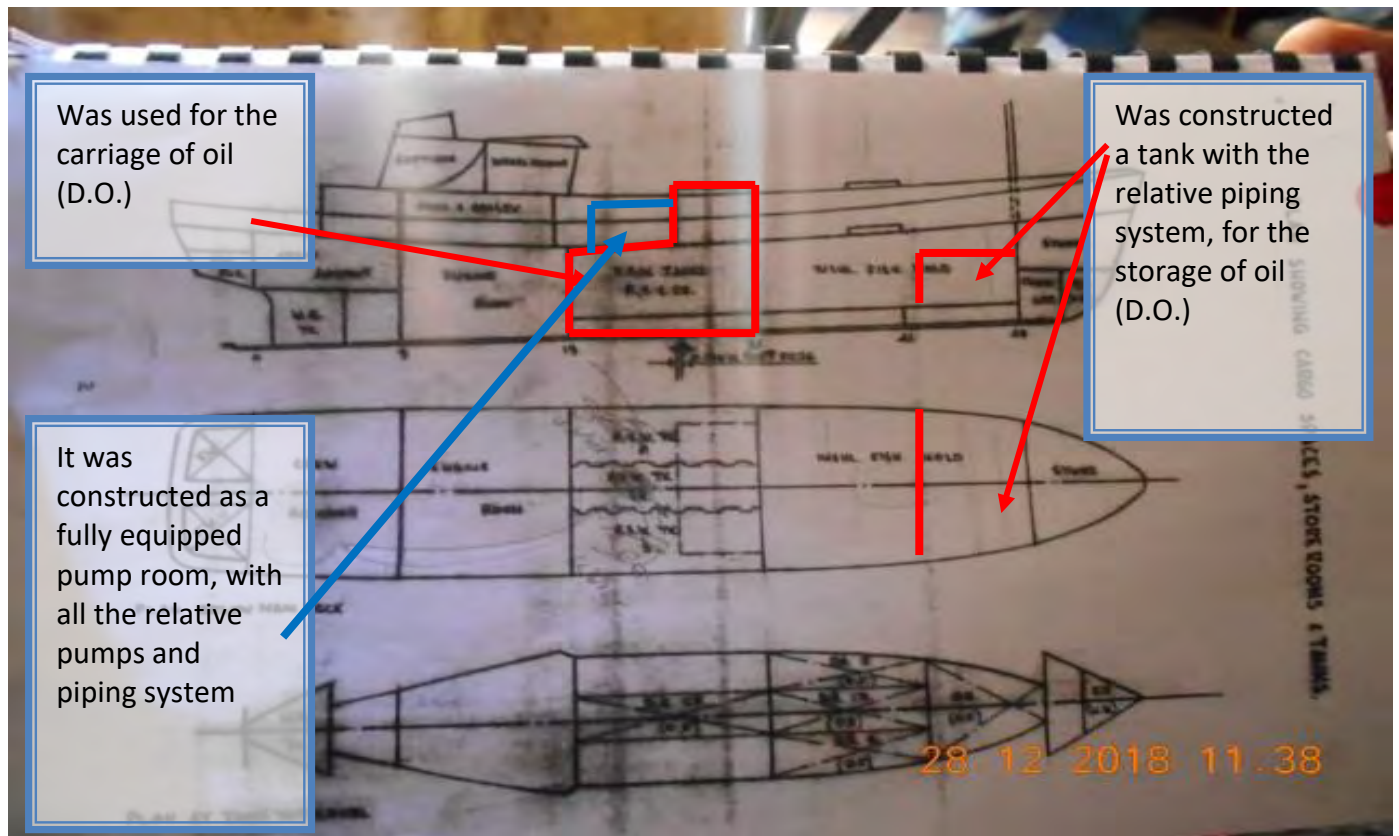
Major modifications and alterations of the ship, with regard of the vessel's mentioned Stability booklet, particularly were found on new bulkheads, oil and ballast tanks, stinger plates, etc.

But the actual condition was found as follows:

The Flag Administration and the R.O. (acting on behalf of the Flag Administration) were requested to verify that the general structural strength of the ship was adequate for the ship to operate, including the loading and unloading of the new tanks.

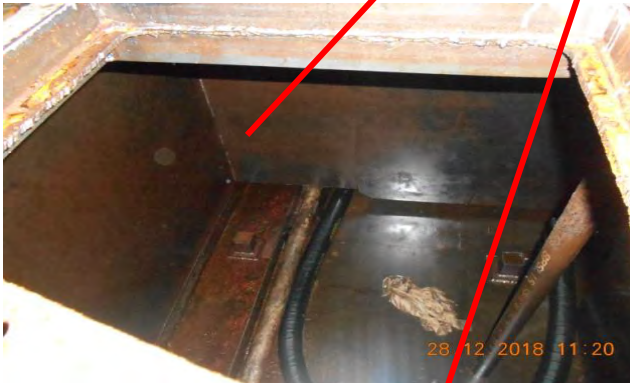
The entrance to the Cargo Hold, which was found with oil residues

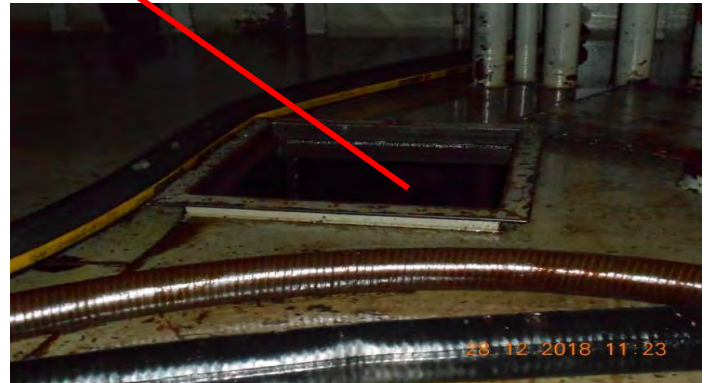
The manhole to the D.B.T., which was found full of oil (D.O.)

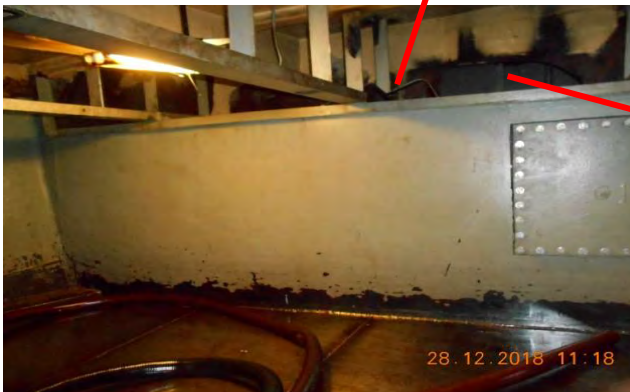
The constructed tank (oil tank) in the C/H
