# Paris MoU

## on Port State Control

Name:	HUANGHAI DEVELOPER
IMO:	9458444
Flag:	Hong Kong, China
Type:	General Cargo
GT:	20682
Class:	Bureau Veritas
RO:	Bureau Veritas
IMO Company:	Tianjin Xinhai Intl Ship Management
Date keel laid:	17/12/2008
Delivery date:	10/03/2013

MV "HUANGHAI DEVELOPER" IMO: 9458444 flying Hong Kong flag, arrived at Hamburg/Germany on 09/08/2016 for cargo operation, no survey or repair work was planned for the port call.

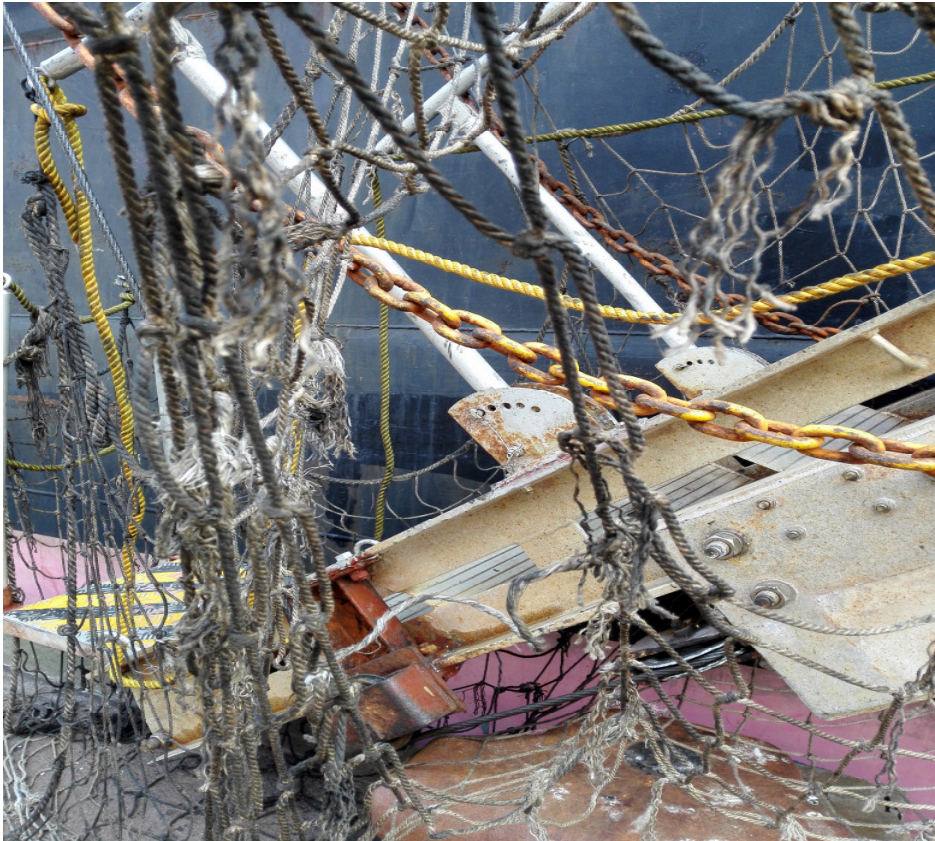
The first deficiency was already recorded when the PSCOs stepped on the gangway. The gangway net was fully worn out, with large gaps, comparable to a patchwork carpet. The picture speaks for itself

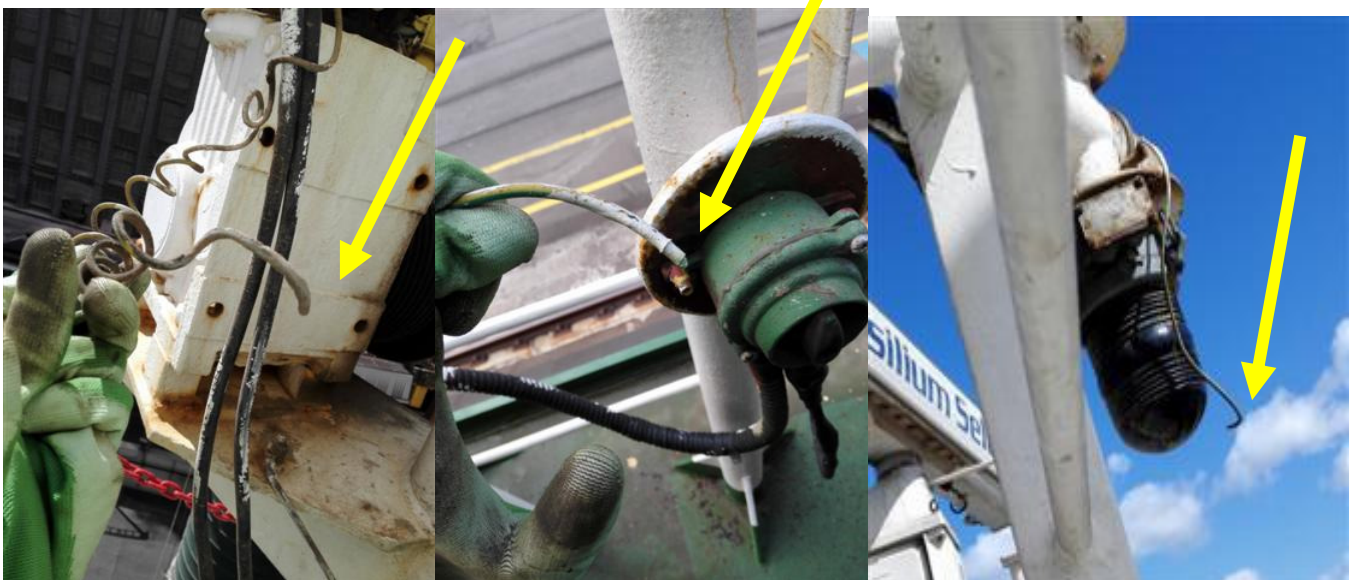
On the way to the ship's office the second deficiency was noted, the protective conductor (earth cable) of the gangway light was rusted away and therefore not connected. Later the PSCOs discovered that this deficiency was found all over the vessel in any possible area. For the sheer amount of damaged conductors this deficiency was noted with "ground for detention".

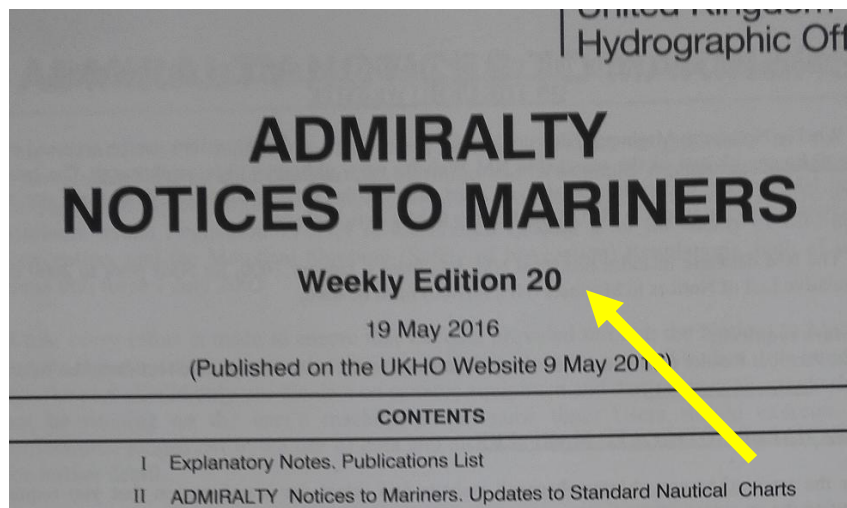
Last NtM available on board was WK 20, the released NtM during the inspection was WK 32. That means that the last 12 (!) weeks no corrections for charts and publications had been done. Additionally, the navigation officer showed a lack of familiarisation with the handling of NtMs, he wasn't able to identify T&P notices on the actual voyage charts. Therefore, the deficiency was marked with ground for detention.

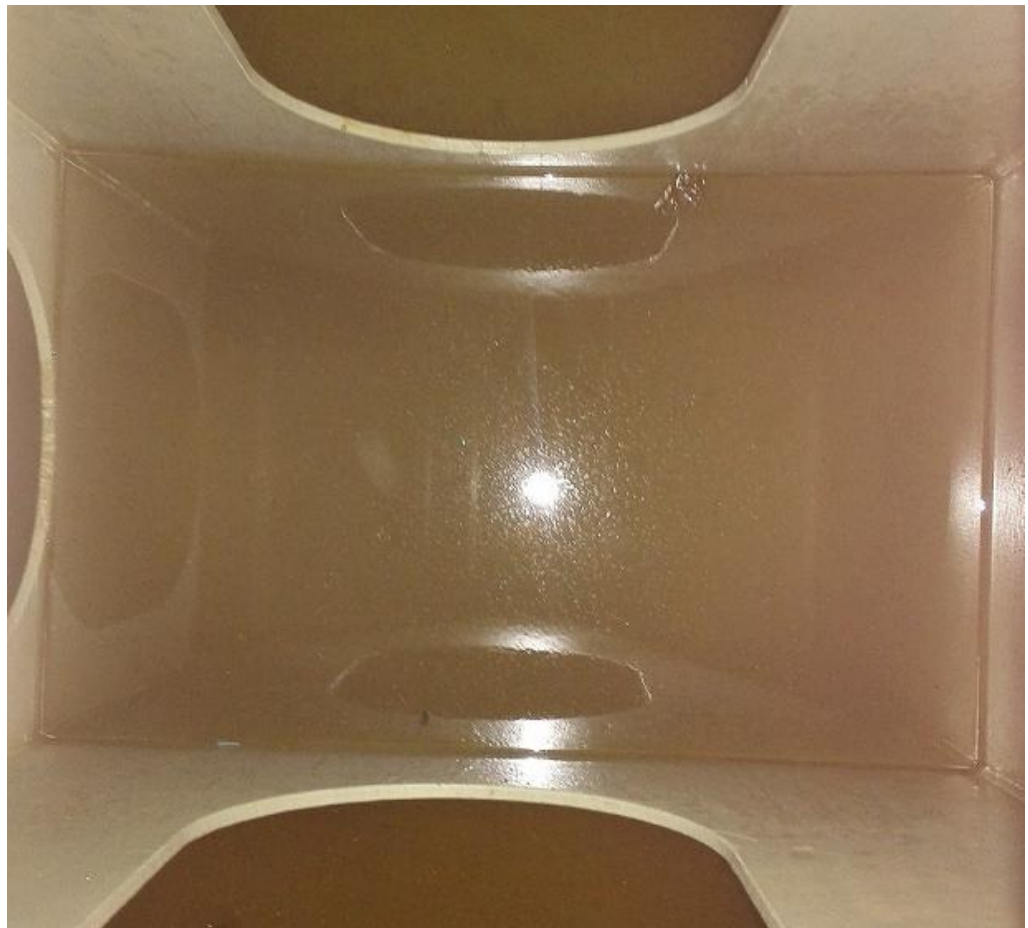
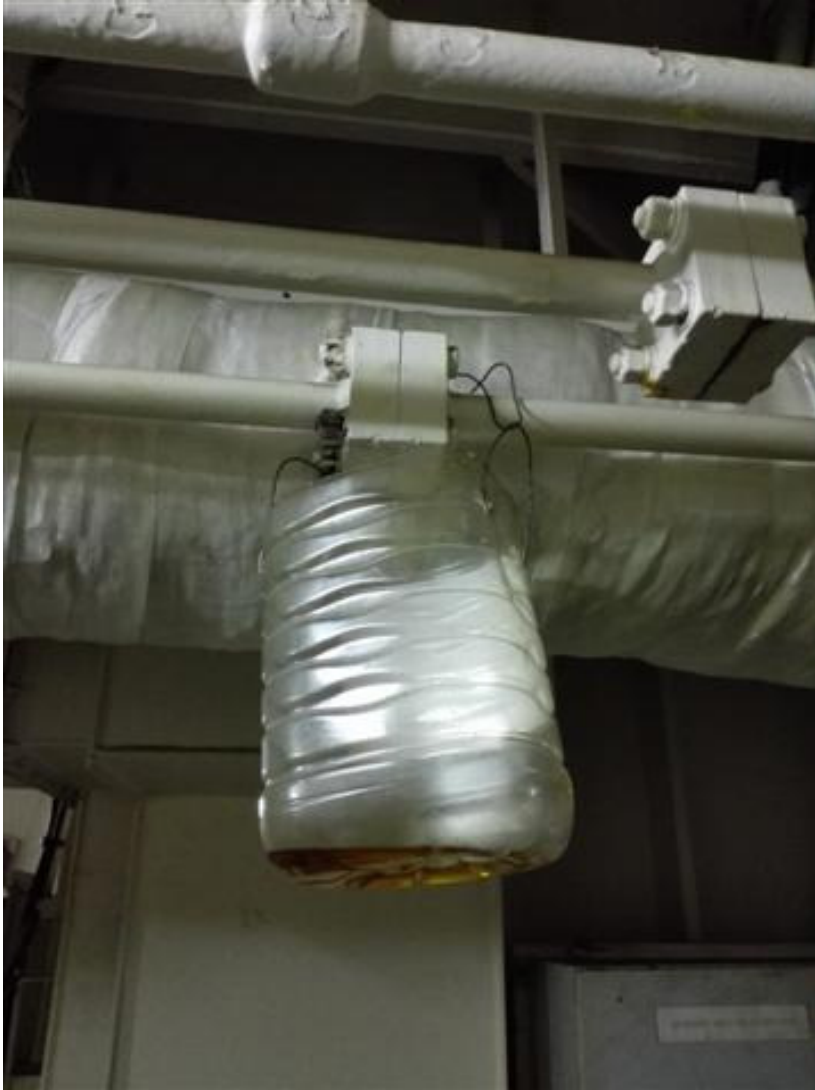
During the inspection of the WATER INGRESS ALARM the EMERGENCY FIRE PUMP ROOM was in alarm. (See pictures below)

An oily water mixture was discovered in the bilge of the emergency fire pump room (about 25cm sounded). According the bilge pumping arrangement a direct discharge to sea was possible. This deficiency was recorded with ground for detention.

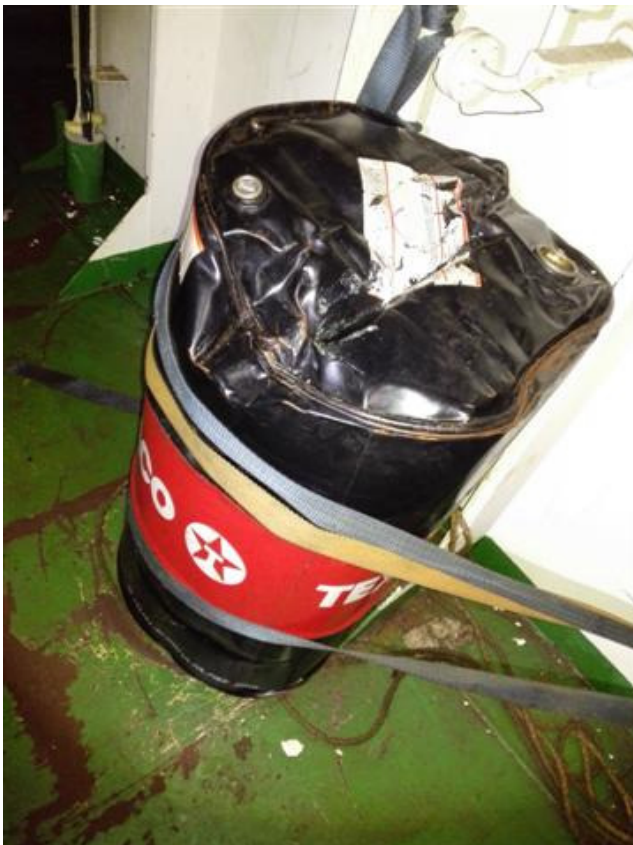
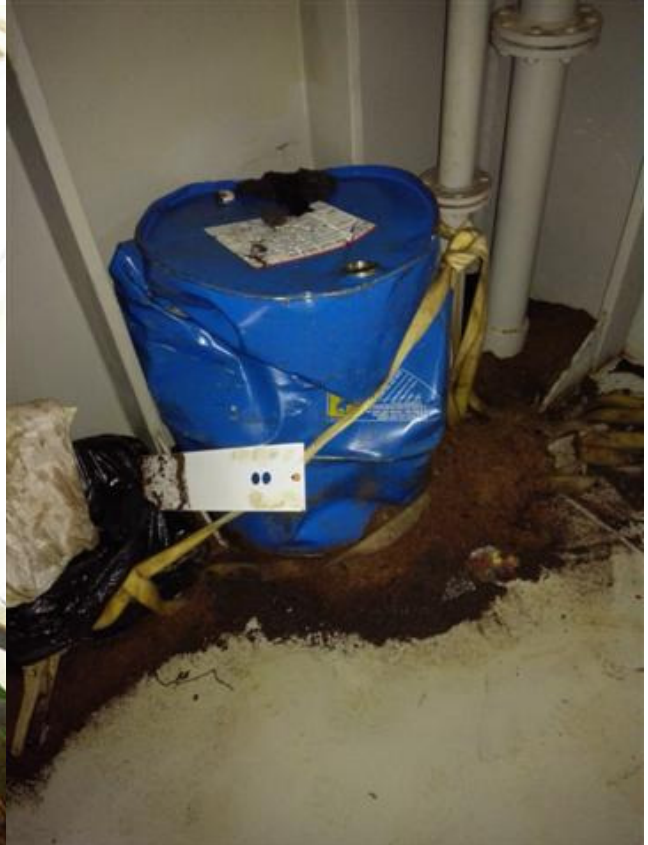
The piping for the hydraulic system of the hatch covers were leaking at every flange. The leaking oil was partly collected in small buckets and partly just dropping to the floor. Therefore, the floors in the bosun store and bow thruster room were fully covered with oil. The crew stated that this leakage had continued for an unknown time already. Inside the bosun store 15+ drums of hydraulic oil were discovered for the constant refilling of the hydraulic hatch cover motor. Also several heavily damaged and leaking drums placed all over the bosun store / bow thruster room, were leading to the extreme oil contaminated walls, floors and bilges. This deficiency was recorded as a ground for detention.

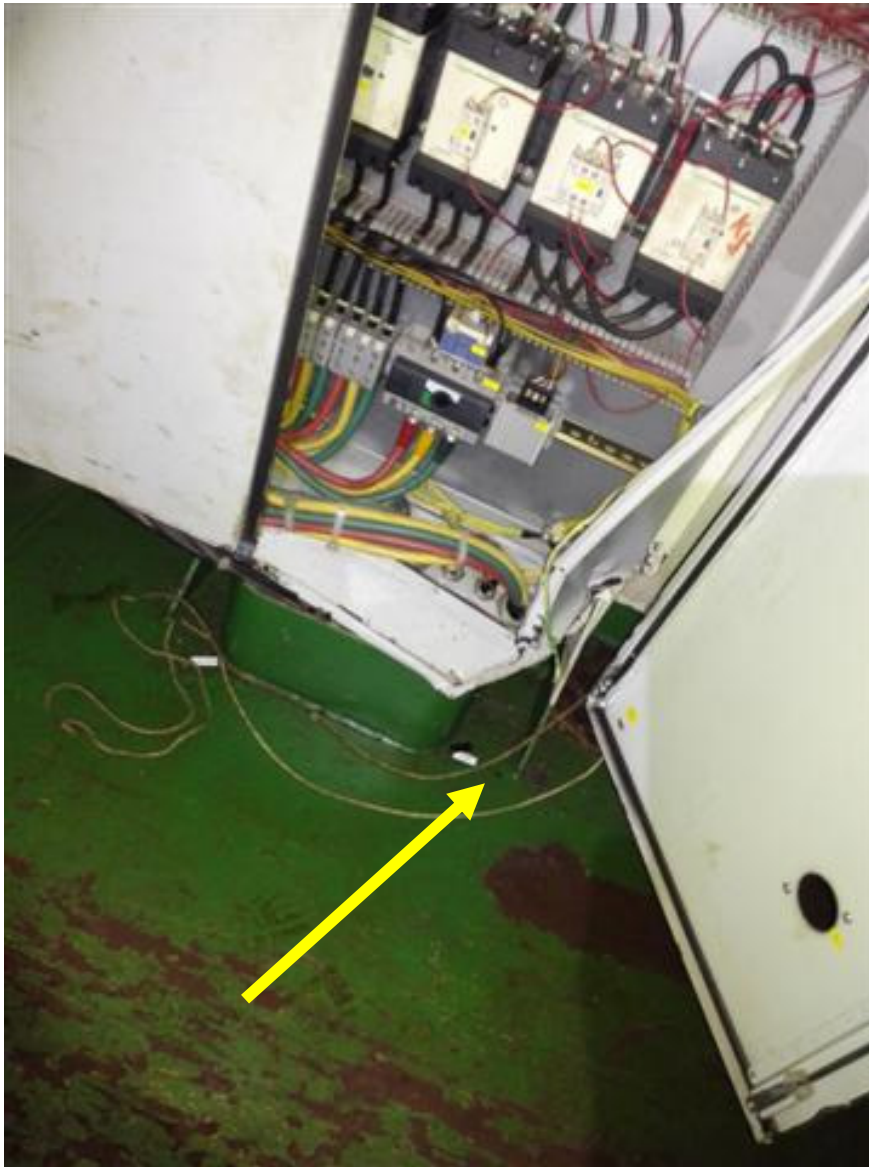
Because of the many unlashed drums, both mooring winch control cabinets were heavily damaged. The cabinets were impossible to be closed at all. Crew stated during interview that this had been known for a long time but no spare part orders were forwarded to the company at all. Due to all these facts, this deficiency was recorded with ground for detention.

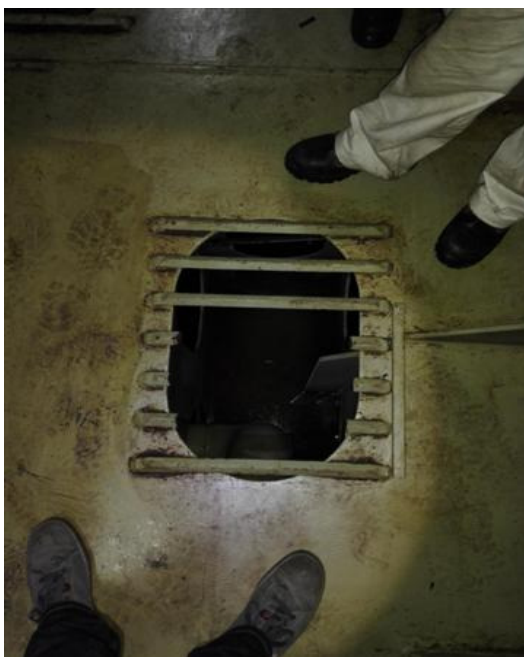
On this picture the fixed steel manhole cover for the bilge is broken. Nobody of the crew could explain why or when this had happened. In this dimly lit area a broken cover like this could lead to serious injuries.

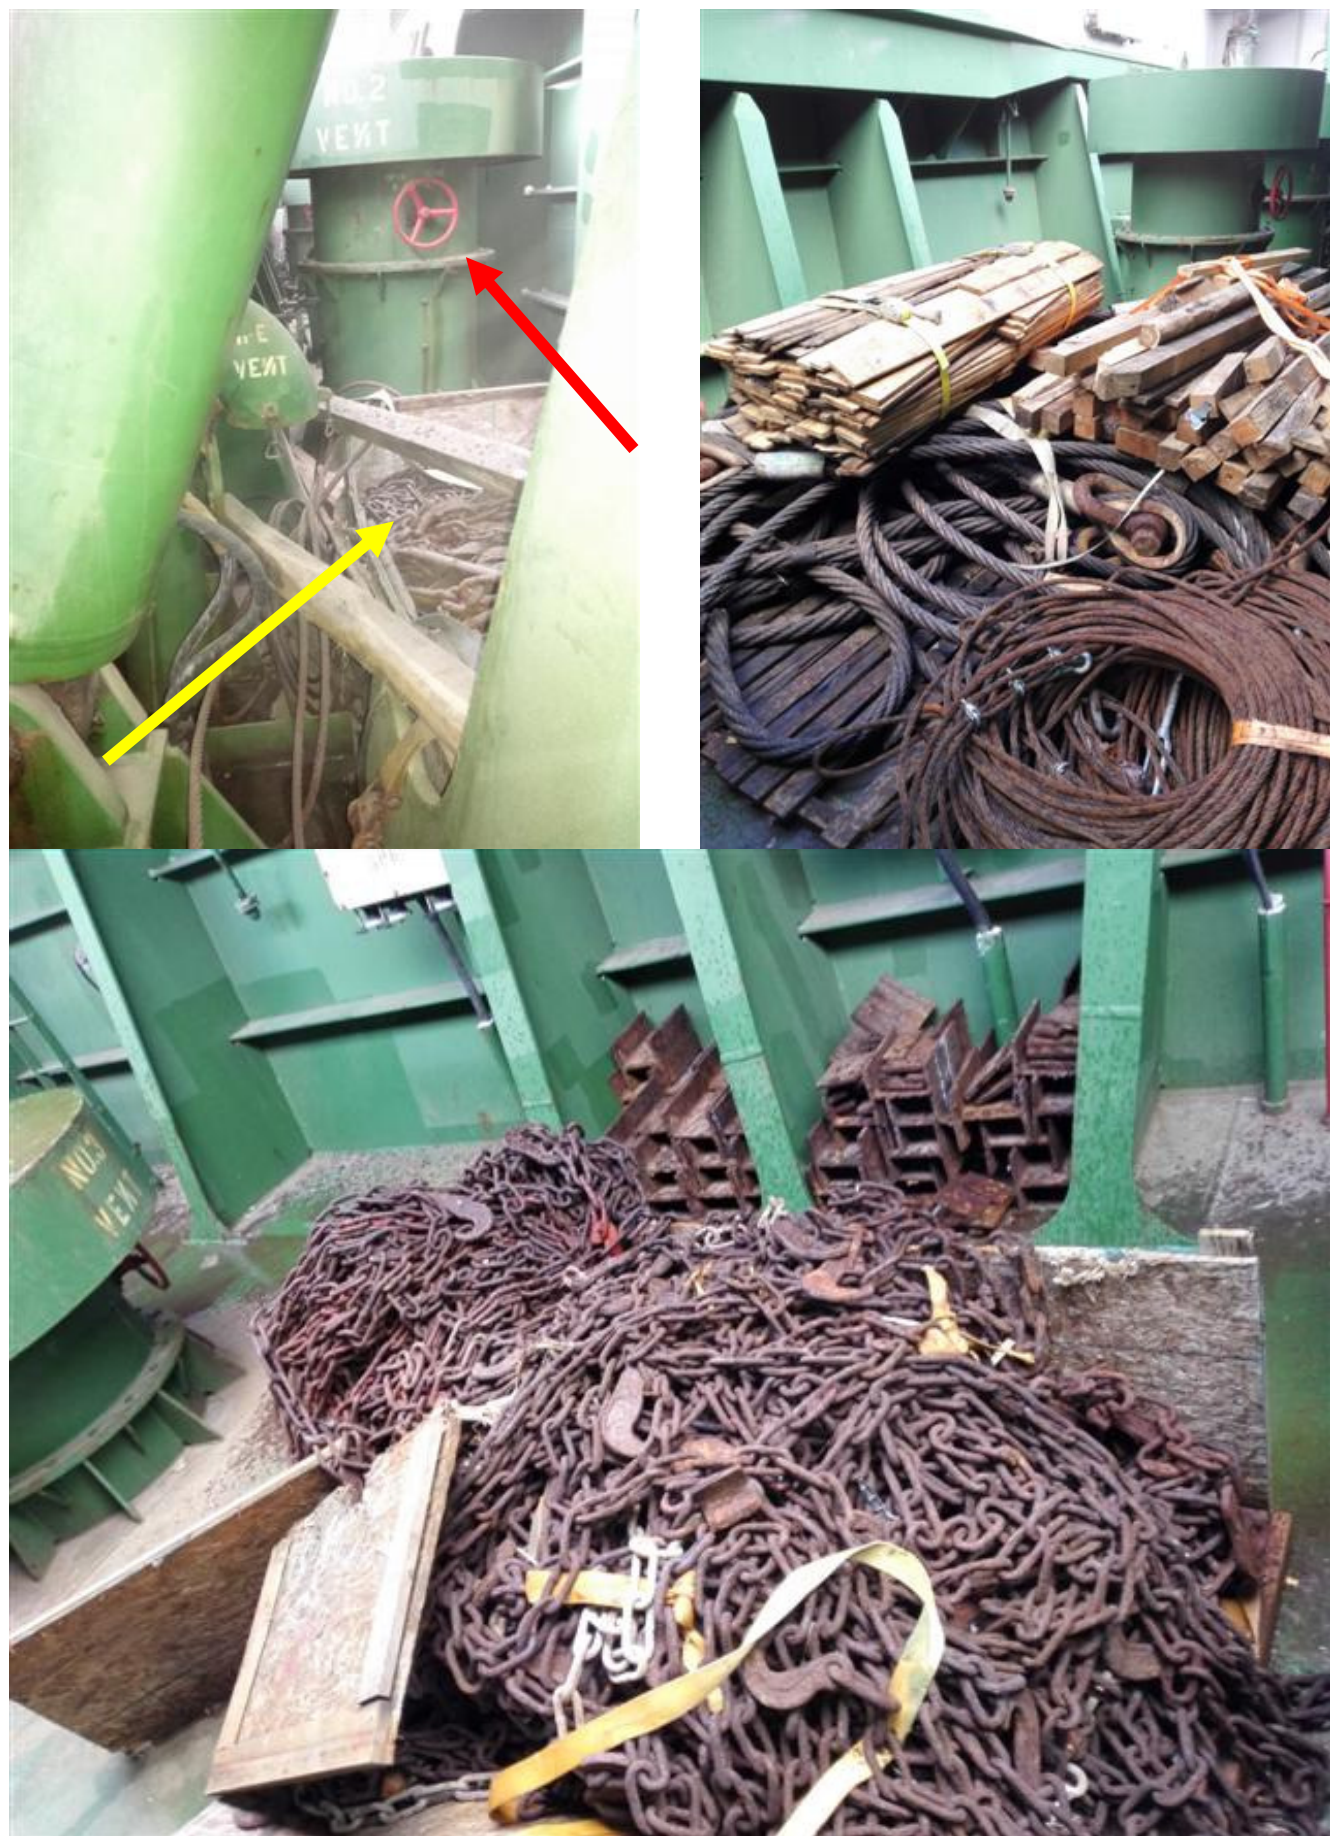
After the inspection of the bosun store, the deck tour continued with an obscure mixture of unlashed deck- and cargo-equipment. Crew confirmed that this equipment remained from previous voyages and had now been "stored" on deck for an unknown time. Ground for detention.

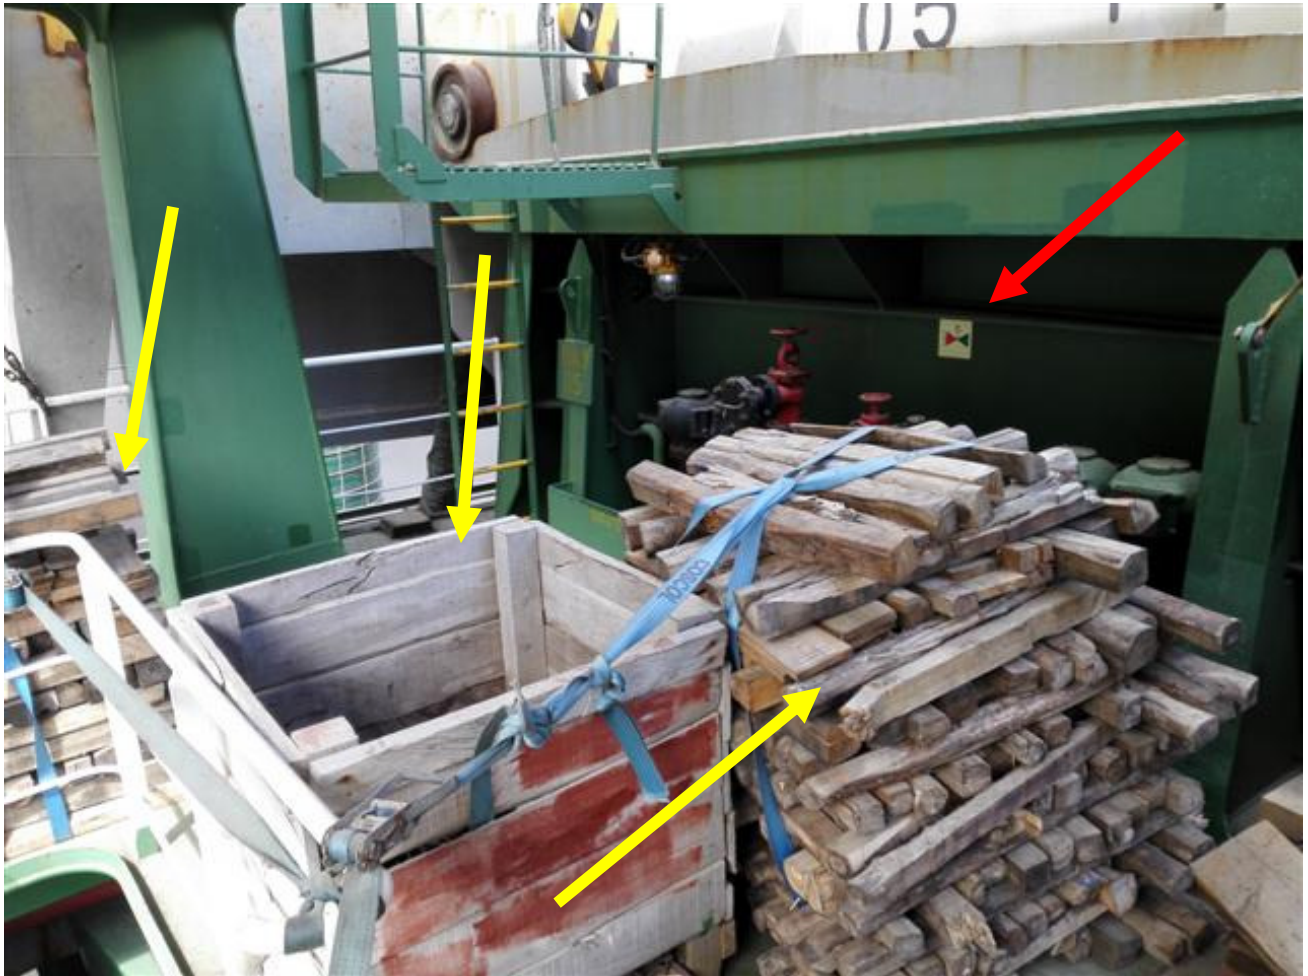
In this picture the fire fighting equipment is totally blocked by dunnage. Hydrants and also fire hose cabinets were not readily accessible at all. This deficiency was recorded with ground for detention.

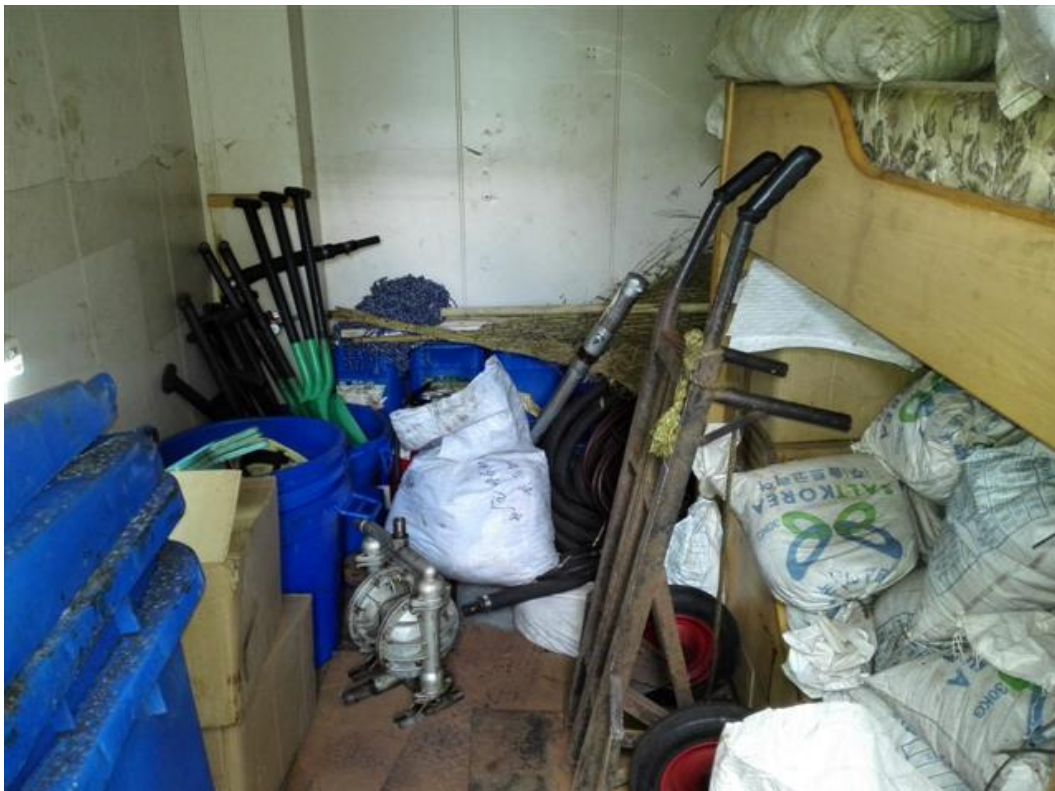
The former Suez crew cabin is used as SOPEP store, still furnished with the bunk beds. Inside the room an unacceptable mess of equipment was discovered. If a quick reaction against an oil spill were necessary, there would be no chance to handle the spill in a professional way.

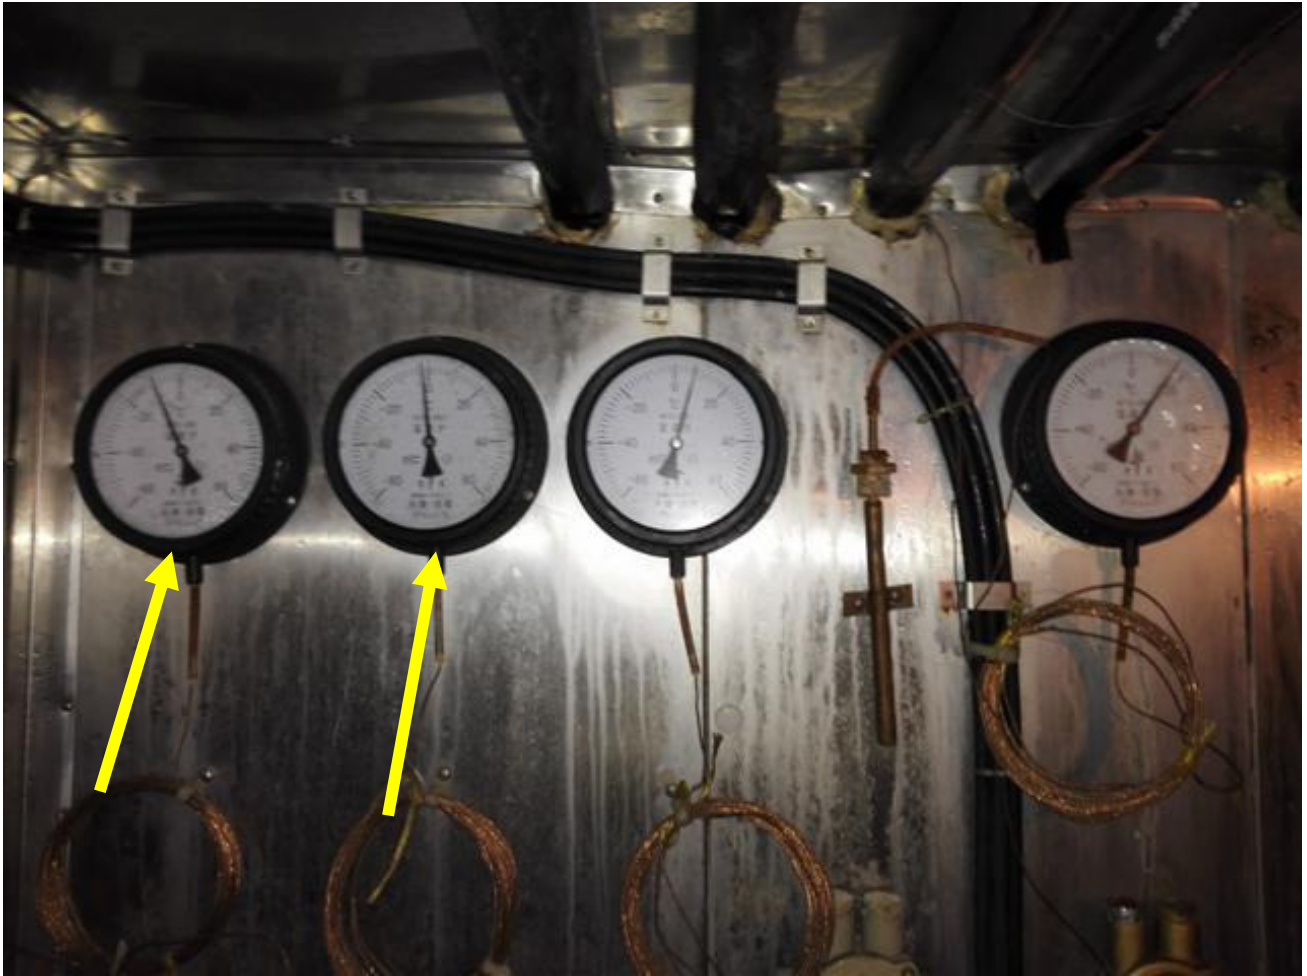
Temperature sensors of freezers fully out of range, resulting in iced meat and rotten food full of mould.

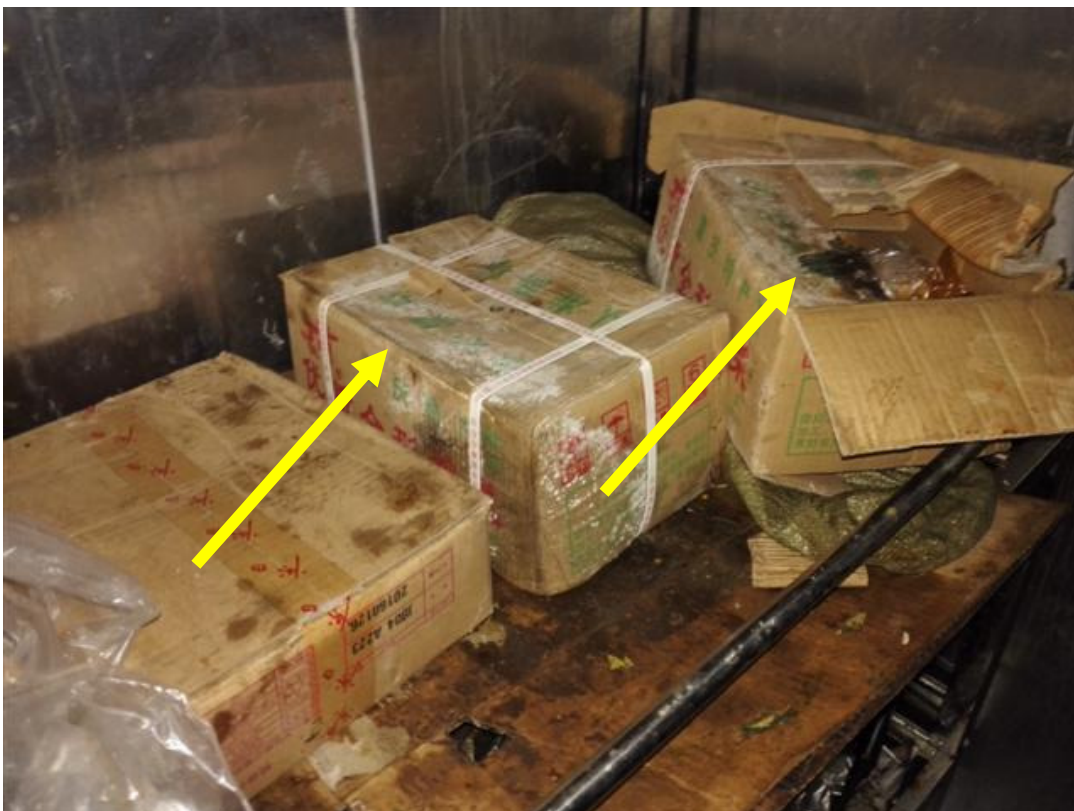
Packed vegetables already fully covered with mould and an awful smell inside all the provision stores.

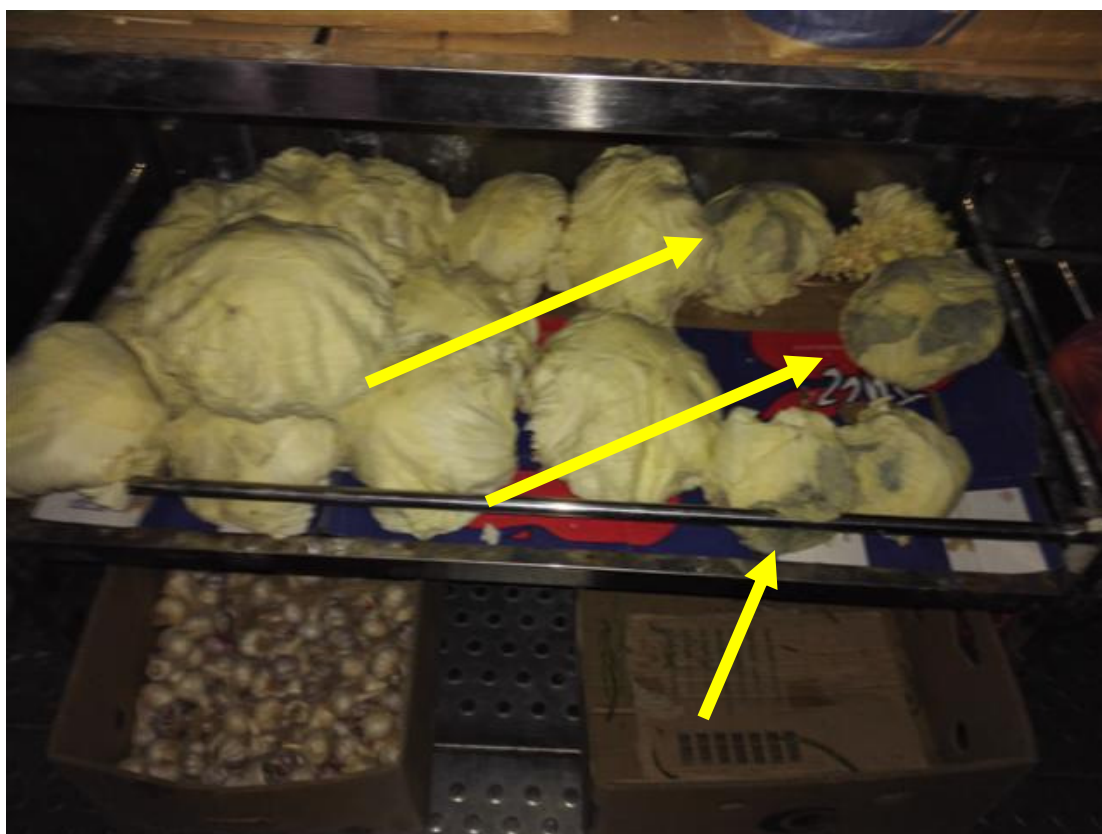
Lettuce heads covered with black mould. This is a high risk of food poisoning for all crew. The mould covered all kinds of vegetables all over the provision store.

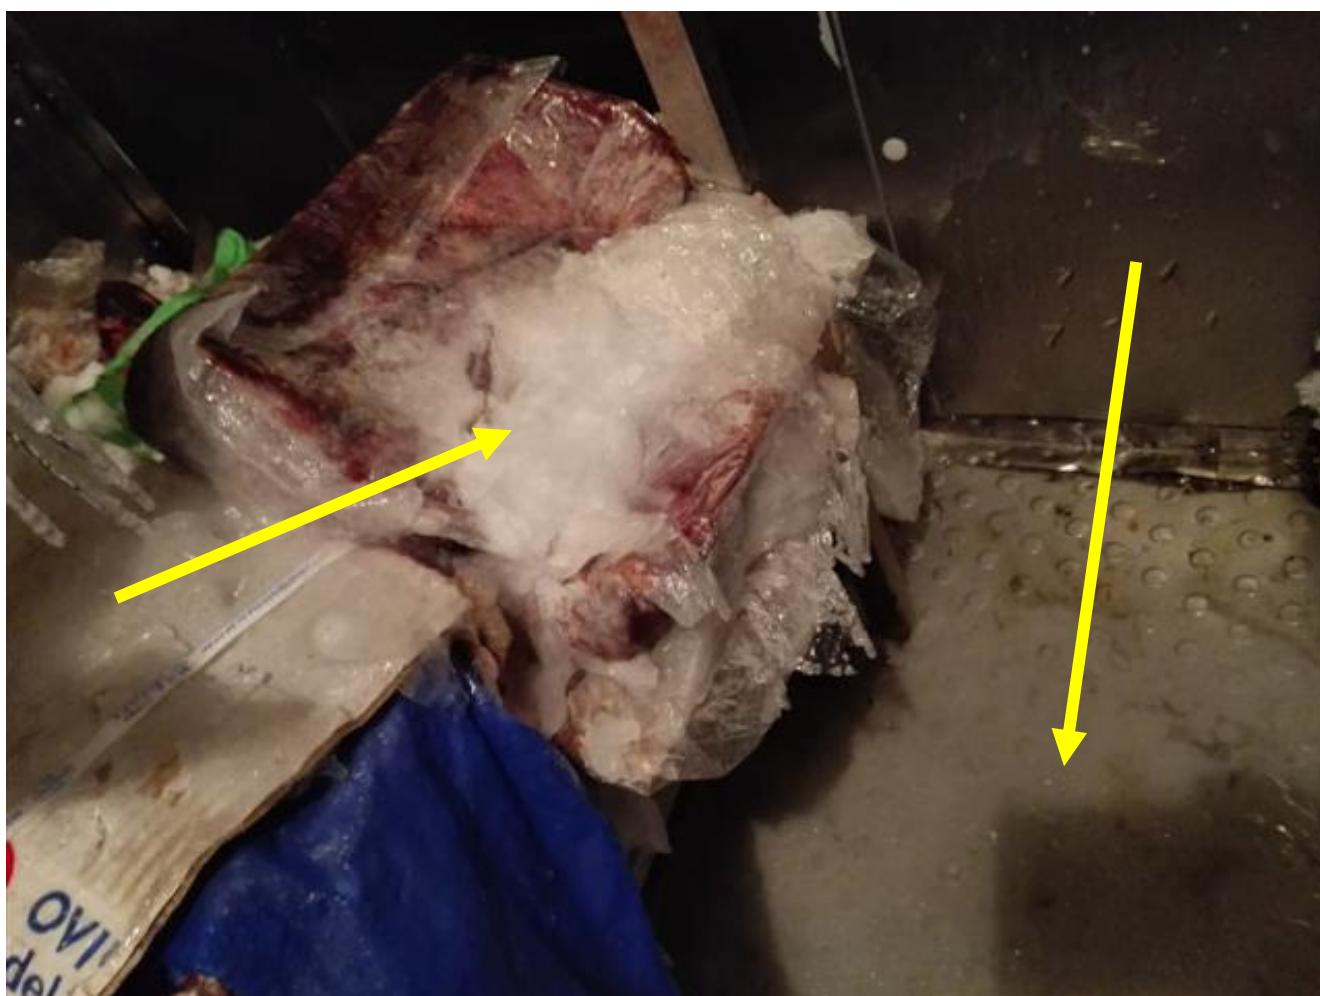
In deep freezer room heavy icing of meat and floor caused by overheating ( $-10^{\circ}$ ) and improper gaskets.

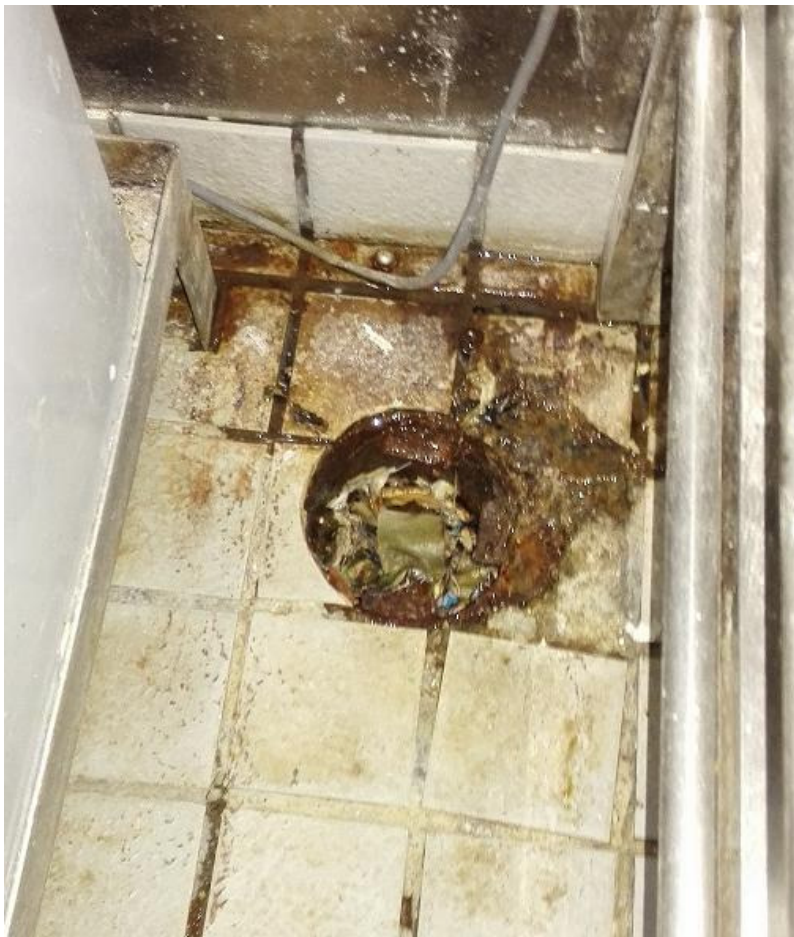
Inside the galley the unhygienic situation continued. Waste, dirt, rotten food and other unknown substances were visible in every corner. The PSCO had the impression, that the galley hadn't been cleaned for months.

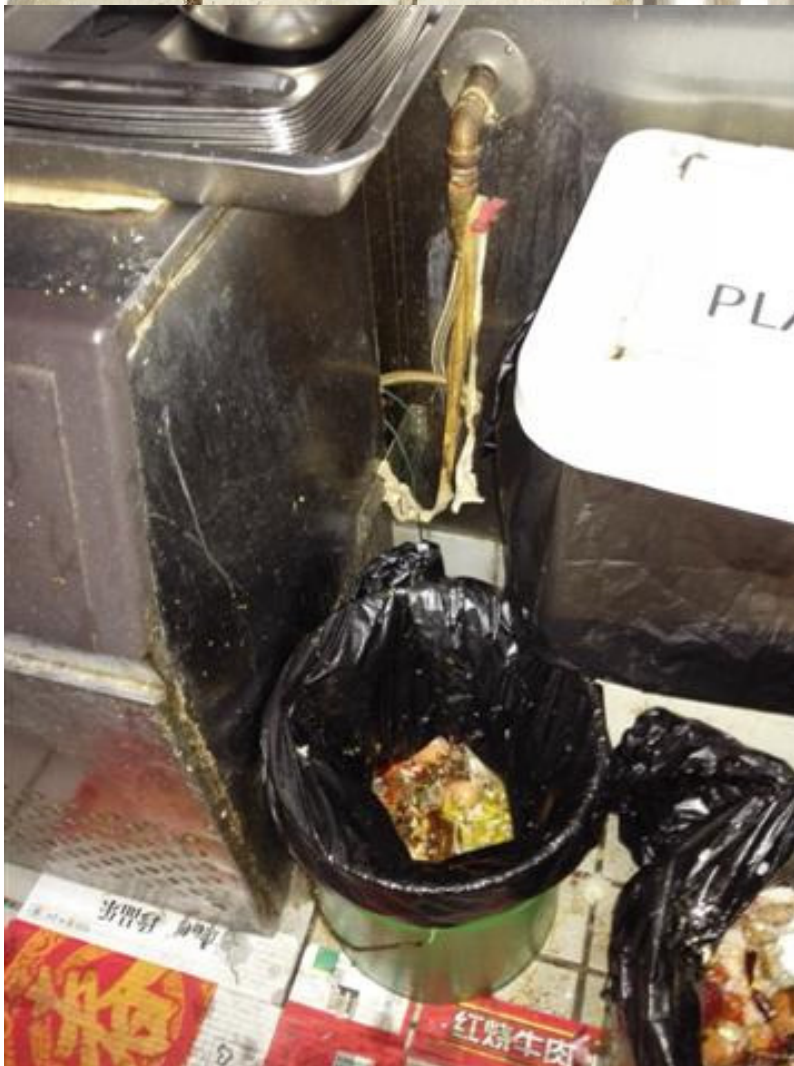
Open waste drums full of old food, walls and floor sticky and a mess of galley equipment was the situation encountered during the first boarding. All these factors combined led to the decision that the absolutely unhygienic situation in galley and provision stores must lead to a deficiency marked with ground for detention.

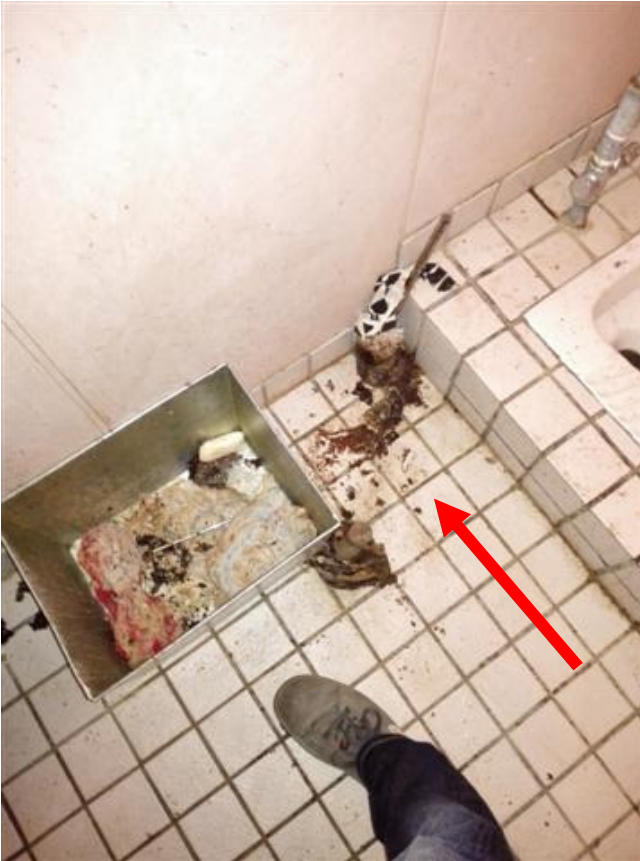
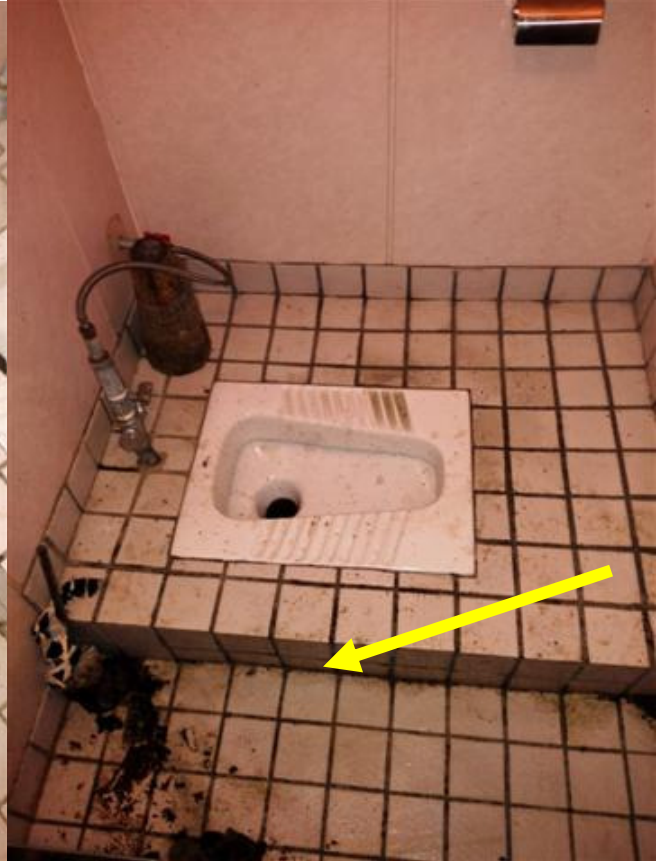
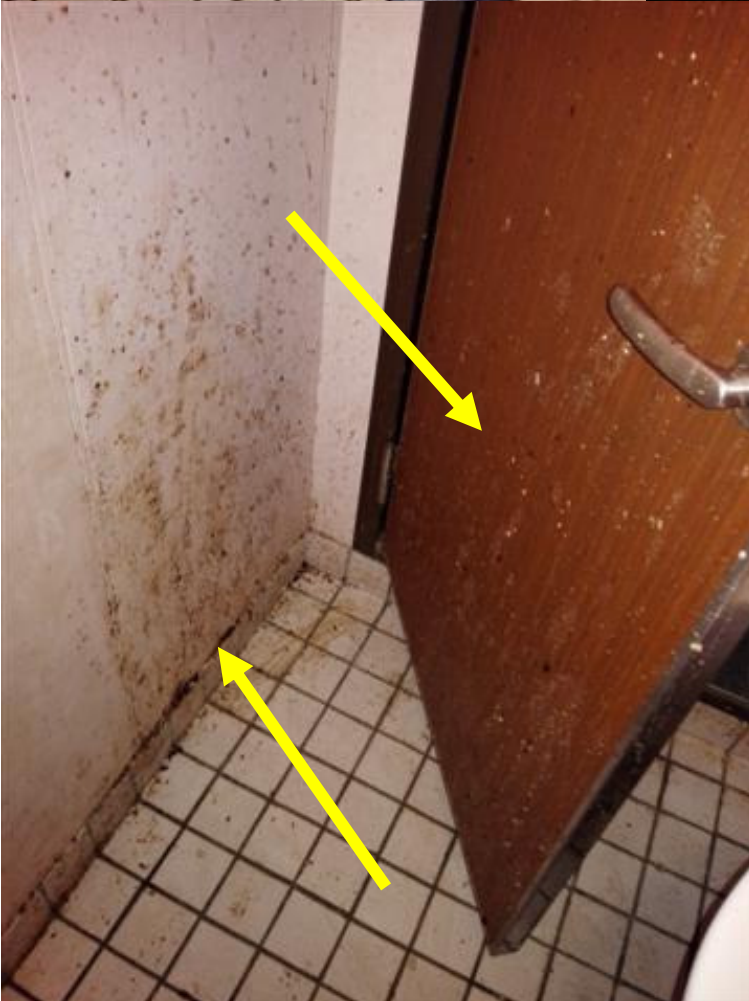
The inspection of the sanitary facilities was the most shocking moment of the PSC, floors and walls were totally contaminated with feces including a disgusting smell. During the whole inspection the PSCOs were under the permanent impression that the crew is fully disinterested and unmotivated. When addressing any of the deficiencies to the crew nobody could explain when or why the specific deficiency occurred. The HUANGHAI DEVELOPER is for sure not the worst ship the PSCOs had ever seen, but she shows what happens to a just 3 years old vessel if the complete ISM system collapses caused by a total lack of maintenance and motivation. At the end of the day, 24 deficiencies were recorded, 11 of them with ground for detention. The vessel was arrested for 3 days before she was allowed to continue her voyage.
