SAFI

IMO no.: 7108899

Ship type: general cargo

Port of detention: Catania
(Italy)

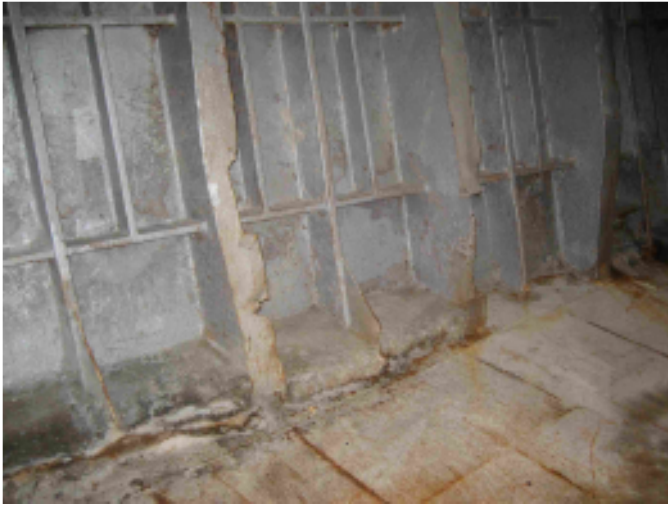
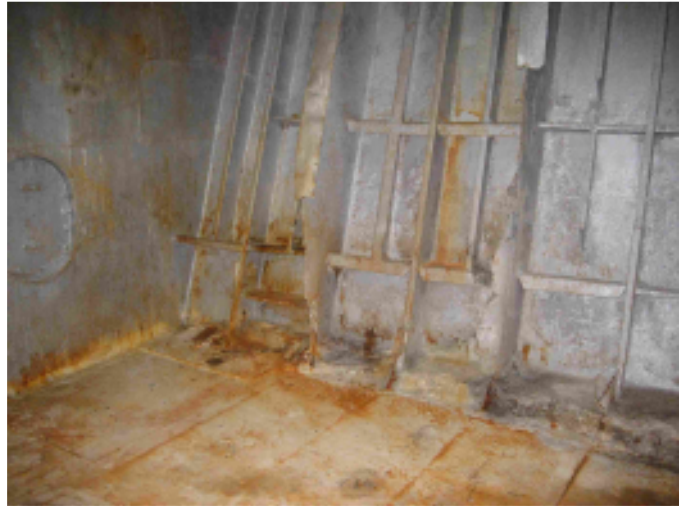
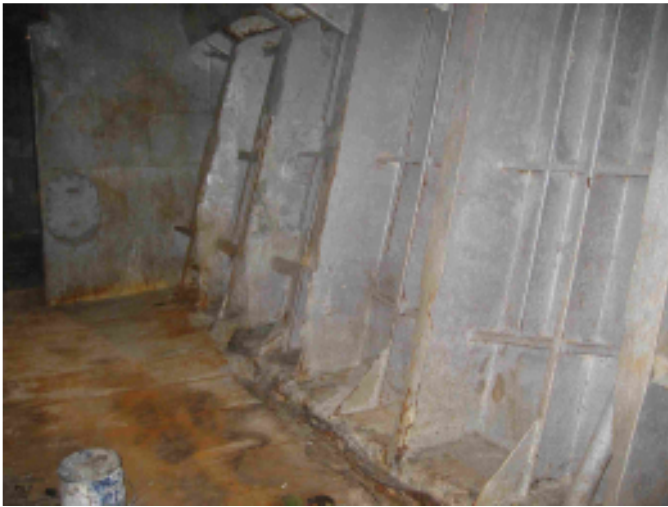
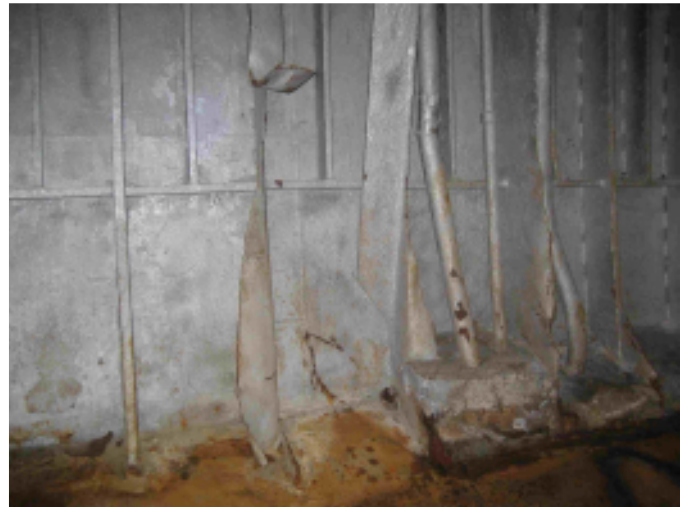
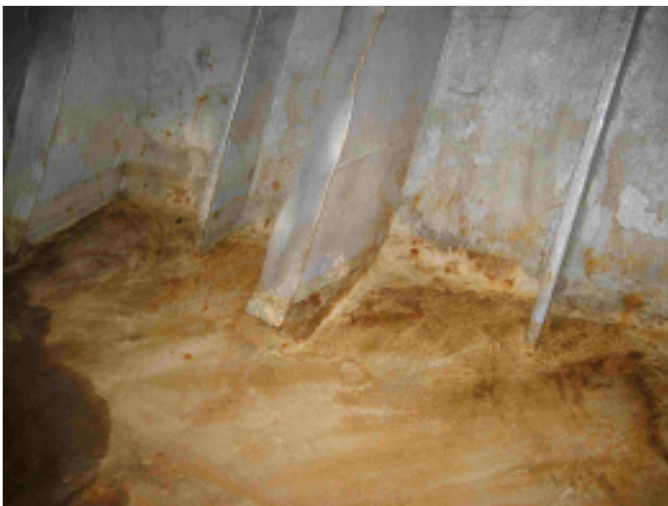
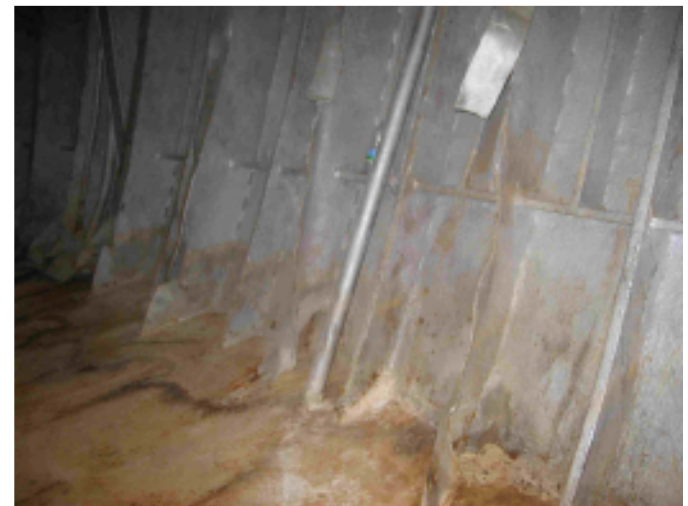
- main fire line is holed in main deck and heavy leaking (temporary repairs by clamps are noted);
- inflatable liferafts are fitted with expired hydrostatic release units (and weak links are not properly connected);

- port side lifeboat is not launchable by gravity and appliances are not properly working (more than 20 minutes needed to lower the boat at sea);
- hatchcovers are heavily corroded and not weathertight;

- furnishings are worn out and/or heavily damaged;
- transom is heavily buckled (some frame is heavily deformed in steering gear and welding seriously damaged);

- pilot ladders are damaged; pilot lifebuoy is without self-igniting light;
- water tanks no. 1 and no. 2 are holed (some temporary repair by doublers is noted);
- water level detectors inside the hold are inoperative.

After that several temporary repairs are carried out before departure and all non-structural deficiencies are rectified in the detention port, a single voyage is agreed by PSC Authority to the owner and Administration towards the indicated repair yard. The ship leaves Catania on the 7th of march 2013 but fails to comply with all conditions indicated in the authorization to proceed. As no confirmation is received from the Port State Authority of the repairing port that the ship has arrived in the planned shipyard within the expected time, on the 19th of march 2013 a banning order is issued.
