# Paris MoU

## on Port State Control

Name:	HUANGHAI DEVELOPER
IMO:	9458444
Flag:	Hong Kong, China
Type:	General Cargo
GT:	20682
Class:	Bureau Veritas
RO:	Bureau Veritas
IMO Company:	Tianjin Xinhai Intl Ship Management
Date keel laid:	17/12/2008
Delivery date:	10/03/2013

MV "HUANGHAI DEVELOPER" IMO: 9458444 flying Hong Kong flag, arrived at Hamburg/Germany on 09/08/2016 for cargo operation, no survey or repair work was planned for the port call.

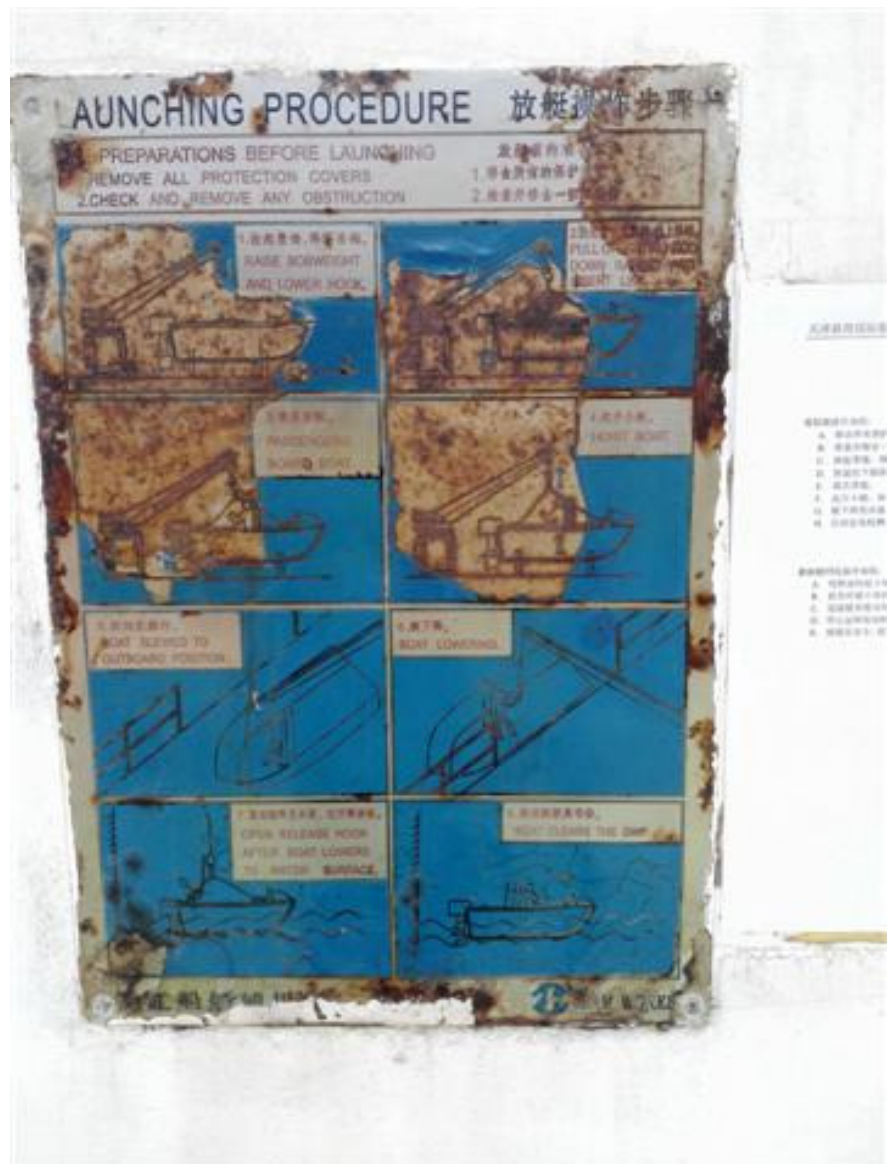
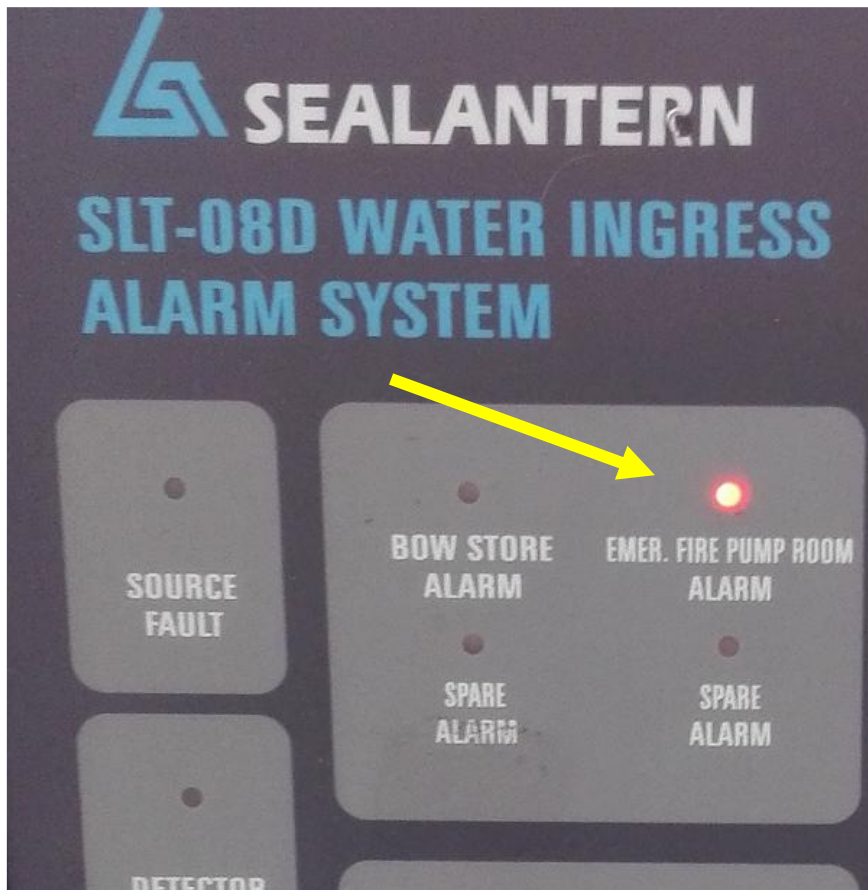
The windows of the free-fall boat, were so dirty that no view from inside to outside was anymore possible.

The poster "launching procedures of rescue boat" was so worn out that single steps of the procedures couldn't be identified. Posters for the familiarisation of the crew are a key point for safe operation at sea.
