M/V "SIMONE" (ex "YONG GI") IMO: 8035104

SHIP'S PARTICULARS

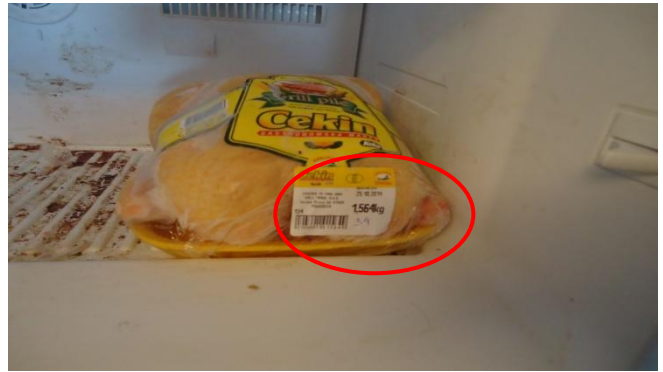
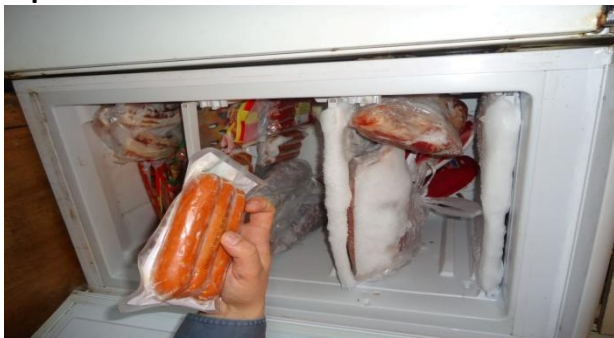
Expired

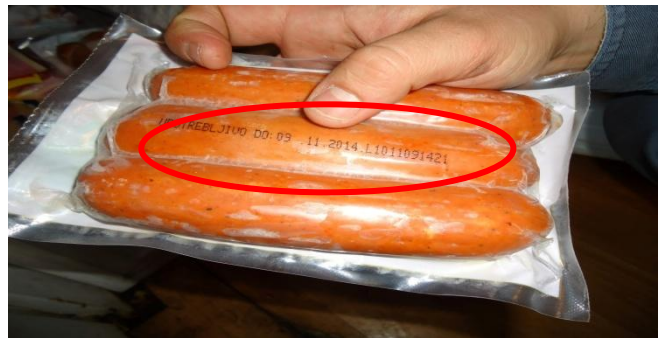
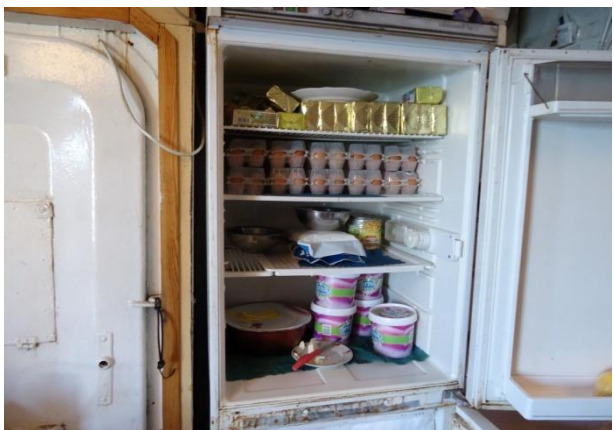
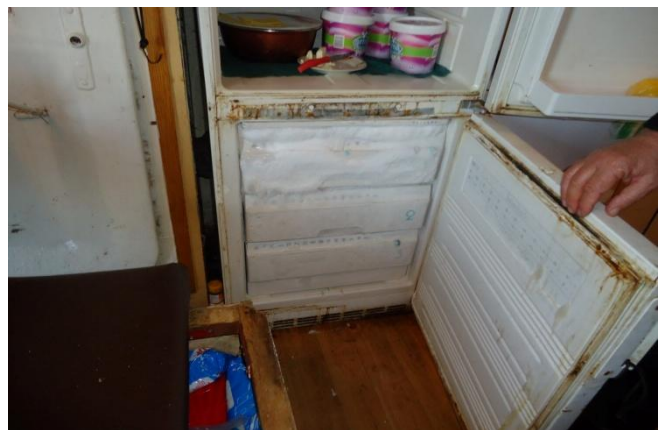
Expired

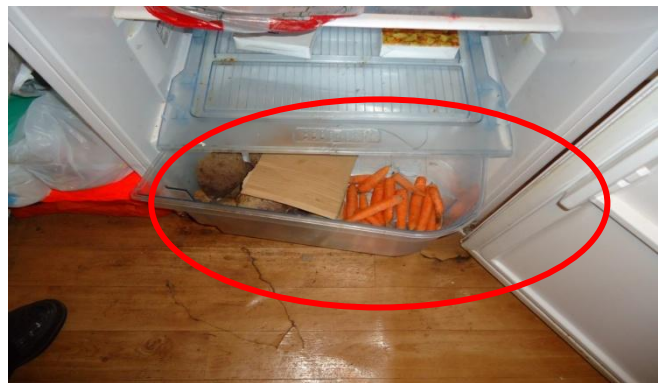
Insufficient quantity of fresh provisions (vegetables, fruits, etc.)

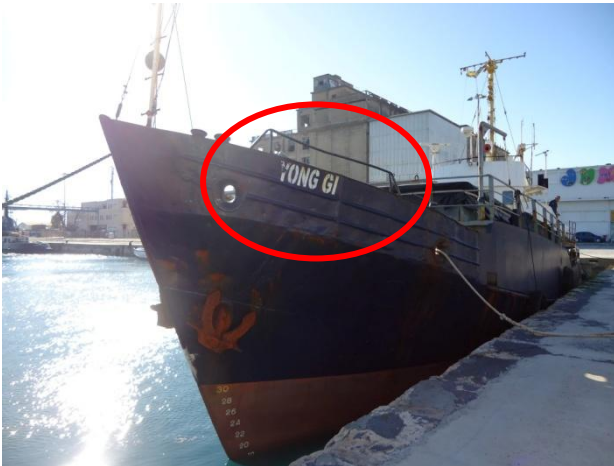
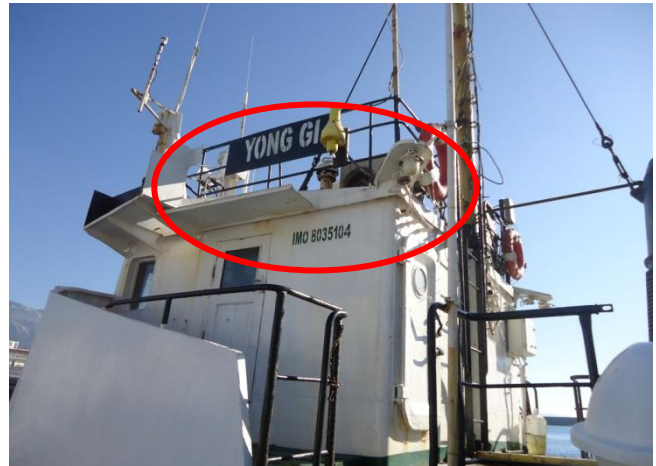
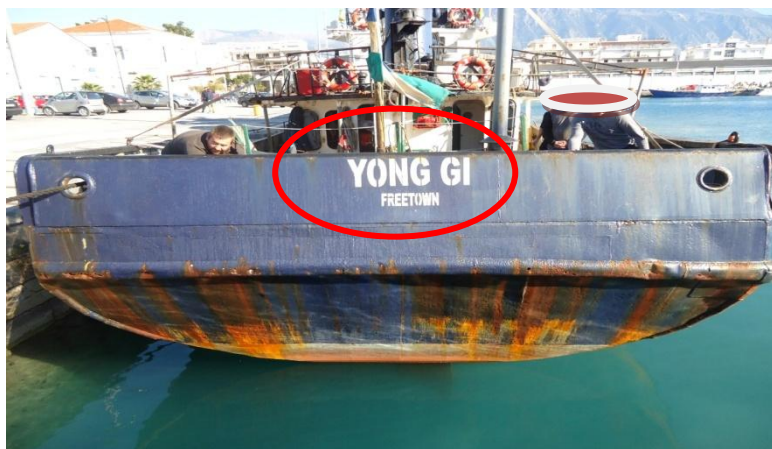
The ship's name on first visit: "YONG GI"

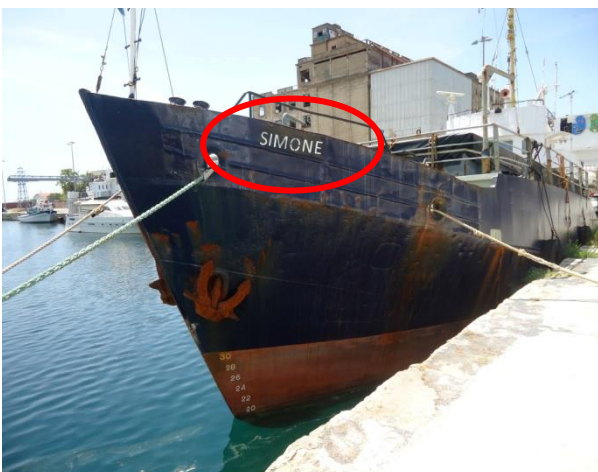
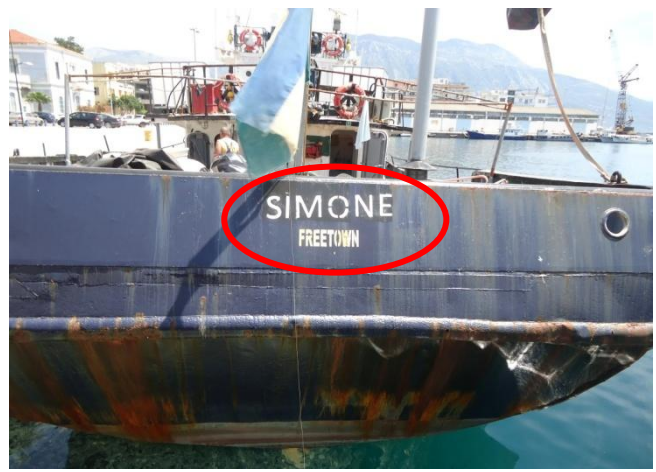
The ship's new name changed before departure from port Kalamata (Greece).
