HELLENIC REPUBLIC
MINISTRY OF MARITIME AFFAIRS AND INSULAR POLICY
HELLENIC COAST GUARD
CENTRAL PORT AUTHORITY OF KALAMATA
P.S.C. DISTRICT OFFICE OF KALAMATA

Detention of M/V "TOK TOK"

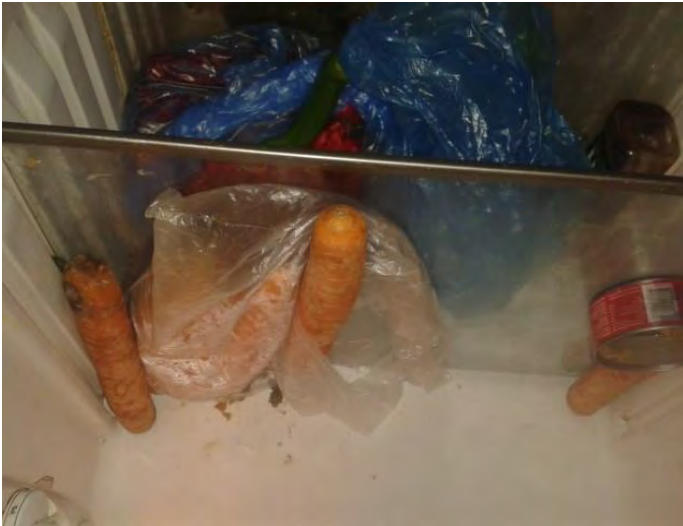
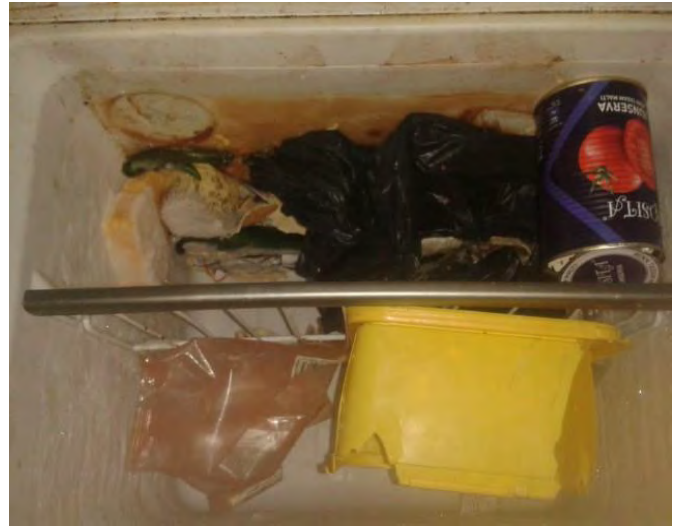
THE FREEZERS

The condition of the refrigerator in the galley

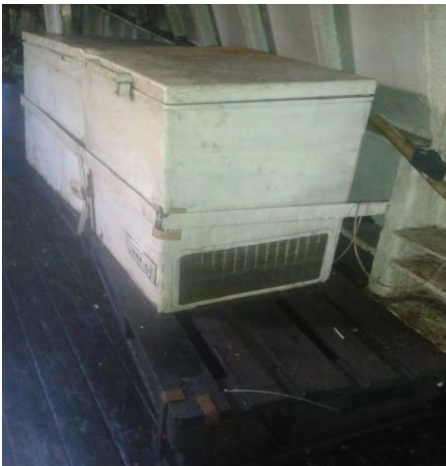
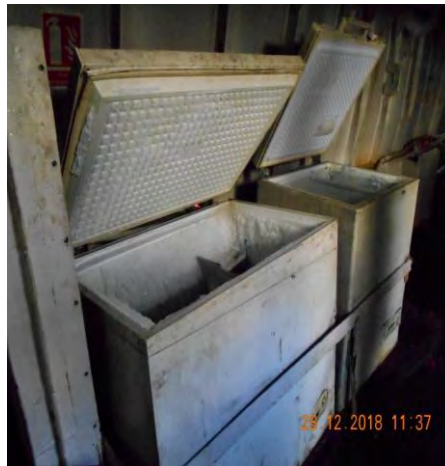
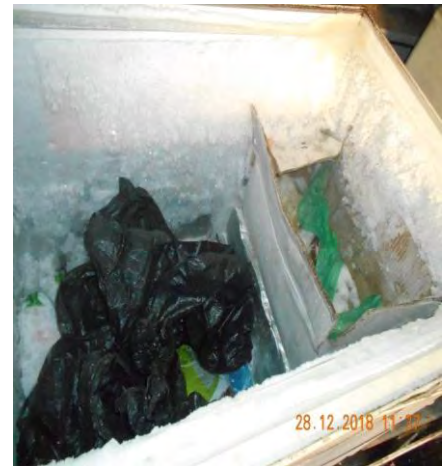
The freezers located at the main deck

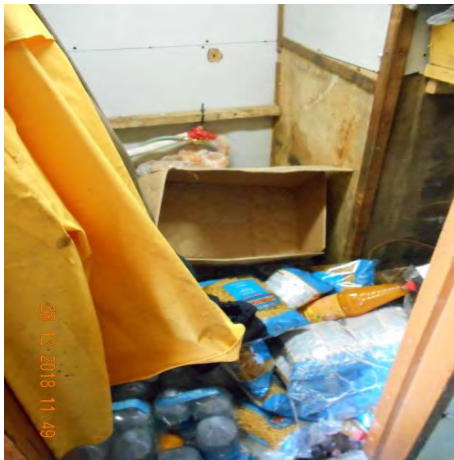
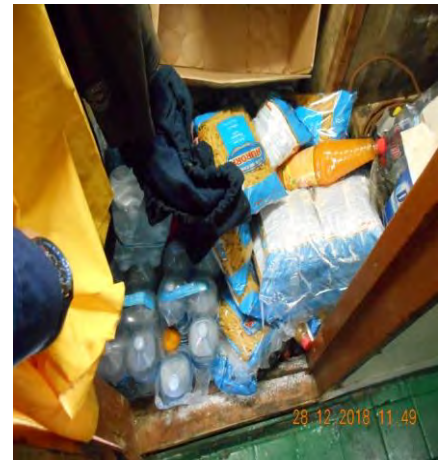
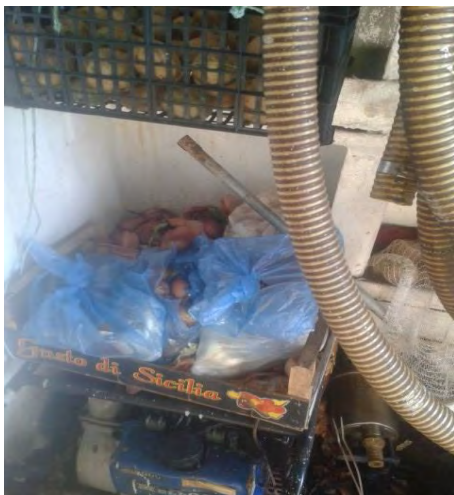
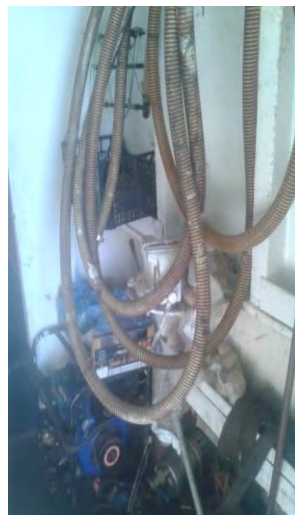
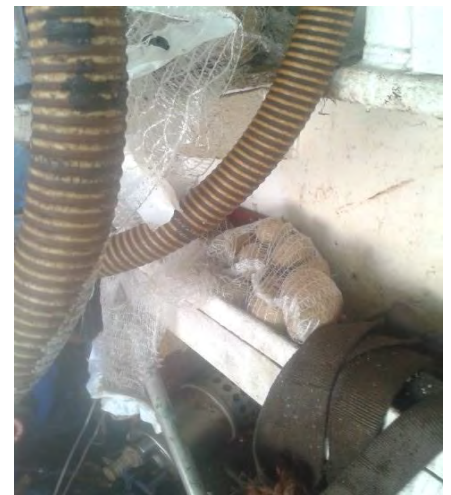
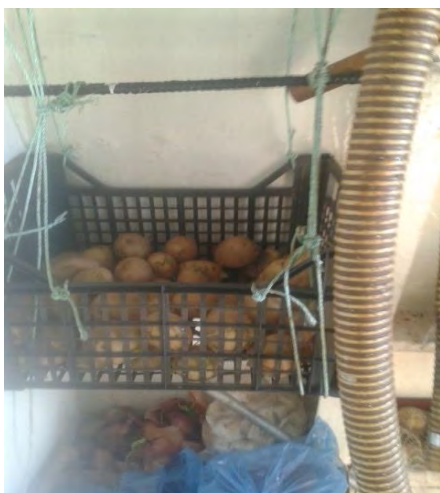
THE STORAGE ROOM FOR THE PROVISIONS

Insufficient quantity of fresh provisions (vegetables, fruits, etc.). Various provisions (potatoes, onions, etc.) were placed in a storage area with other materials and in other inappropriate spaces.

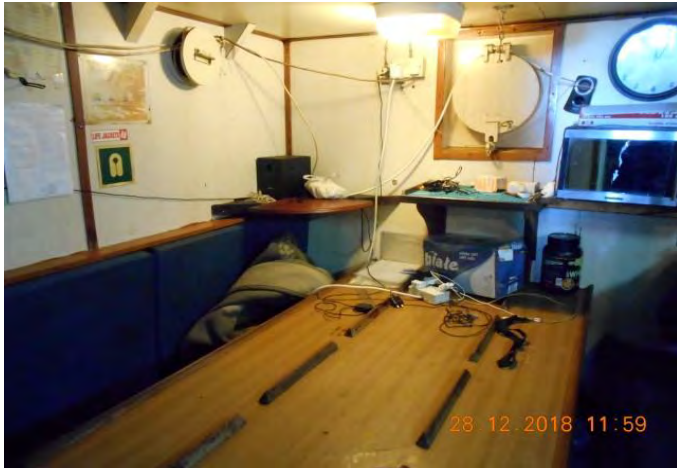
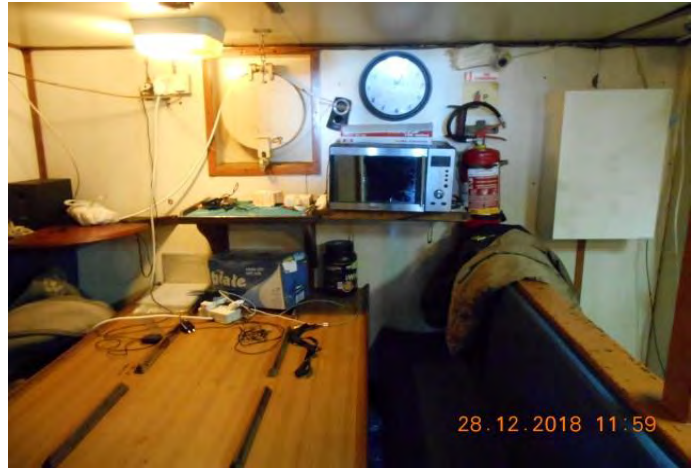
THE MESS ROOM

The mess room with provisions stored under the seats.
Cables were hanging all over the room and the cleanliness was not as it should be

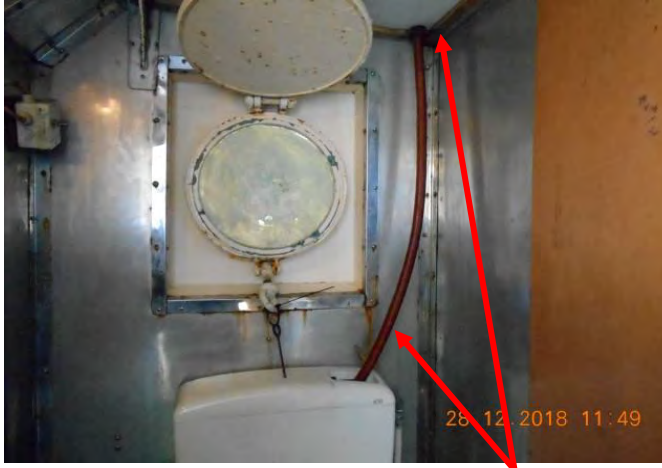
THE CREW ACCOMMODATION SPACES (WC)

The way of providing water to the toilet

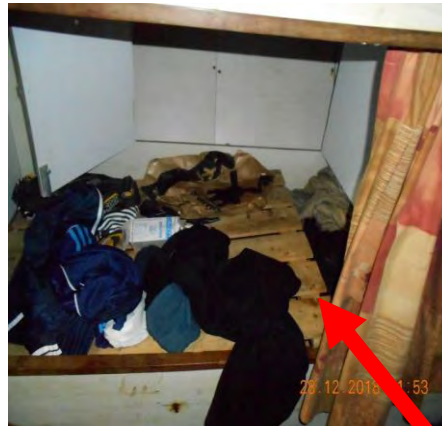
The beds of crew members

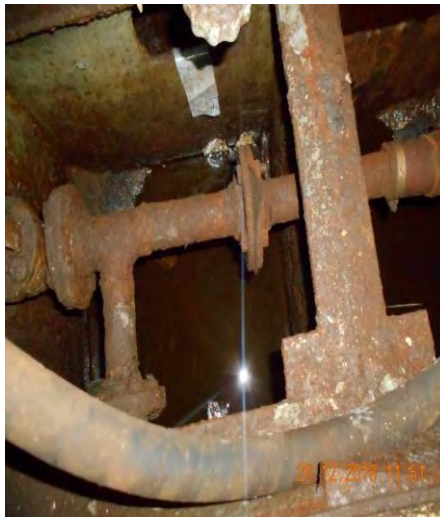
The Steering Gear hydraulic piping system

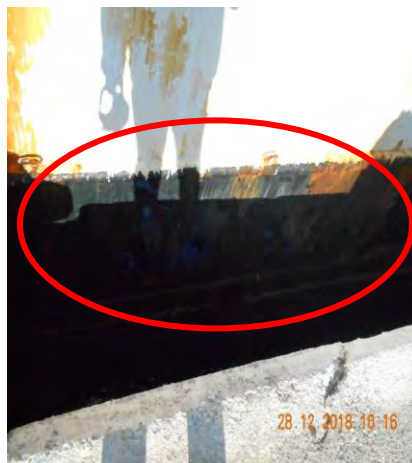
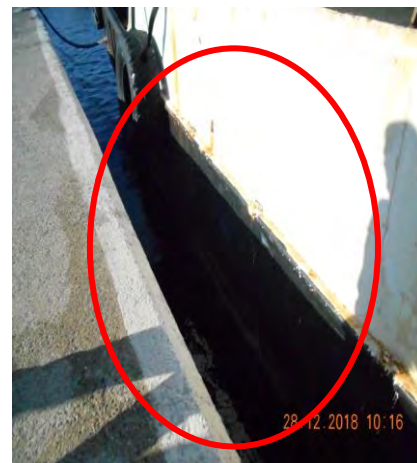
The Deck Lines, the Load Lines and the Mark of the Assigning Authority, on both sides of the vessel, were missing

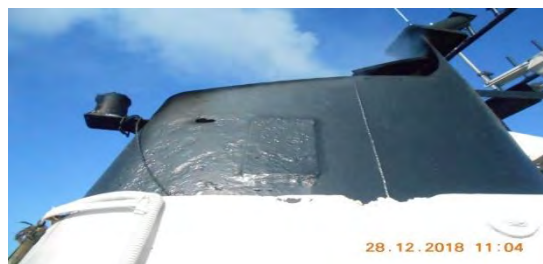
Cracks and holes all around the main body of the funnel

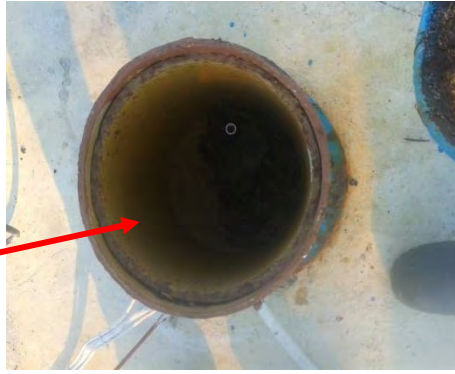
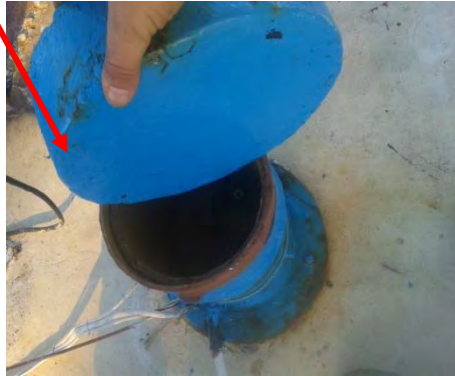
The ventilator of on the upper deck, aft of the wheel house

The natural ventilators (mushroom type) located at the monkey deck and on the upper deck (aft of the wheel house) are corroded and the closing mechanism is inoperative

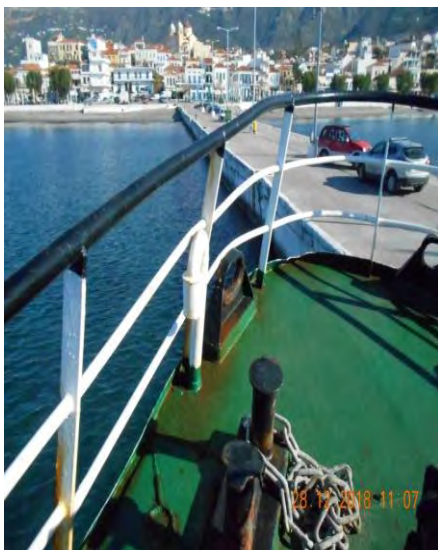
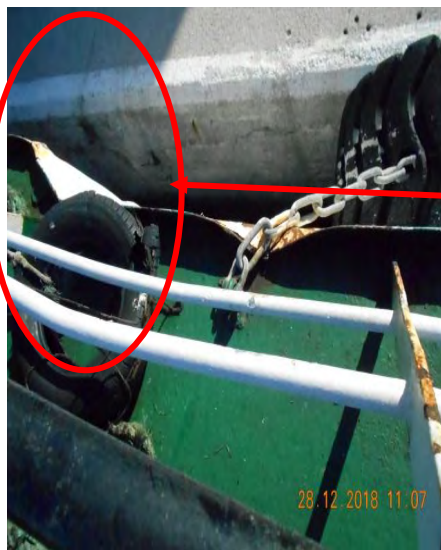
Many protective hand rails found damaged and bended. Also many cracks, bends and holes on the metal plate on both sides of the upper deck plate (between the bulwark slays of the rails) were found

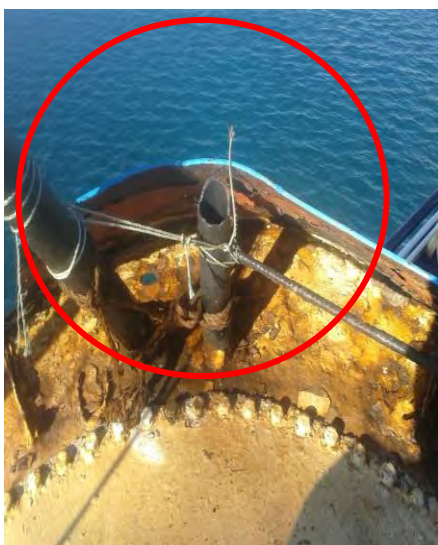
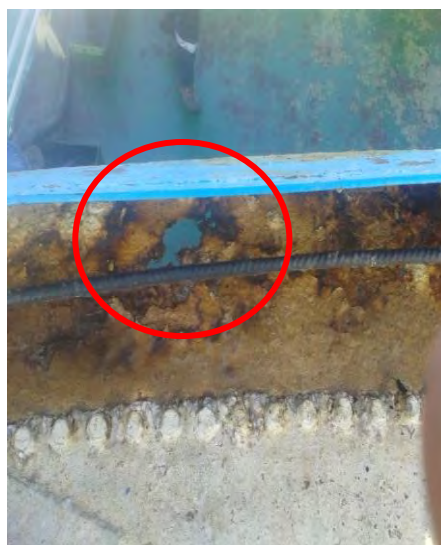
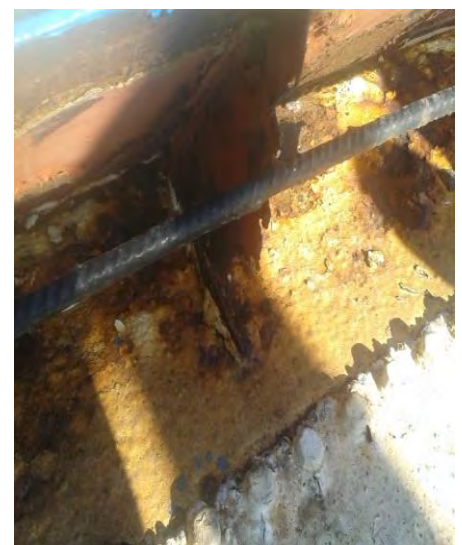
Various cracks / bends and holes, on the metal plate all around the monkey deck

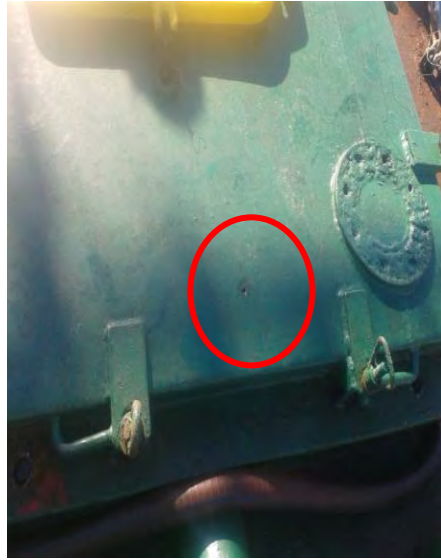
Holes on the cargo hold hatch (which was converted as cargo tank)

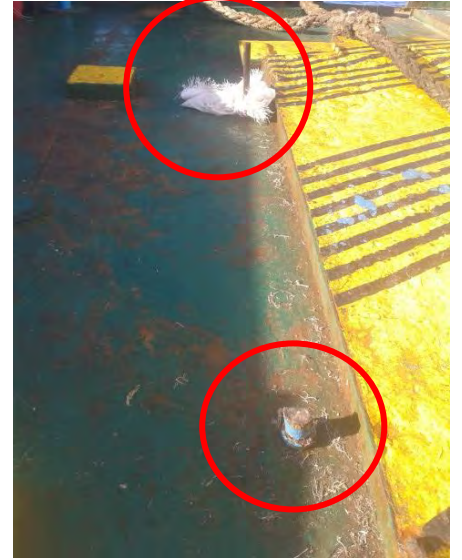
Openings on the main deck closed with wooden plugs

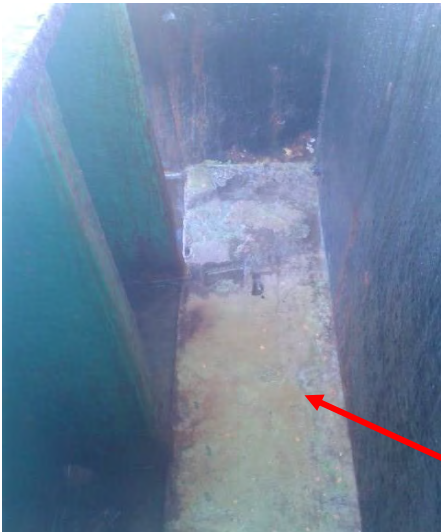
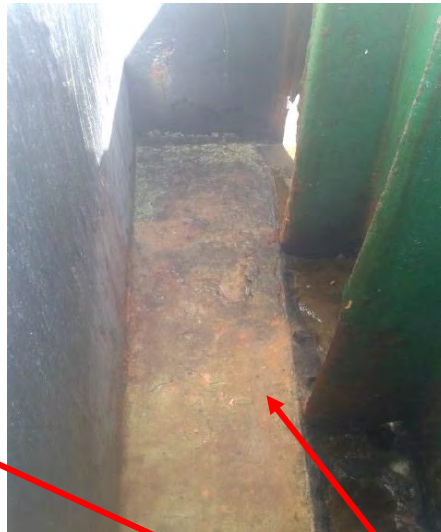
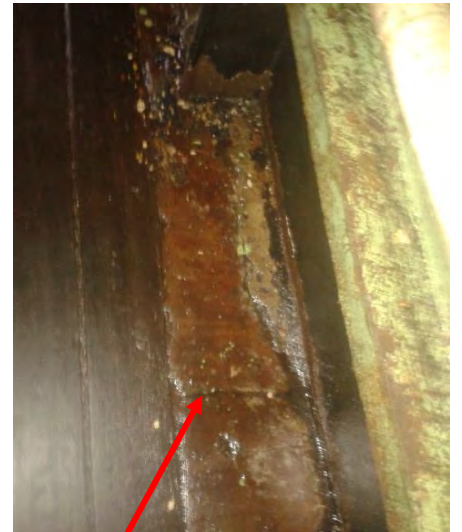
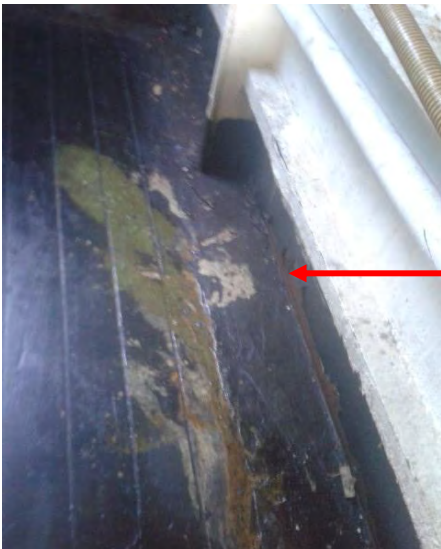
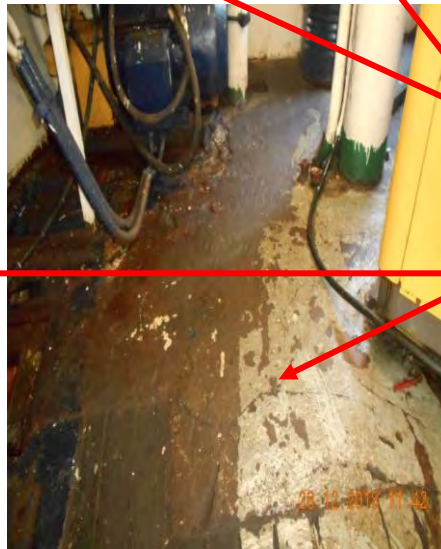
The surfaces located:

- a) at both sides of the aft part of the accommodation superstructure on the main deck
- b) at both sides on the main deck from the accommodation superstructure until forward and in the centre of the main deck forward of the cargo hatch, were covered by cement

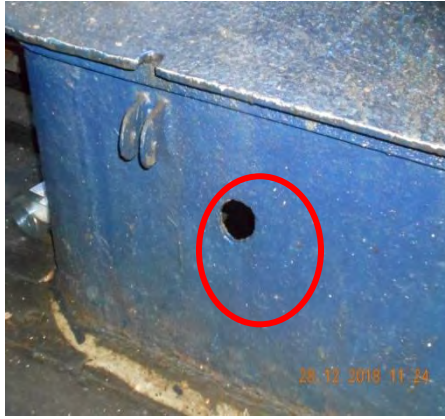
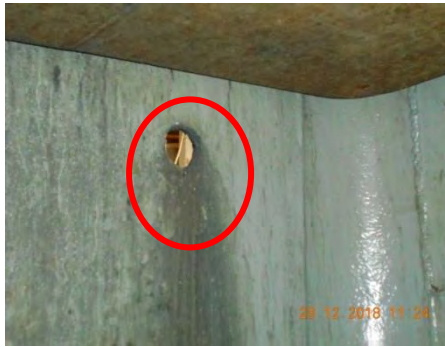
Holes on the C/H hatch

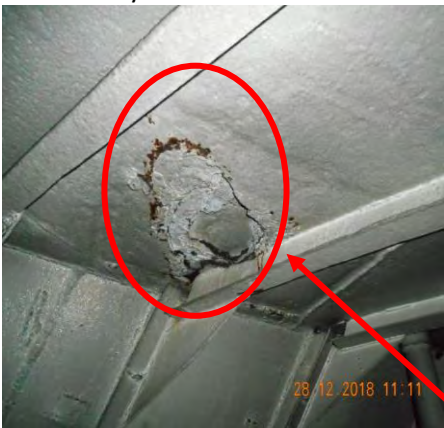
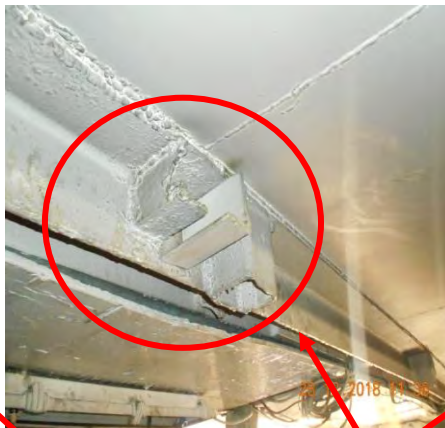
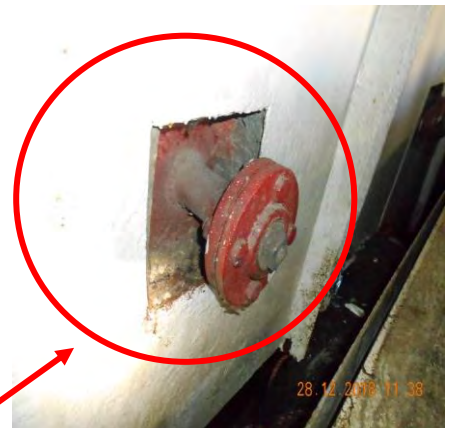
Various holes and other structural alterations

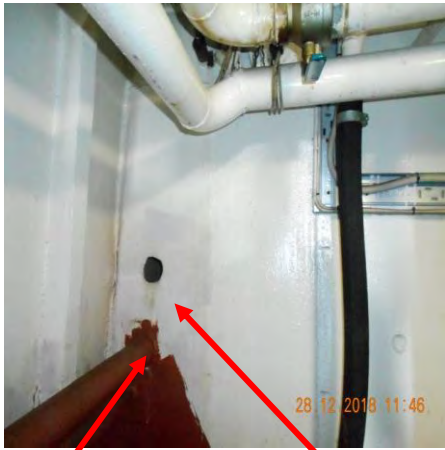
Hole
Bulkhead penetration

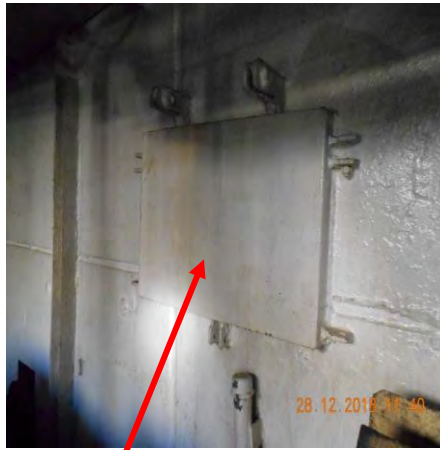
Sized hatch

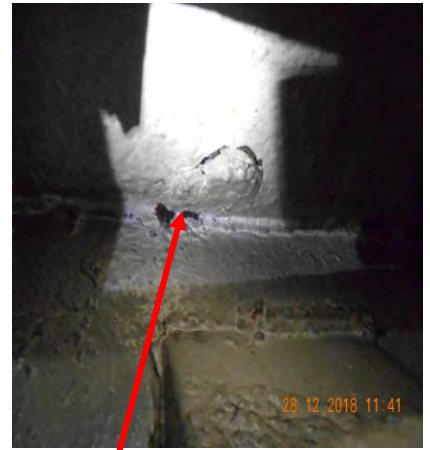
Holed deck

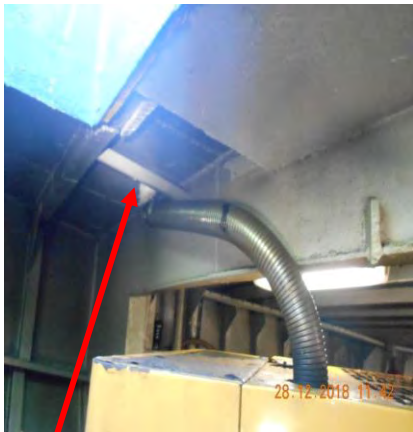
Alterations of the deck plate, in order to create access for the above pipes lines to the upper deck

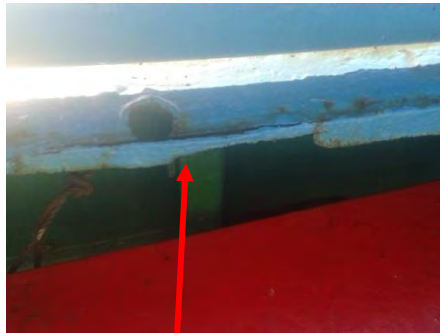
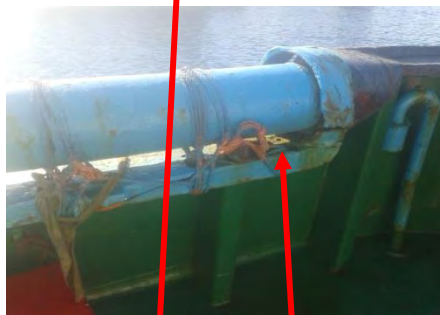
Corroded

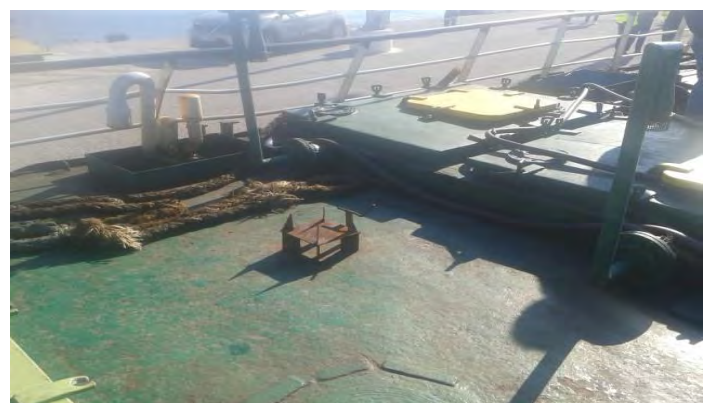
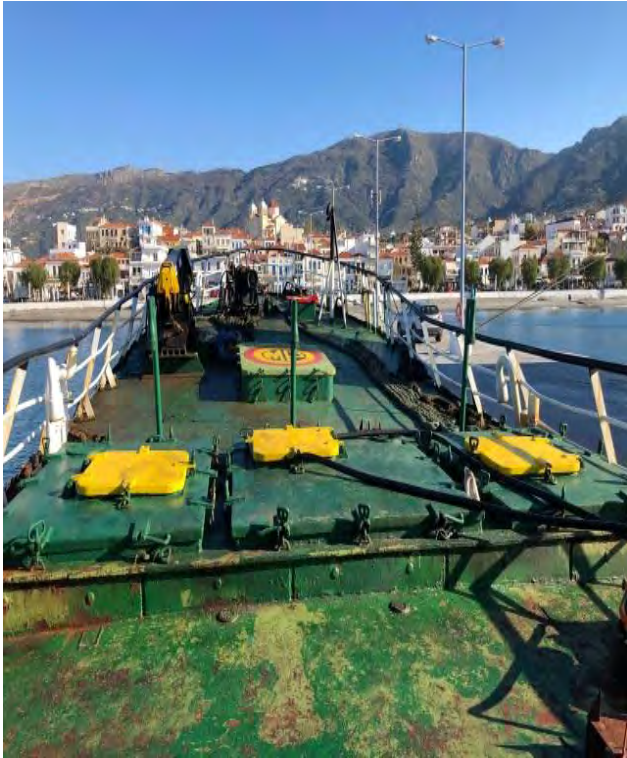
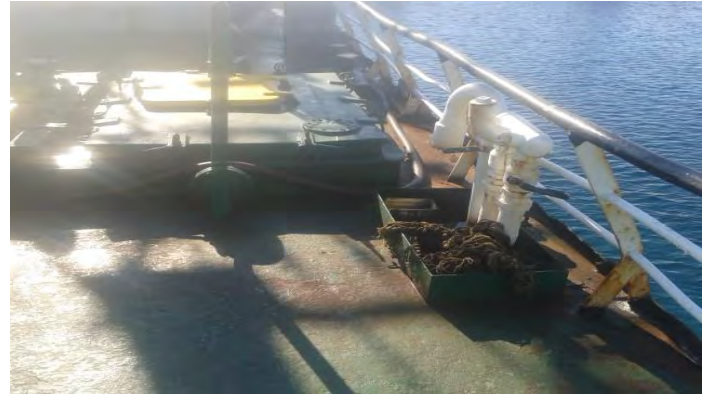
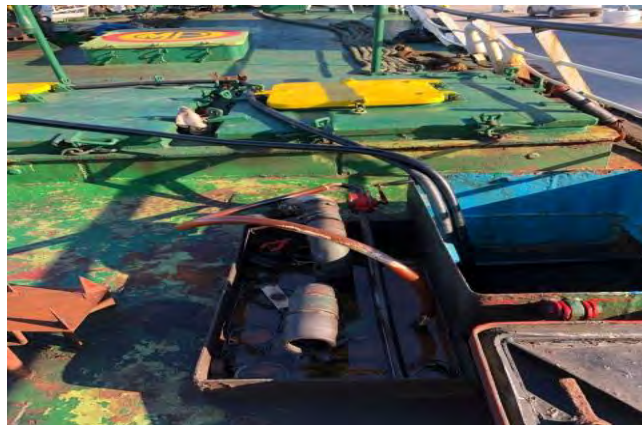
The main deck

- The hatch of the oil tanks
- Piping lines constructed and modified for the oil transfer
- Plastic pipes all over the ship, for the transfer of oil

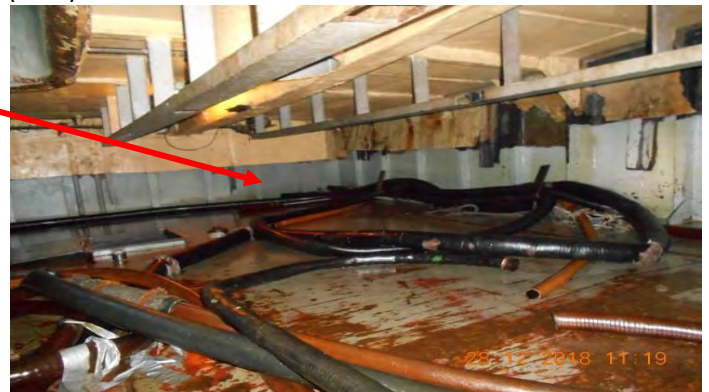
The upper part of the oil tank

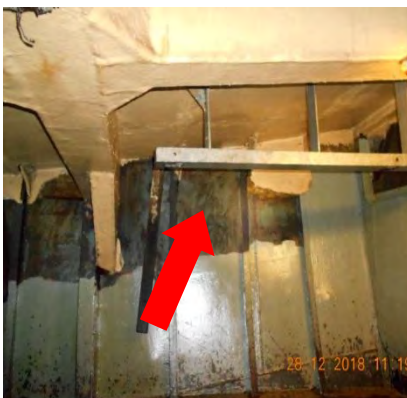
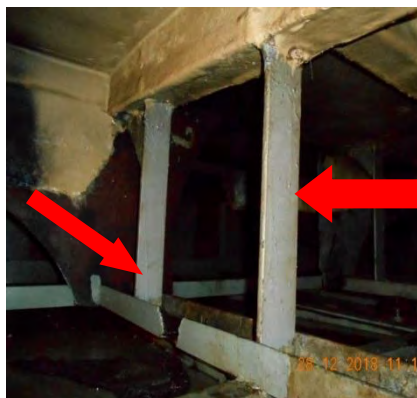
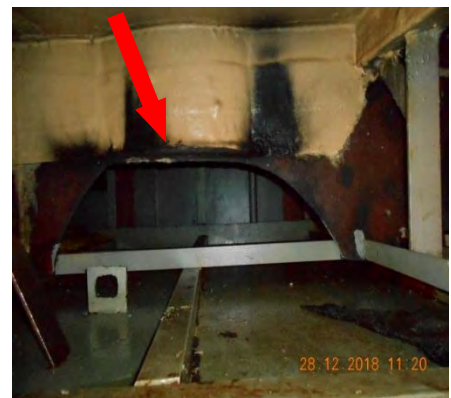
Modified bulk heads, vertical and longitudinal frames

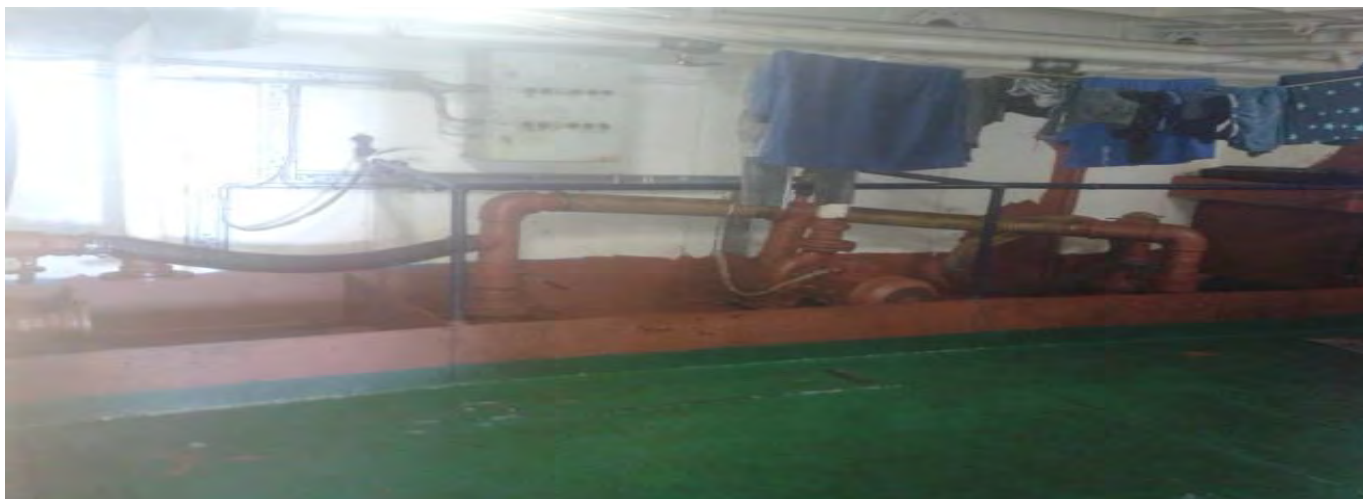
The modified "Cargo Pump Room"

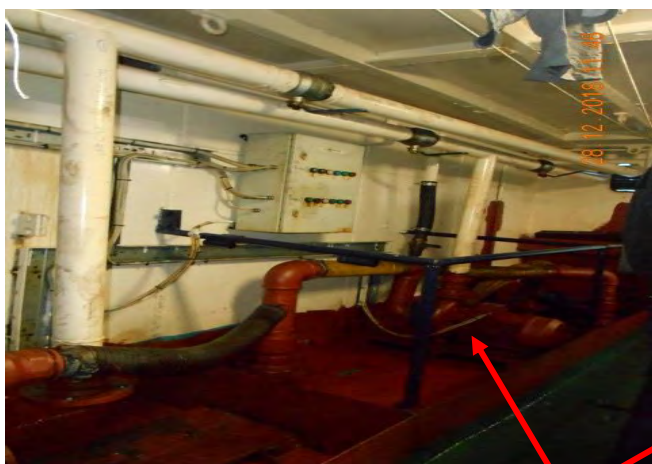
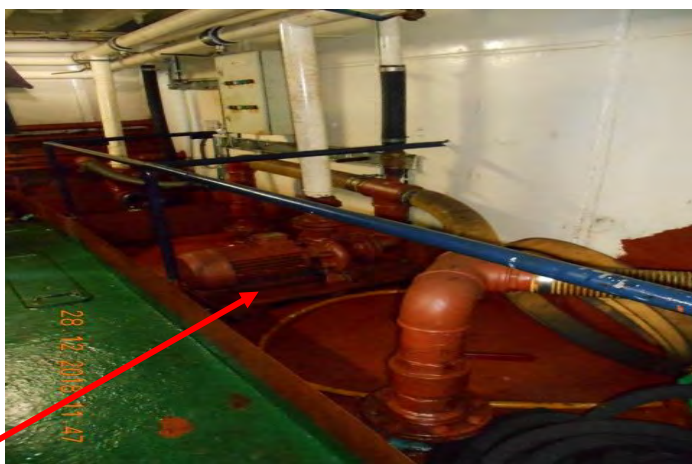
Cargo transfer pumps, with the relative piping system

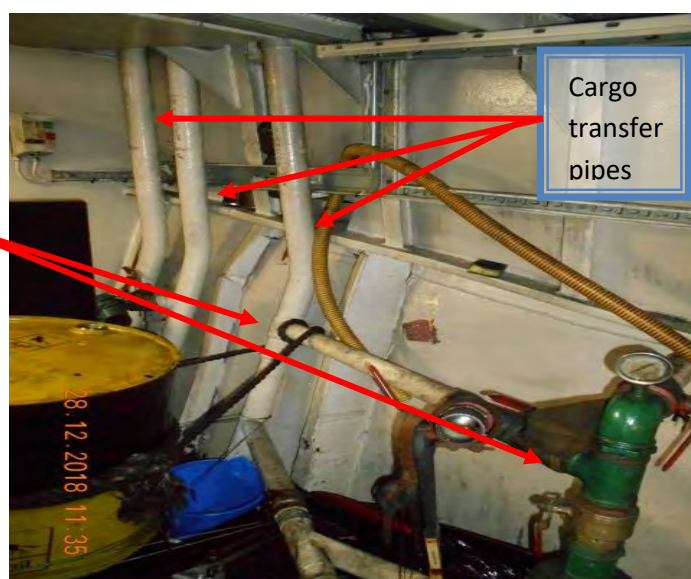
Ballast pump, connected with the cargo transfer piping system, modified as such to be able to transfer oil from the cargo tanks to the main deck and also overboard.

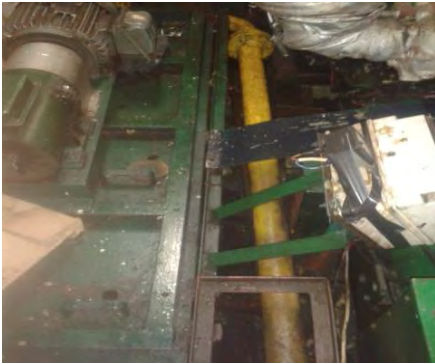
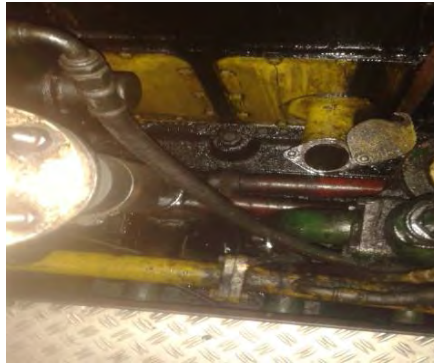
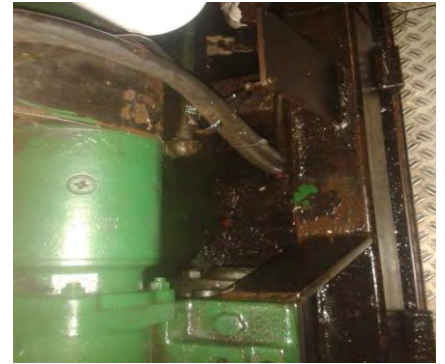
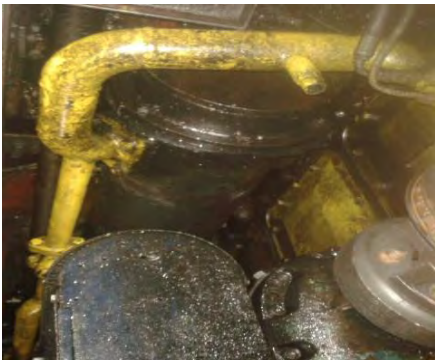
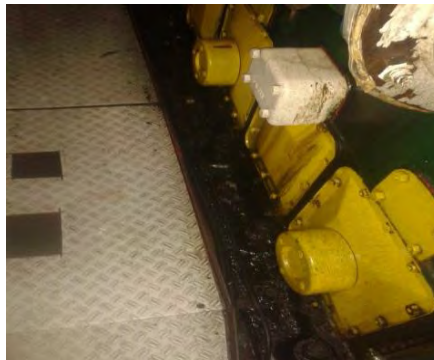
The M/E, and the D/G were found with oil leakages.
The bilges were found with significant quantities of oil residues

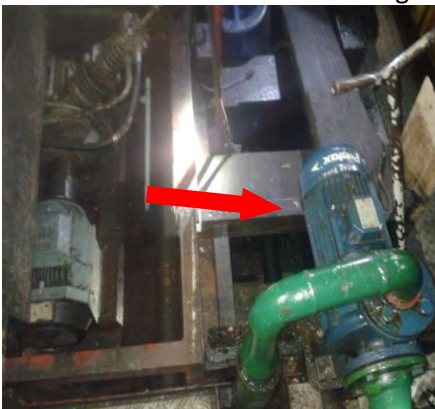
Suction pump (bilge pump)

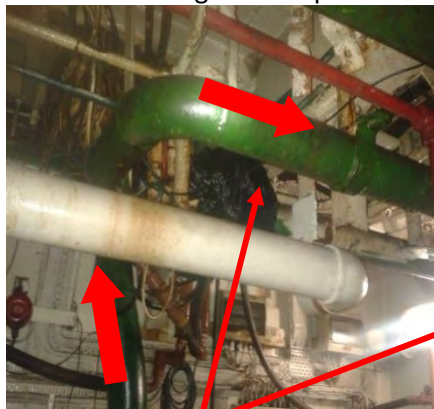
The piping from the suction pump (bilge) leading to the upper deck (overboard)

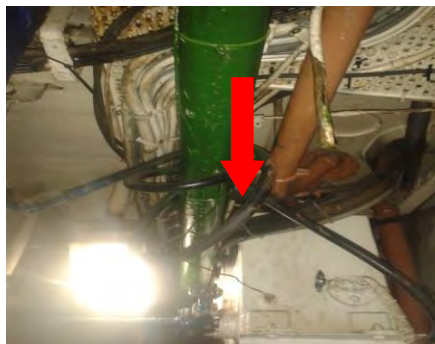
The same piping was connected with the fire line.

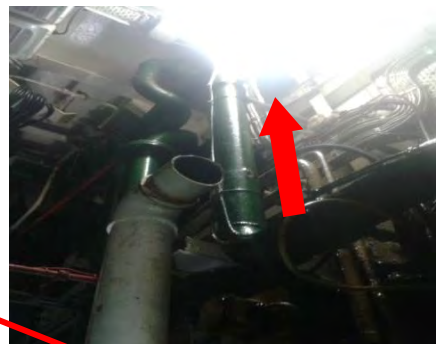
Due to the fact that the vessel was under convention size, according C/E, the vessel was not equipped with holding tanks for the storage of bilges and also without sludge tank. A common piping system (pumps , pipes), with connections to the fire line, to the bilge suction pump, and straight overboard were found
